Illicit Discharge Incident Tracking Sheet

Incident ID: 2017-01				
Responder Information				
Call taken by: N/A			Call date: N/A	
Call time: N/A			Precipitation (inches) in past 24-48 hrs: 0.00	
Reporter Information				
Incident time: _____ PM			Incident date: 1/20/2017	
Caller contact information (<i>optional</i>): N/A				
Incident Location (<i>complete one or more below</i>)				
Latitude and longitude: 38.989771, -76.934763				
Stream address or outfall #: Outfall 002				
Closest street address: Baltimore Ave. & Lakeland Rd., College Park, MD 20742				
Nearby landmark: Brendan Iribe Center				
Primary Location Description		Secondary Location Description:		
<input checked="" type="checkbox"/> Stream corridor (<i>In or adjacent to stream</i>)		<input checked="" type="checkbox"/> Outfall	<input type="checkbox"/> In-stream flow	<input type="checkbox"/> Along banks
<input type="checkbox"/> Upland area (<i>Land not adjacent to stream</i>)		<input type="checkbox"/> Near storm drain	<input type="checkbox"/> Near other water source (storm water pond, wetland, etc.):

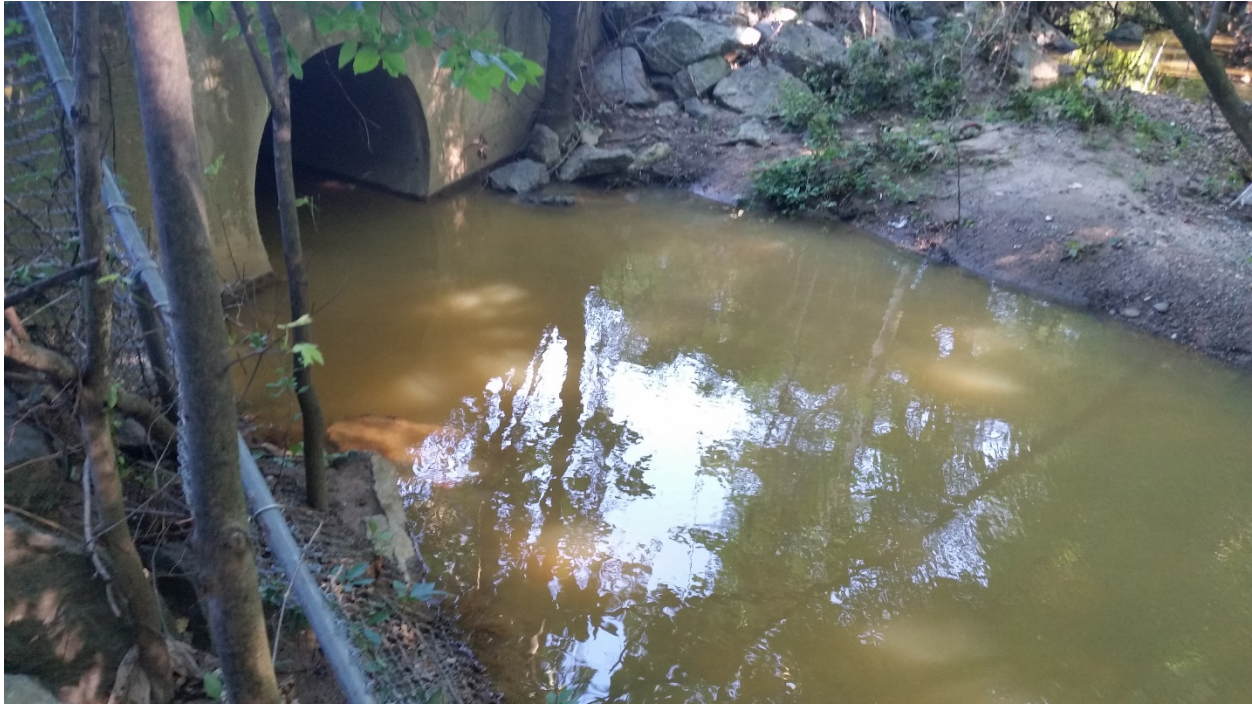
During the monthly NPDES sampling, Environmental Affairs observed a large amount of sediment being discharged from Outfall 005 (photos attached). Environmental Affairs later investigated the Outfall 005 watershed to determine the source, and it was concluded that the most likely source was construction runoff from the area between Francis Scott Key Hall and Woods Hall (photos attached). Environmental Affairs notified Chris Ho and Bob Olen from UMD Facilities Management of the situation via email on 7/25/17. Facilities Management notified the contractor who later installed a berm to divert the water and secured filter fabric over the inlet to prevent sediment from entering the storm drain. The contractor also cleaned up the loose soil spills on the pavement.

Outfall 005 discharging highly turbid, sediment laden water.

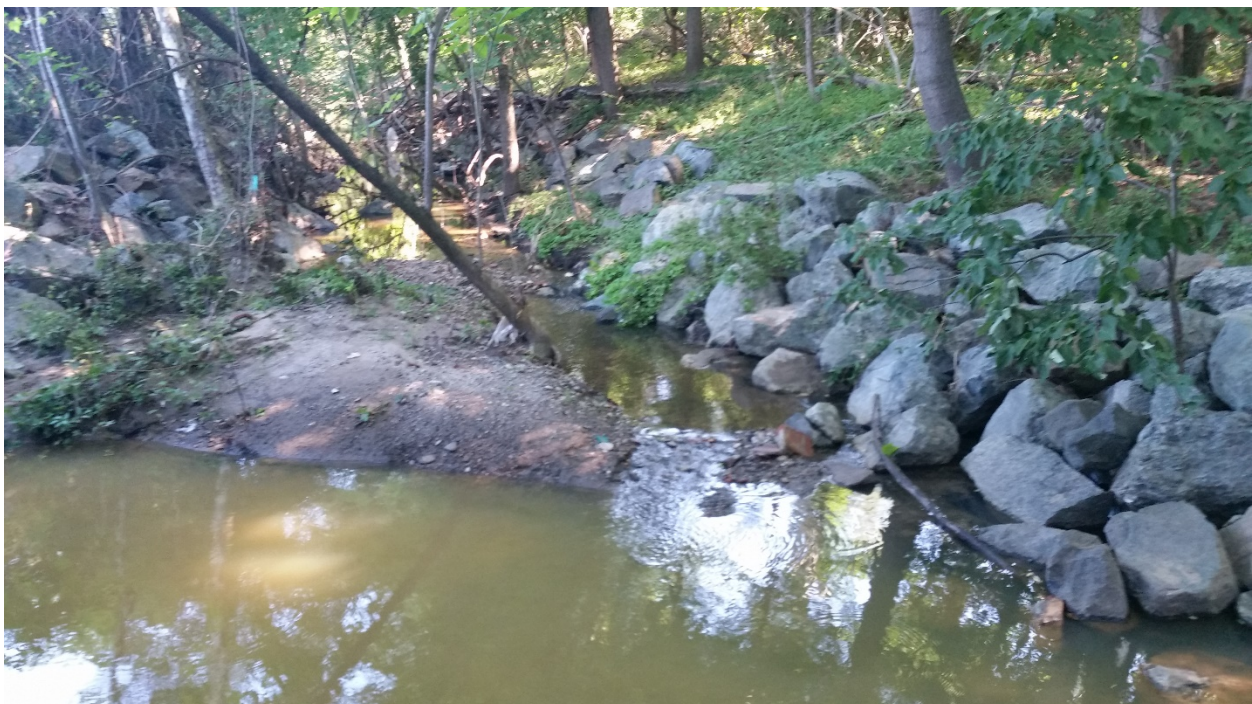
Intersection of Outfall 005 discharge and an unnamed tributary of Paint Branch Creek; discharge is highly impacting receiving waters.

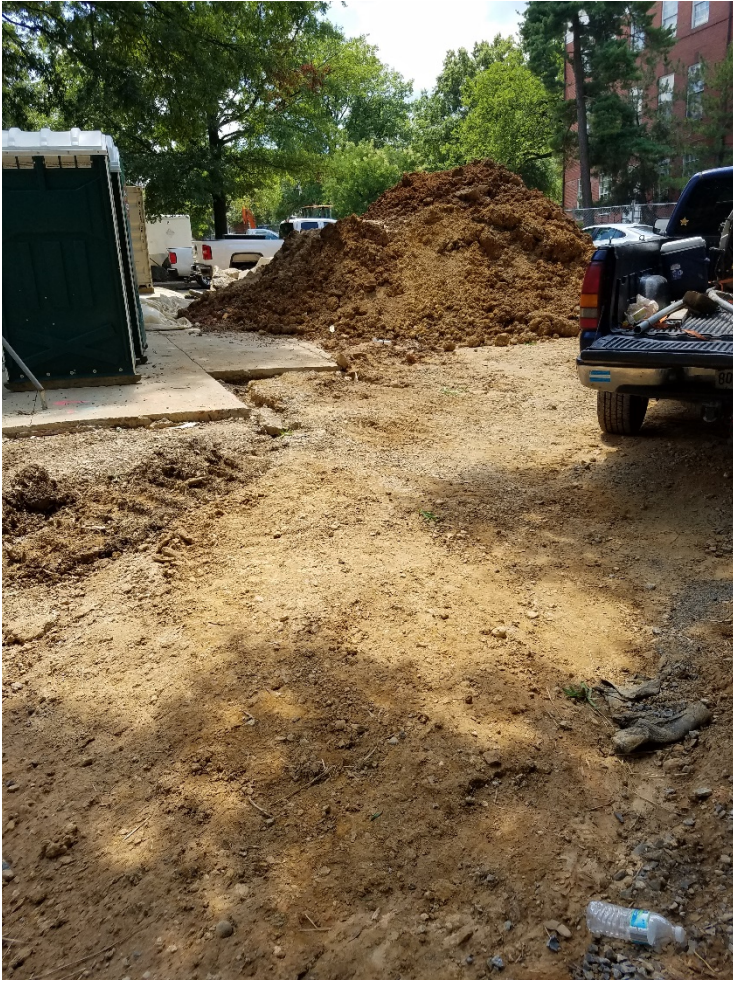
Between Francis Scott Key Hall (FSK) and Woods Hall, looking towards FSK; large soil pile uncovered and exposed to stormwater

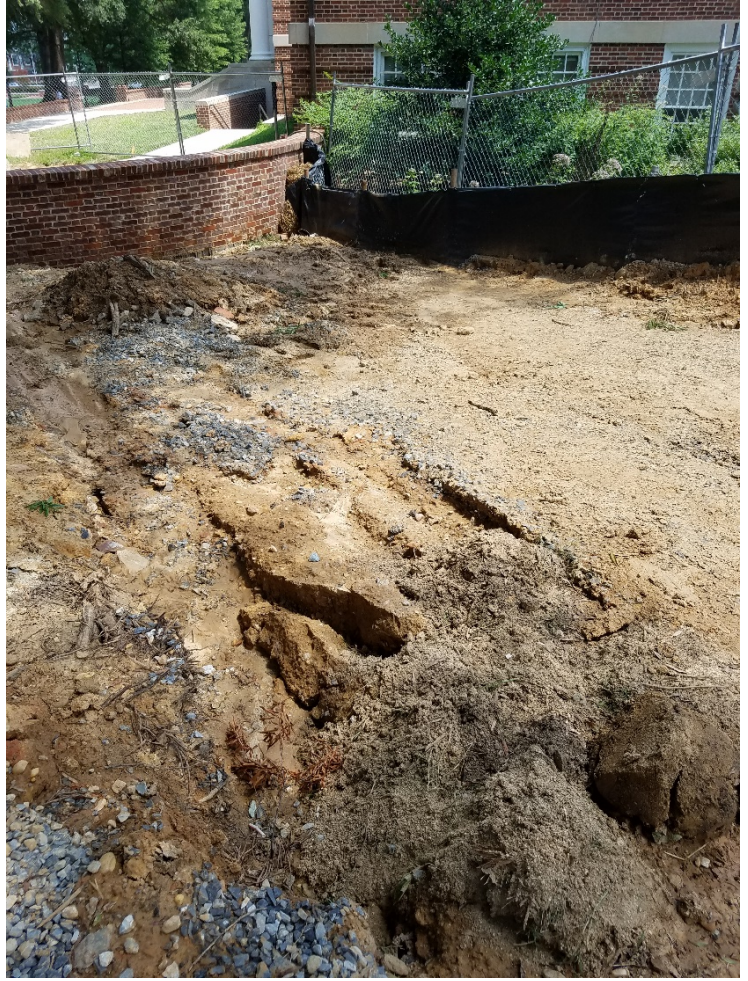
Between Francis Scott Key Hall (FSK) and Woods Hall, looking towards Woods Hall; large rill suggesting recent erosion. Storm drain is located on the right side of the pictured fence.

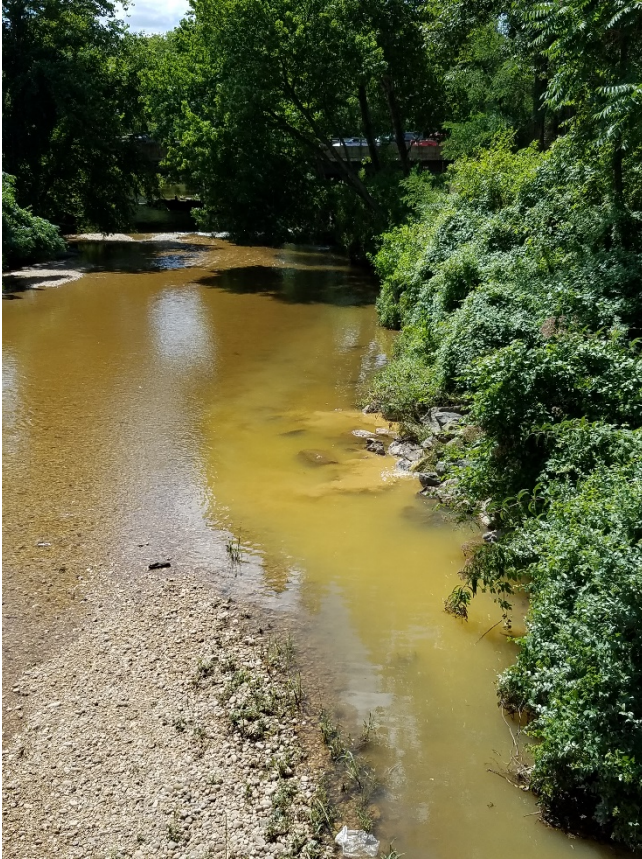
During the monthly NPDES sampling, Environmental Affairs observed a large amount of sediment and some persistent foam being discharged from Outfall 003 (photos attached). Environmental Affairs later investigated the Outfall 003 watershed to determine the source, and it was concluded that the source was construction runoff from the Cole Field House project. Environmental Affairs notified Chris Ho and Bob Olen from UMD Facilities Management of the situation via email on 7/25/17. Facilities Management notified the contractor who then swept up all debris, covered up soil piles, and installed inlet protection.

Top left: intersection of Outfall 003 and Paint Branch Creek; sediment highly impacting receiving waters.

Improve existing BMPs and/or implement new BMPs in order to prevent construction sites from contaminating stormwater runoff

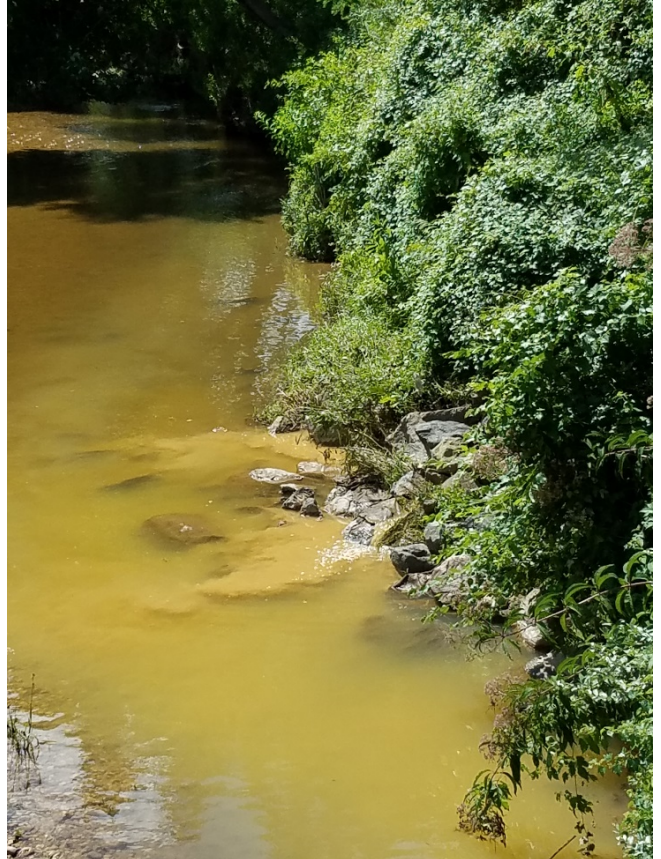
Top right: close up of the intersection of Outfall 003 and Paint Branch Creek.

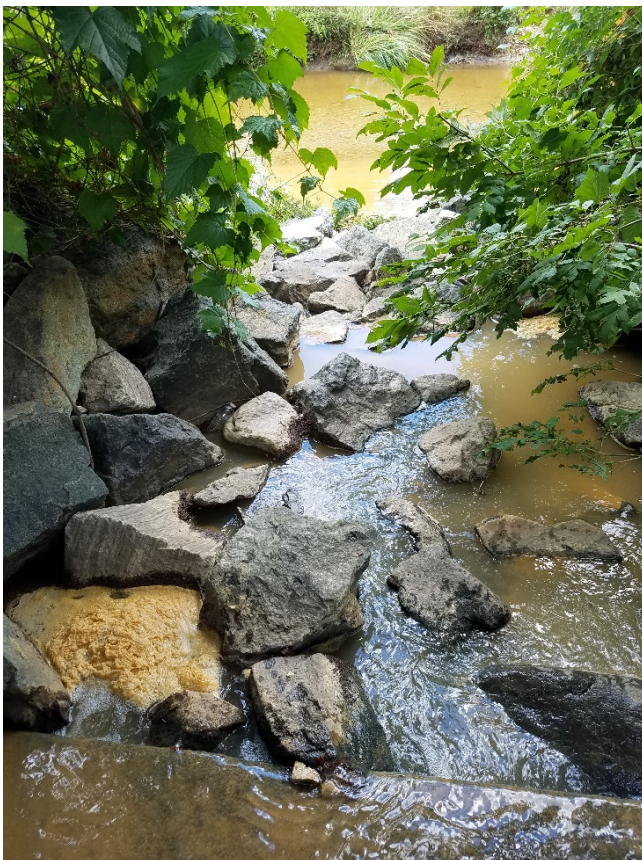
Bottom: view from Outfall 003 looking towards Paint Branch Creek; persistent foam and sediment discharging.

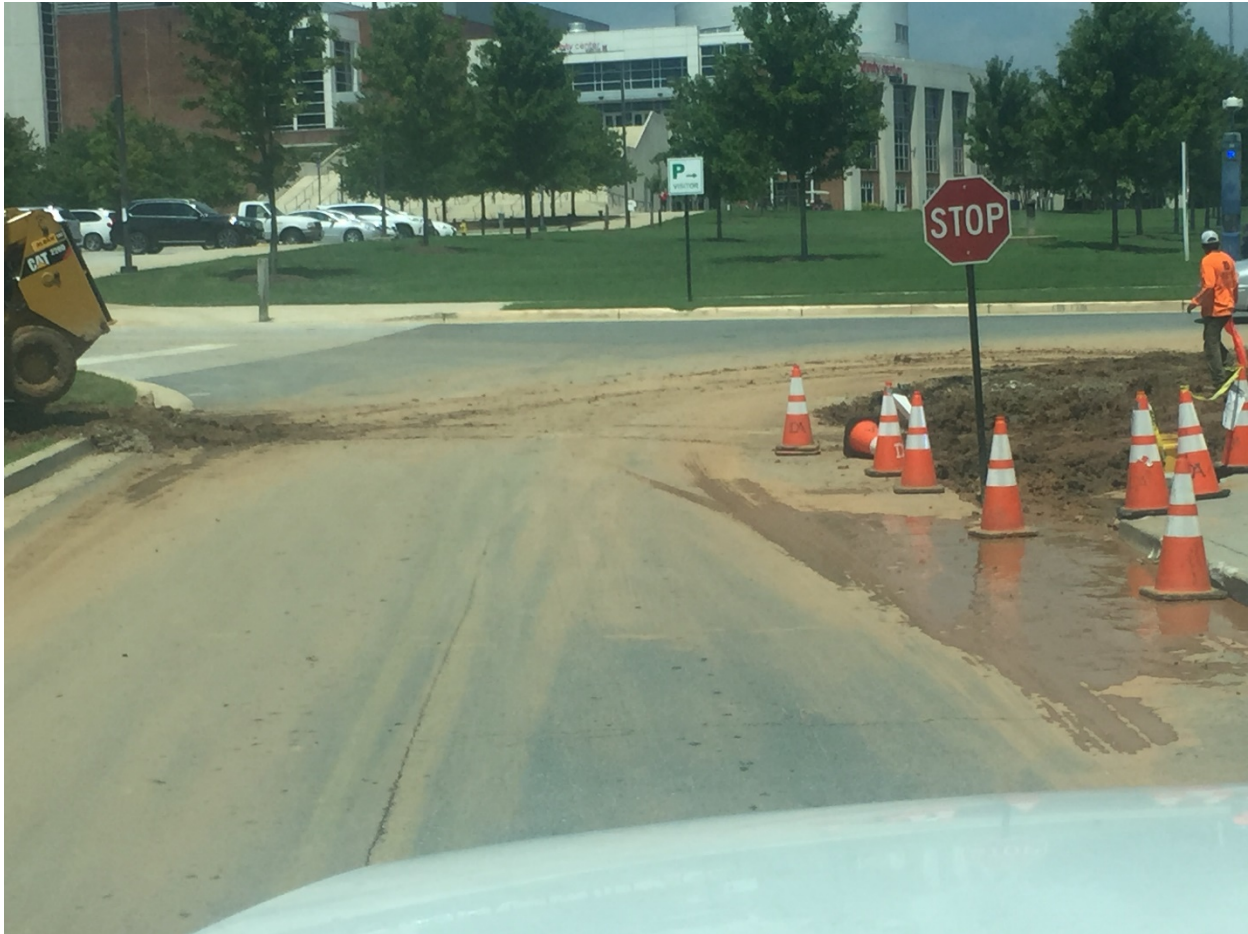
Environmental Affairs observed a small construction project at the corner of Regents Drive, near Wellness Way and the Xfinity Center parking lots. Although the area of disturbance was relatively small, there was a significant amount of sediment and sediment-laden water entering Campus Creek by way of curb cuts located 20-30 feet from the construction area. The contractor did not have any BMPs in use to protect the nearby waterway. Jason Baer notified Facilities Management via email on 8/2/2017. Facilities Management will implement BMPs to prevent construction activities from contaminating stormwater runoff.

On Regents Drive looking north towards Xfinity Center, a small construction site without any BMPs discharging highly turbid, sediment laden water to Campus Creek

Implement BMPs in order to prevent construction from contaminating stormwater runoff

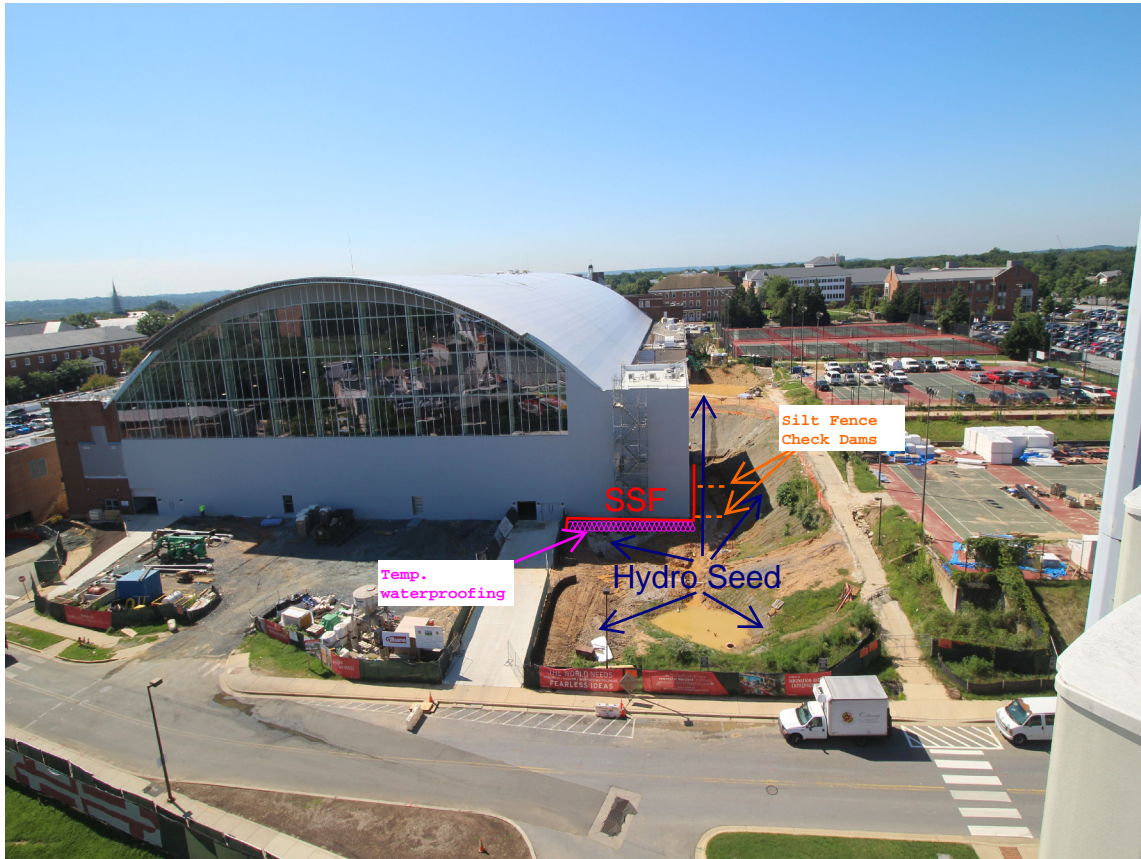
The New Cole Fieldhouse PTZ - View 2, College Park, MD

Approx. 150 Linear Feet of SSF. Tied into existing.

Some dress up of the slope and areas around the sediment pond will need to be addressed.

Sediment pond will need to be pumped down and sediment removed.

See attached for Hydro-seeding. Approx. 21000sq.ft.

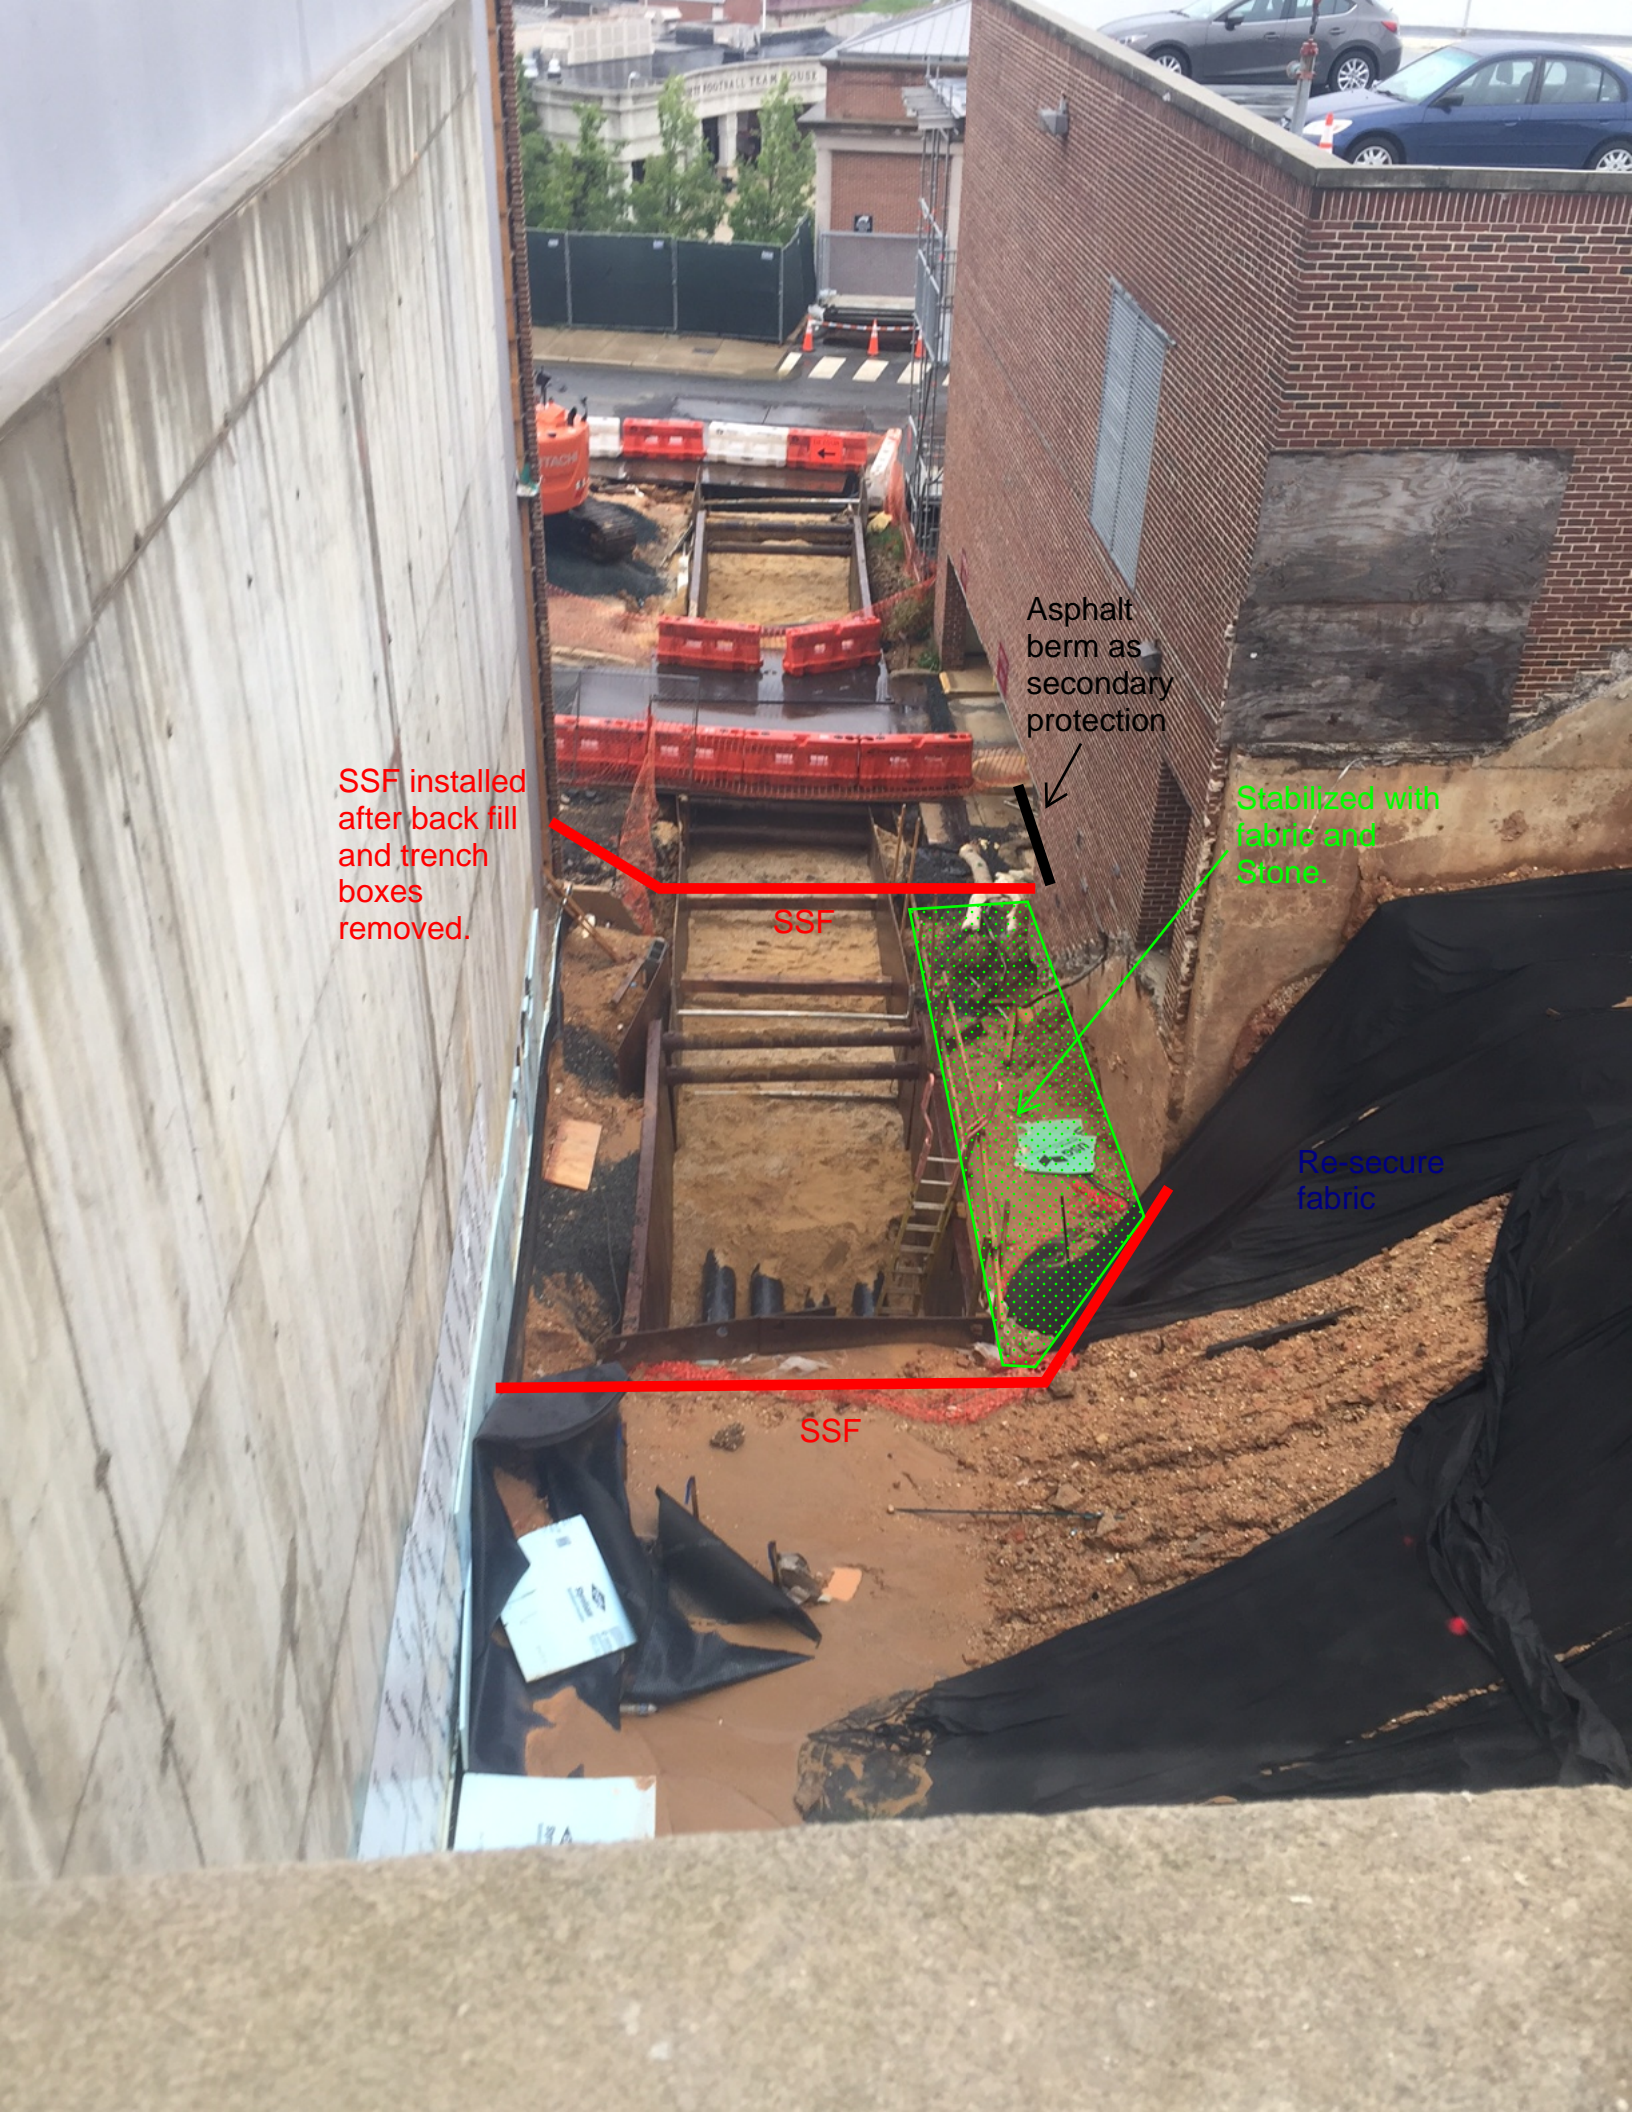
SSF installed after back fill and trench boxes removed.

Asphalt berm as secondary protection

Stabilized with fabric and Stone.

Re-secure fabric

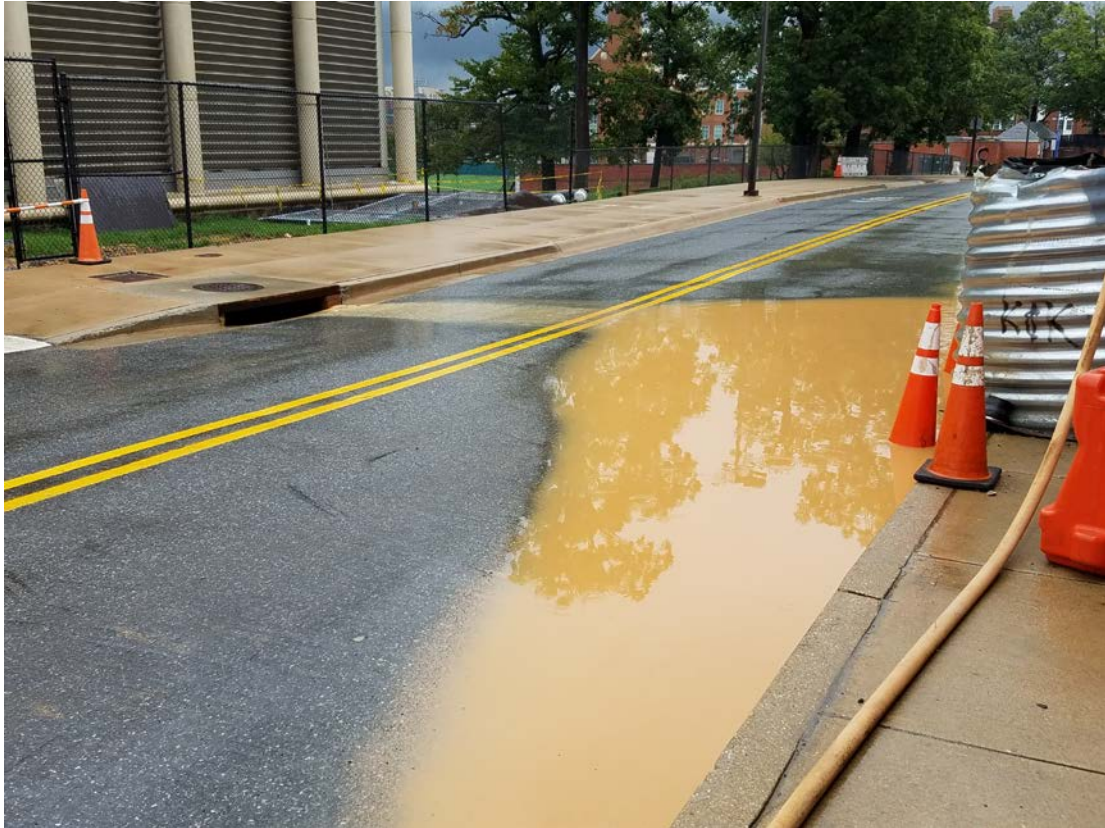
Environmental Affairs (EA) observed highly turbid, sediment laden water was being discharged from Outfall 003 due to the dewatering at the Cole Field House construction site. EA notified UMD Facilities Management, who then notified the contractor, Gilbane Building Co., to perform corrective action. Gilbane is going to install approximately 150 linear feet of super silt fence and hydro-seed 21,000 sq. feet (see attachment for details).

Looking east on Fieldhouse Drive, sediment-laden water being discharged from Cole Field House construction site to the storm drain.

Improve existing BMPs and/or implement new BMPs in order to prevent construction site from contaminating stormwater runoff

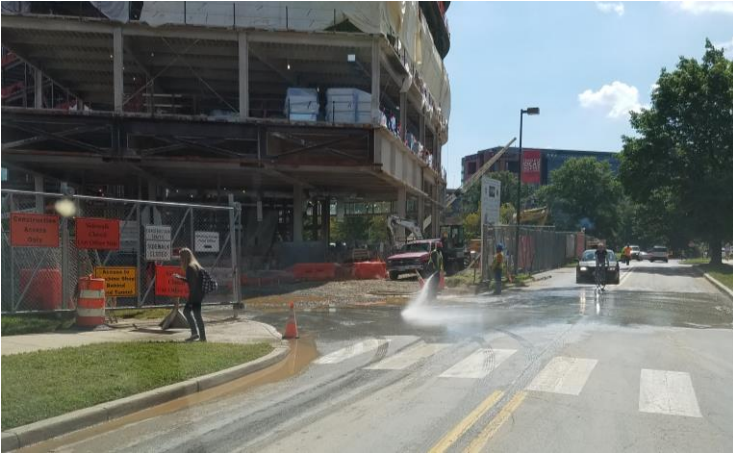
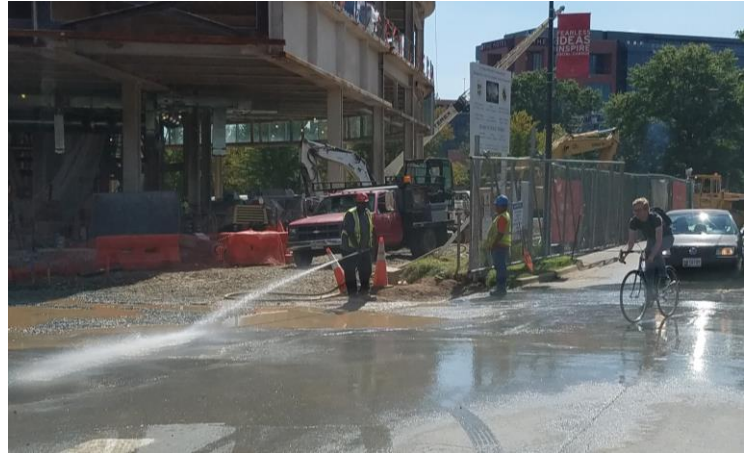
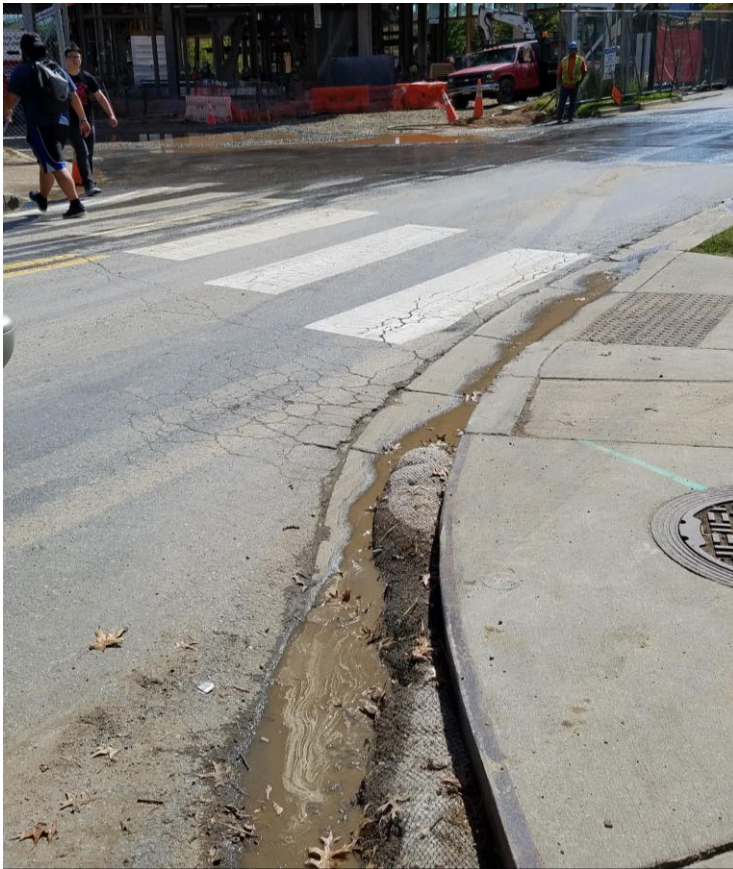
Environmental Affairs (EA) received a phone call about muddy water discharging from the Brendan Iribe Center construction site. EA immediately investigated and found that the contractor was spraying water on the street and washing a considerable amount of sediment directly into the storm drain. See attached photo log. EA will notified UMD Facilities Management, who will then notify the contractor to cease the illicit discharges and use an alternate method to clean up sediment. A new stabilized construction entrance was installed, Paint Branch Dr. was dry swept, the construction crew was instructed not to wet clean the roadway, and the inlet protection was cleaned.

Looking south on Paint Branch Drive, contractor at Brendan Iribe Center construction site spraying water onto the road and discharging sediment-laden to the storm drain.

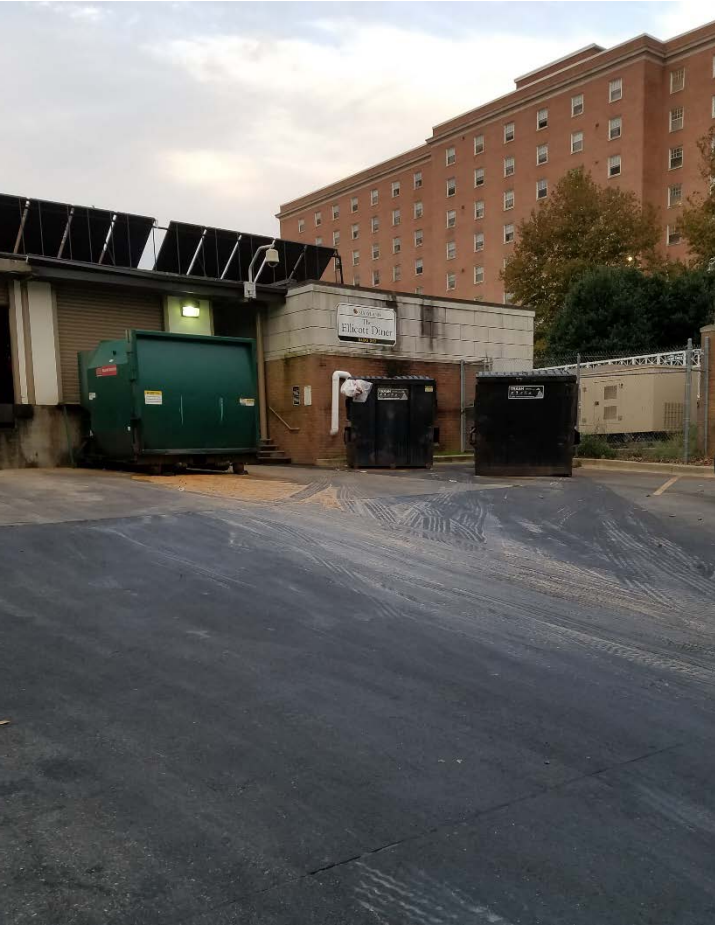
When EA staff consulted with Greg Thompson of Dining Services regarding the issue, he noted that oily liquid was found leaking from a compost compactor unit near the loading dock on Friday, September 22nd. Greg indicated that a UMD trash truck removed the leaking compactor last Friday and that dining hall staff had flushed the spilled material into a trench drain located along the northern edge of parking lot #S8. Dining Services believed that the trench drain discharged to a grease trap located in the parking lot in front of the dining hall offices. However, EA staff conducted dye testing of the trench drain and determined that it did not discharge to the grease trap, but rather the trench drain discharges directly to a nearby storm drain inlet that ultimately discharges to Outfall #019.

Top left: Ellicott Dining Hall loading dock with food oil/grease leaking from compost compactor

Additional measures taken to prevent further illicit discharges from the Ellicott Dining Hall include: 1) Dining Services has hired a contractor to seal the compactors to reduce spillage; 2) Facilities Management will haul compost compactors more frequently to ensure compactors are not overfilled and to minimize breakdown time in the compactor of food waste; 3) Dining Services will add cardboard to the compost compactor prior to filling them with food waste in order to absorb oil/grease; and 4) Oil sorbent booms will be installed in the trench drain to prevent oil/grease from reaching the stormwater conveyance system. EA and Dining Services will consult with the UMD utilities group in order to determine a long-term solution to prevent drainage to the trench drain from reaching the storm drains.

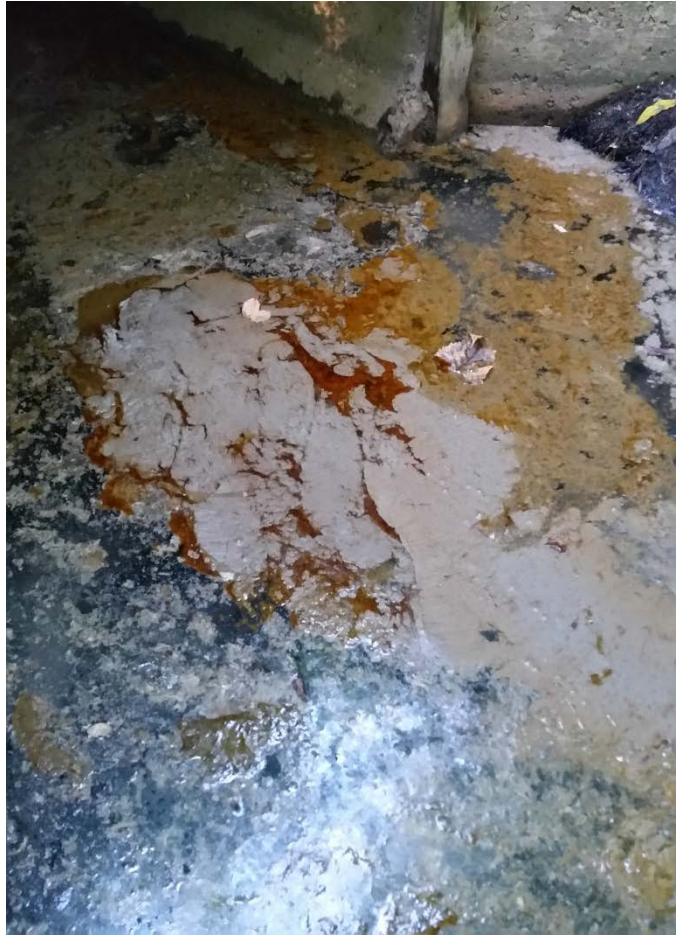
During monthly NPDES sampling at Outfall 019, Environmental Affairs (EA) staff observed oil or grease (which was believed to be food-related) discharging from Outfall #019. The material was very viscous and did not move far beyond the immediate area of the outfall. After making the required notification to the Maryland Department of the Environment, EA staff began investigating the watershed serviced by Outfall 019 and discovered evidence of oil/grease residue in the parking area behind the Ellicott Dining Hall (Bldg. #257).

Top right: Food oil/grease on water surface at Outfall 019

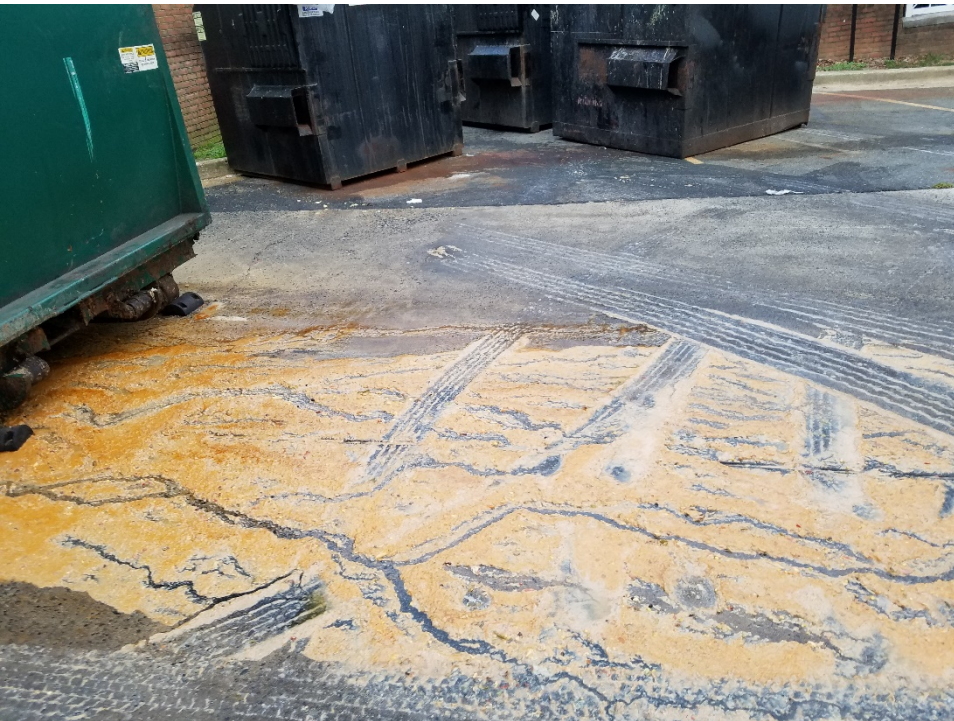
Bottom: Ellicott Dining Hall loading dock with food oil/grease leaking from compost compactor

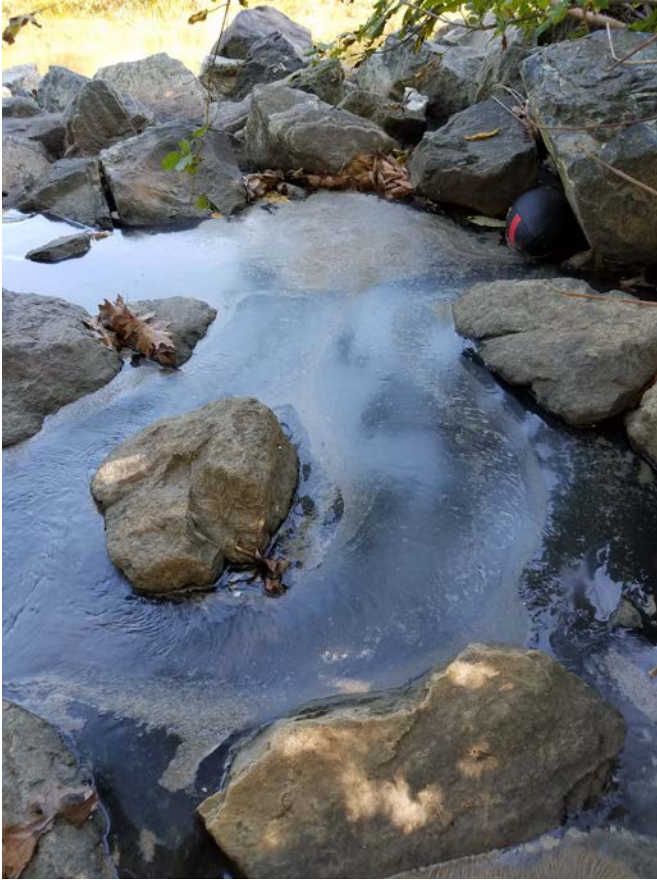
Environmental Affairs (EA) staff observed a spill from a compost compactor at the Stamp Student Union loading dock that had discharged to the storm drain on Fieldhouse Drive. The liquid appeared to contain cooking oil and food grease. EA then investigated the Outfall that the spill location drains to, Outfall 003, and found cloudy water with an oil sheen discharging to Paint Branch Creek. The sheen was very minor and did not appear to significantly affect the creek.

Top left: Scum layer on the water surface at Outfall 003

EA staff made the required phone notification to Maryland Department of the Environment and deployed oil sorbent booms and pads at Outfall 003 in an attempt to capture the oil/grease that was released. Oil continued to discharge from the stormwater conveyance system so a contractor was brought in on 10/19 to jet and vacuum the stormwater lines between the Stamp Student Union and Outfall 003 in order to remove residual oil/grease that could be discharged during the next rain event.

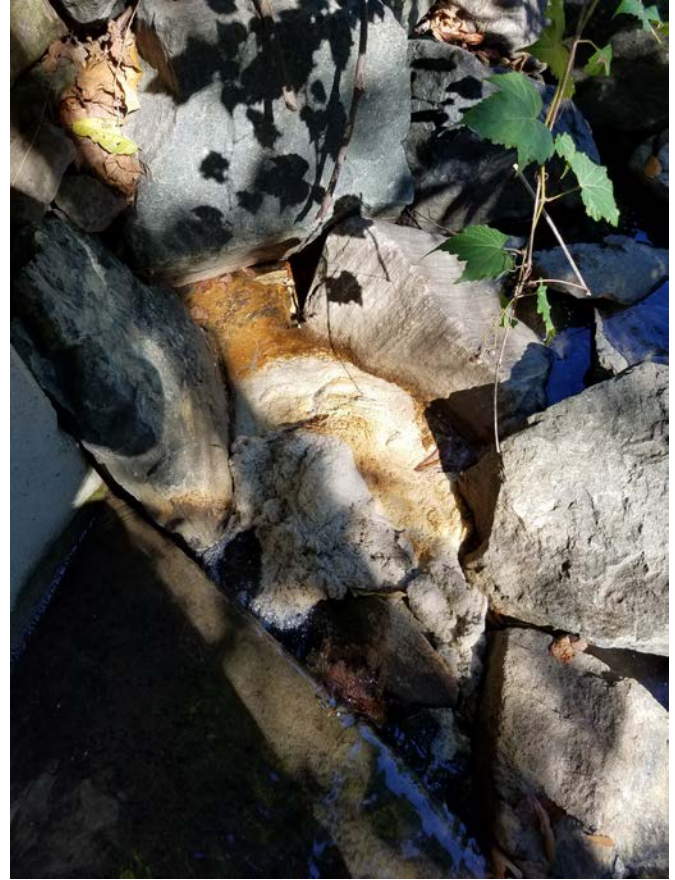
Top right: Persistent foam at Outfall 003

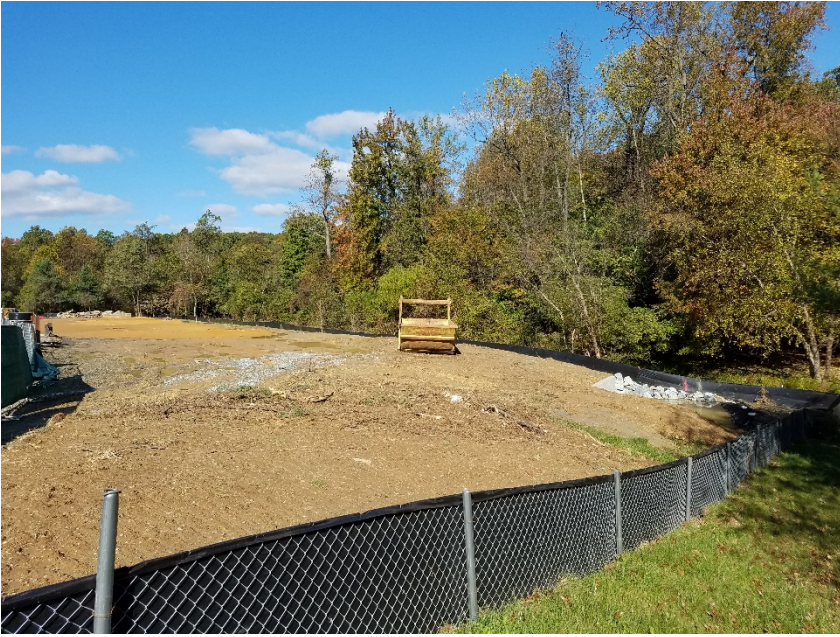
During monthly NPDES sampling, Environmental Affairs (EA) observed highly turbid, sediment laden water discharging from Outfall 019. EA investigated the Outfall 019 watershed and determined that the source of the sediment was the construction site at the parking lots (lot # 2g) just west of Eppley Recreation Center. The site had a large area of disturbed, uncovered soil that eroded during the heavy rains on 10/29, and the existing stormwater BMPs (silt fence and stormwater retention pond) were not adequately containing the sediment. See attached photo log. EA notified UMD Facilities Management, who then notified the contractor to improve the existing BMPs and/or implement new BMPs that prevent sediment from contaminating stormwater runoff.

Top left: Looking west from Eppley Recreation Center, disturbed, uncovered soil at former parking lot #2g.

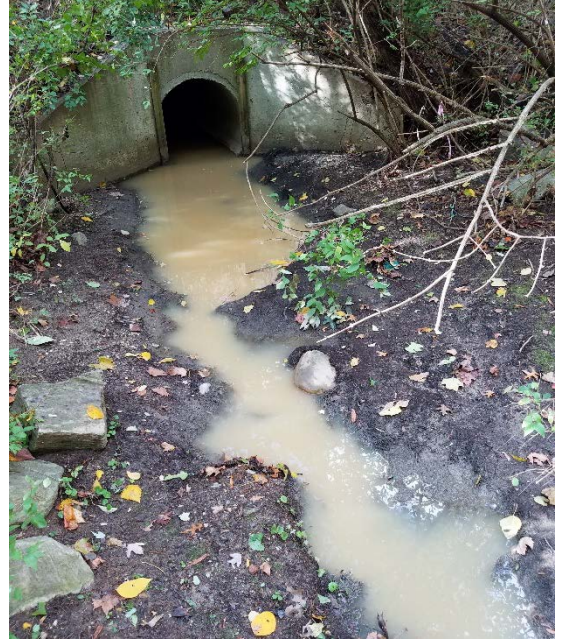
Top right: Outfall 019 discharging highly turbid, sediment laden water.
