Illicit Discharge Incident Tracking Sheet

UMD Illicit Discharge Photo Log
3/30/2018 – Cole Student Activities Building Construction

University of Maryland Photo Log
4/2/2018 – Sewage Spill

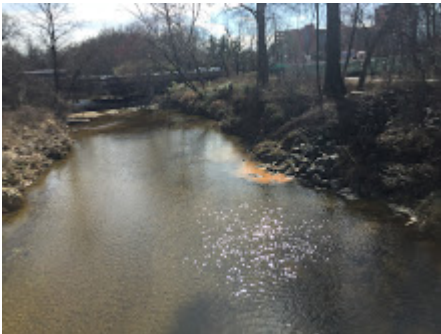
IMG_3608.JPG
3124K

We received a call today regarding the discharge of sediment laden water from Outfall #003 (see the attached photo). We believe that the sediment is being discharged from the Cole Fieldhouse project site, as there are no other areas of land disturbance within the Outfall #003 drainage area. Please notify the appropriate parties and let us know what corrective actions are taken. Thanks.

Our de-watering operation earlier today could have contributed to this. We have Inlet 400 (Blue on attached drawing) protected with two layers of fabric and 10" of stone but the water backed up to the nearby curb inlet that was removed and had a breach in the fabric/stone protection. We were de-watering into a 10x15' filter bag but the clay fines don't filter as we have discussed before. This backup at Inlet 400 gave a path to the storm drain system through the CIP breach(Green). We do have a straw bale inserted in Inlet 400 before the discharge pipe as a secondary measure but it will only filter so much. Unfortunately, our contractors were working in the basement and were not monitoring the discharge of the de-watering effort. Gilbane caught this and shut it down.

All de-watering was stopped when this was discovered but sediment laden water could have entered the storm system. Strittmatter has been notified to replace all AGIP/GIP/CIP onsite per plan and we are bringing in an additional PST for the NE side on Friday. This will be our de-watering point for the tunnel pit/basement moving forward. The pumping distance to our PST at the West end of site is too far for our pumps to be efficient.

We also have some asphalt berms that help with water flowing from Fieldhouse Drive into our LOD that were never installed. These will also be installed tomorrow. A few of which will be better located due to site set up.

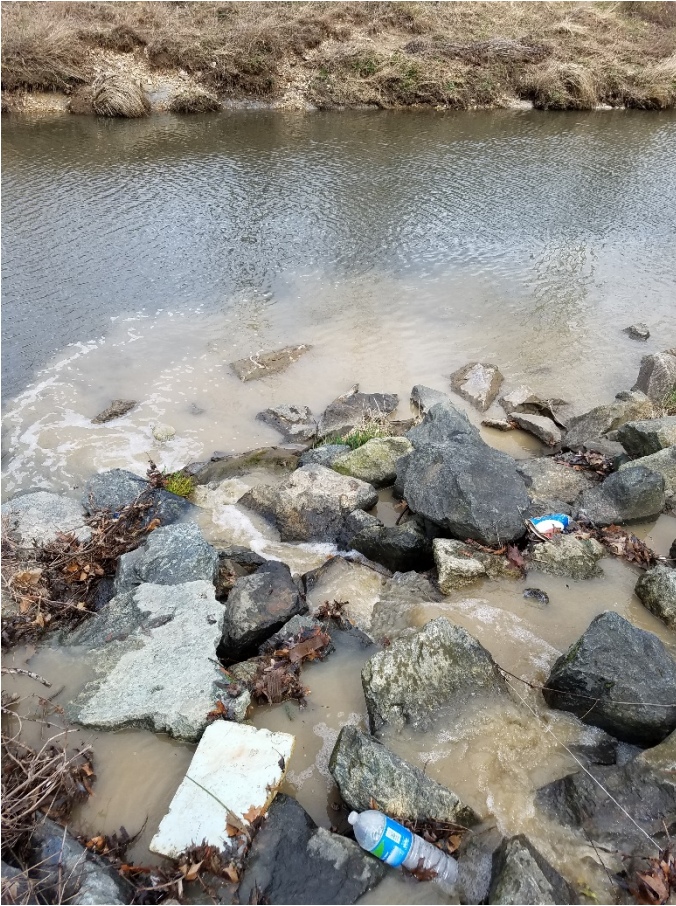
Top left: sediment laden water discharging from Outfall 003 to Paint Branch Creek.

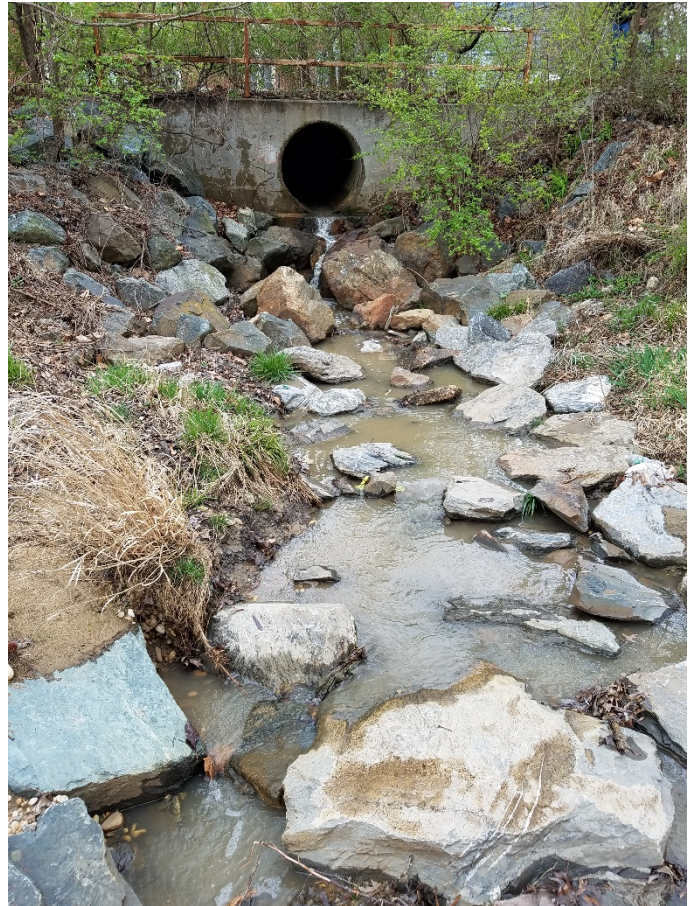
Top right: sediment laden water discharging from Outfall 004.

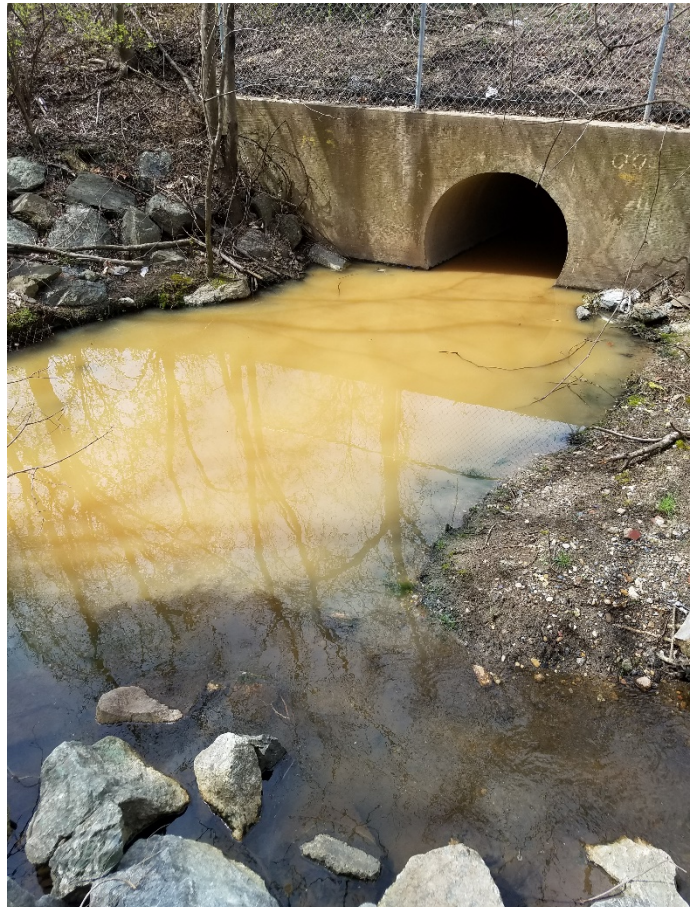
Bottom: sediment laden water discharging from Outfall 005

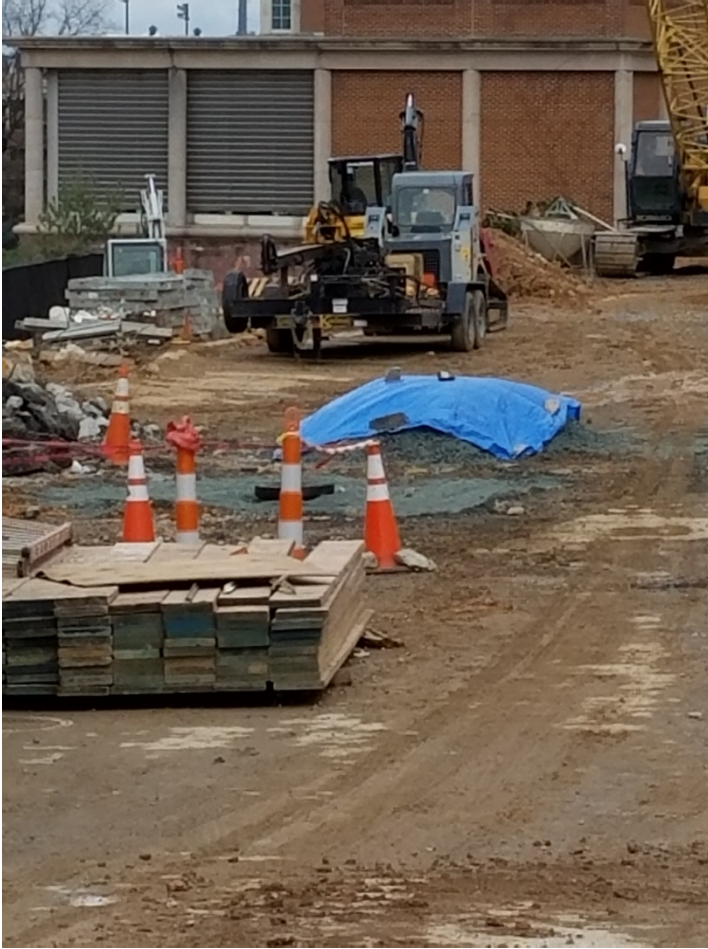
Top left: looking east on Fieldhouse Drive, recently poured concrete on the construction site.

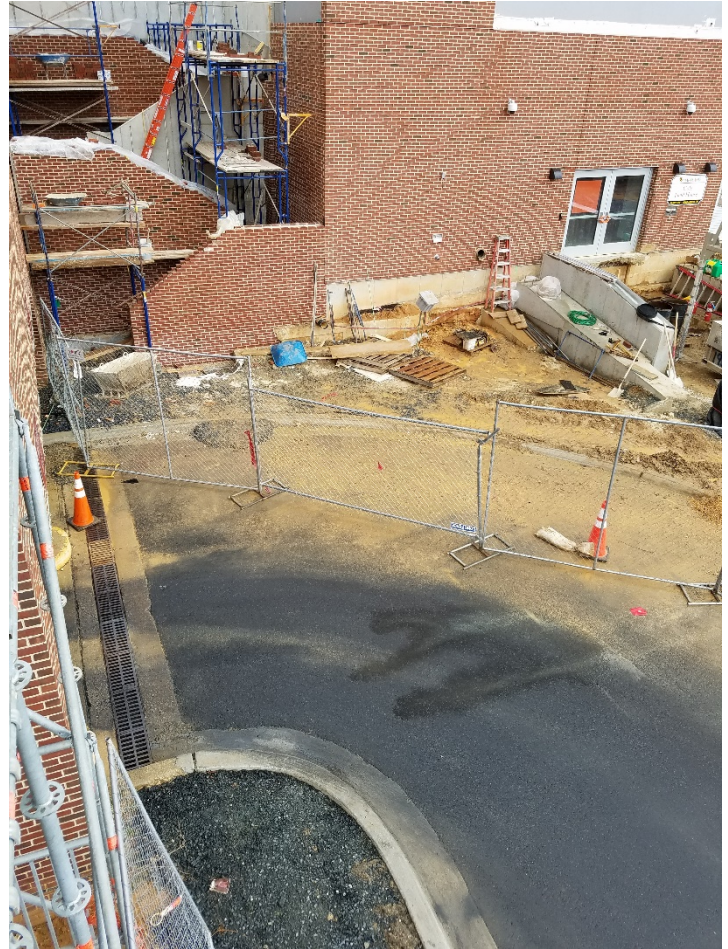
Top right: facing west from the Union Lane Parking Garage, sediment runoff from the construction site to the storm drain.

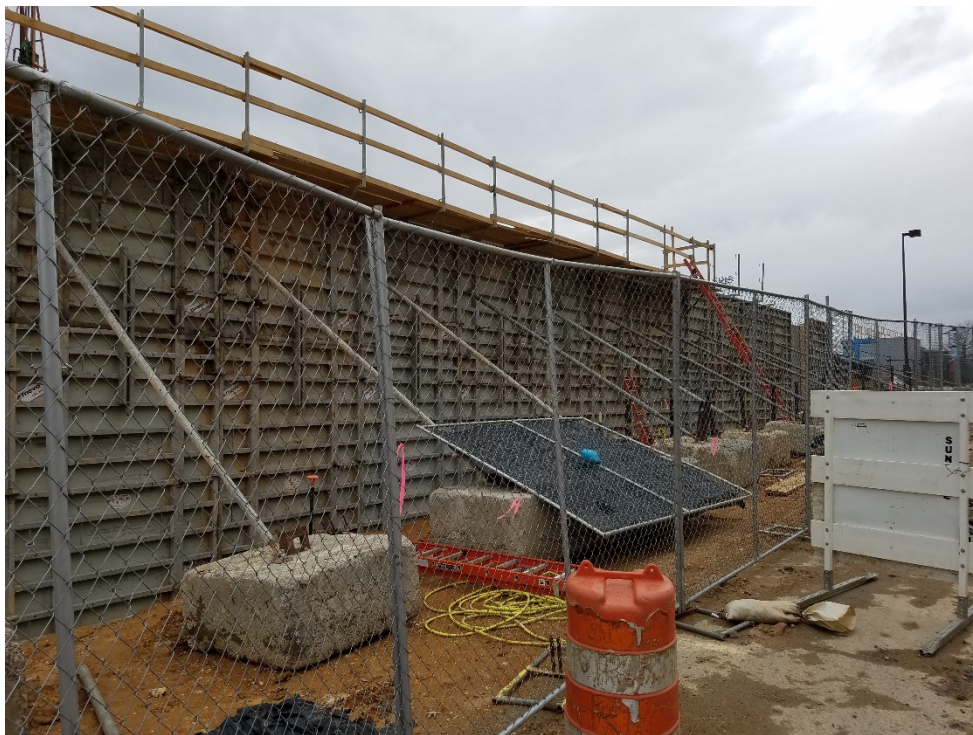
Bottom: looking west on Fieldhouse Drive, recently poured concrete on the construction site.

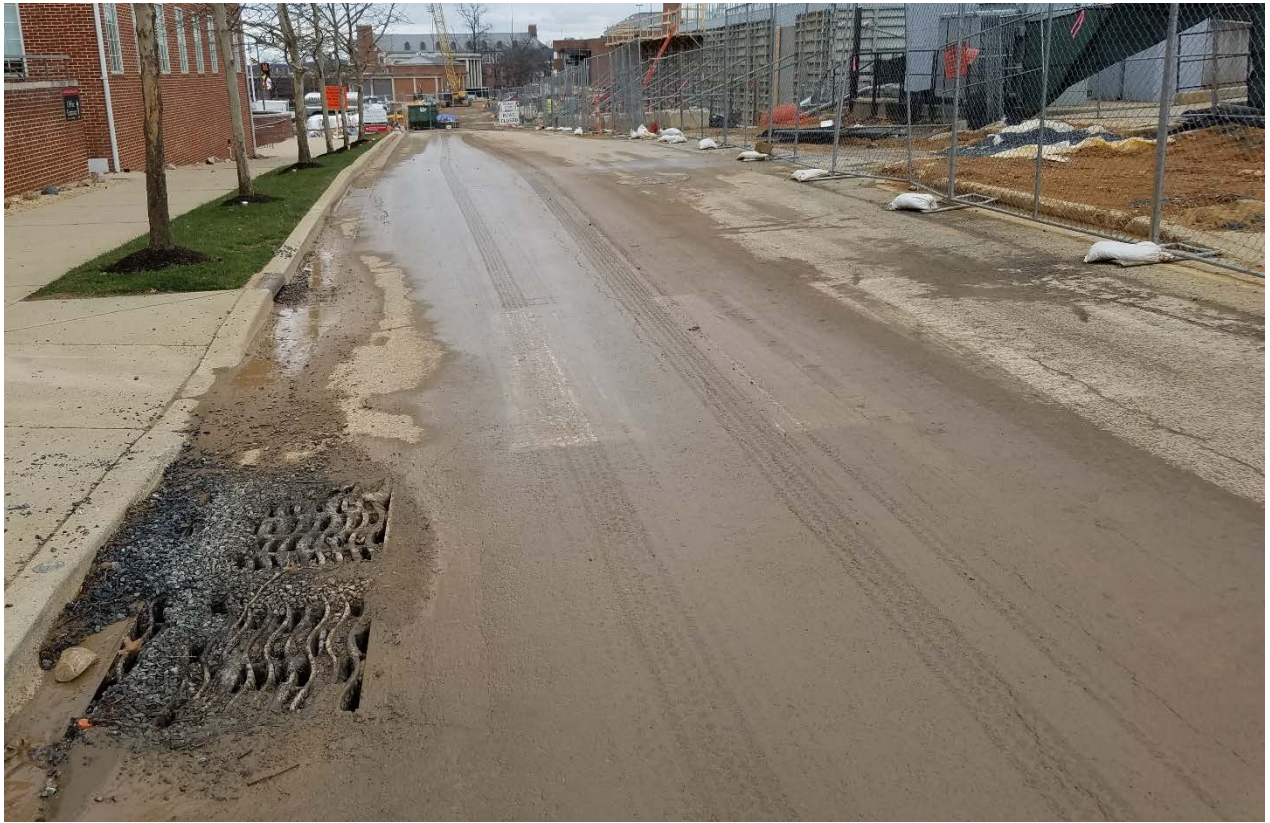
Top: looking east on Fieldhouse Drive, sediment drag-out/runoff from construction site impacting storm drain. Poorly maintained inlet protection.

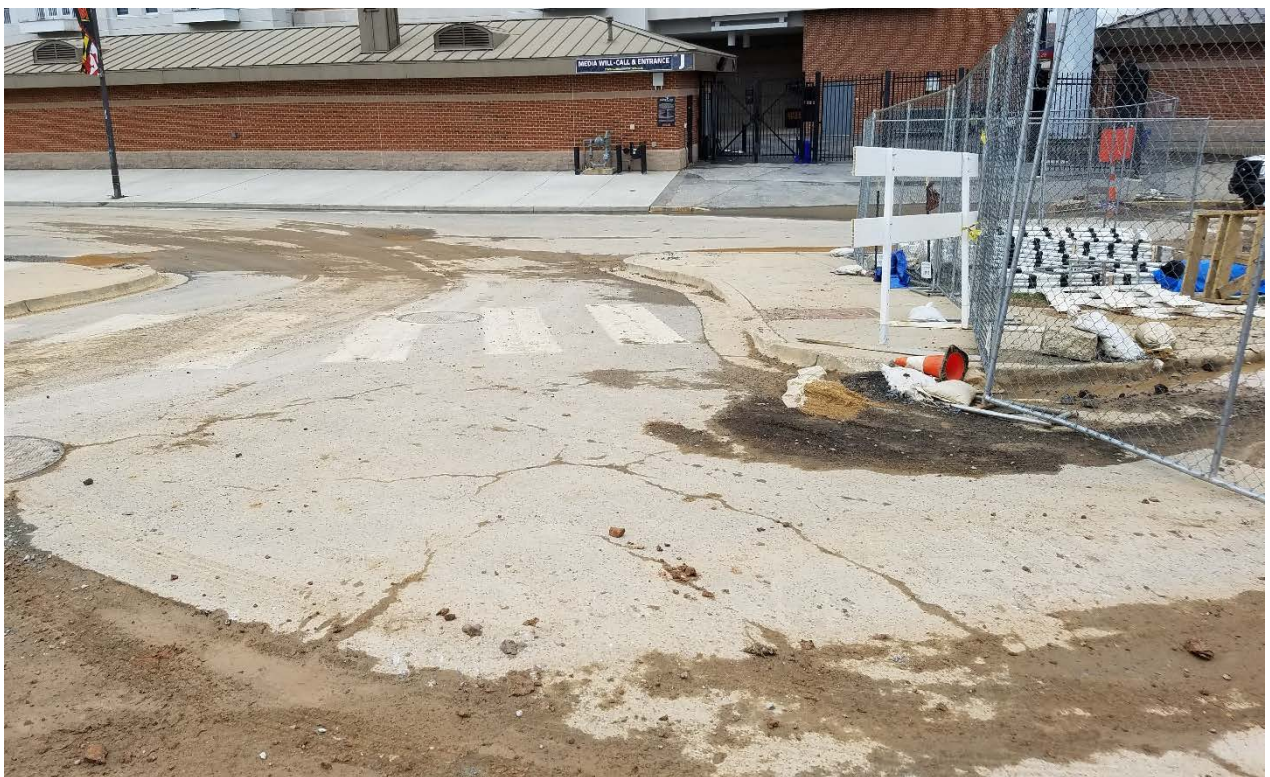
Bottom: facing north on Fieldhouse Drive towards the football stadium, sediment drag-out/runoff impacting storm drain.

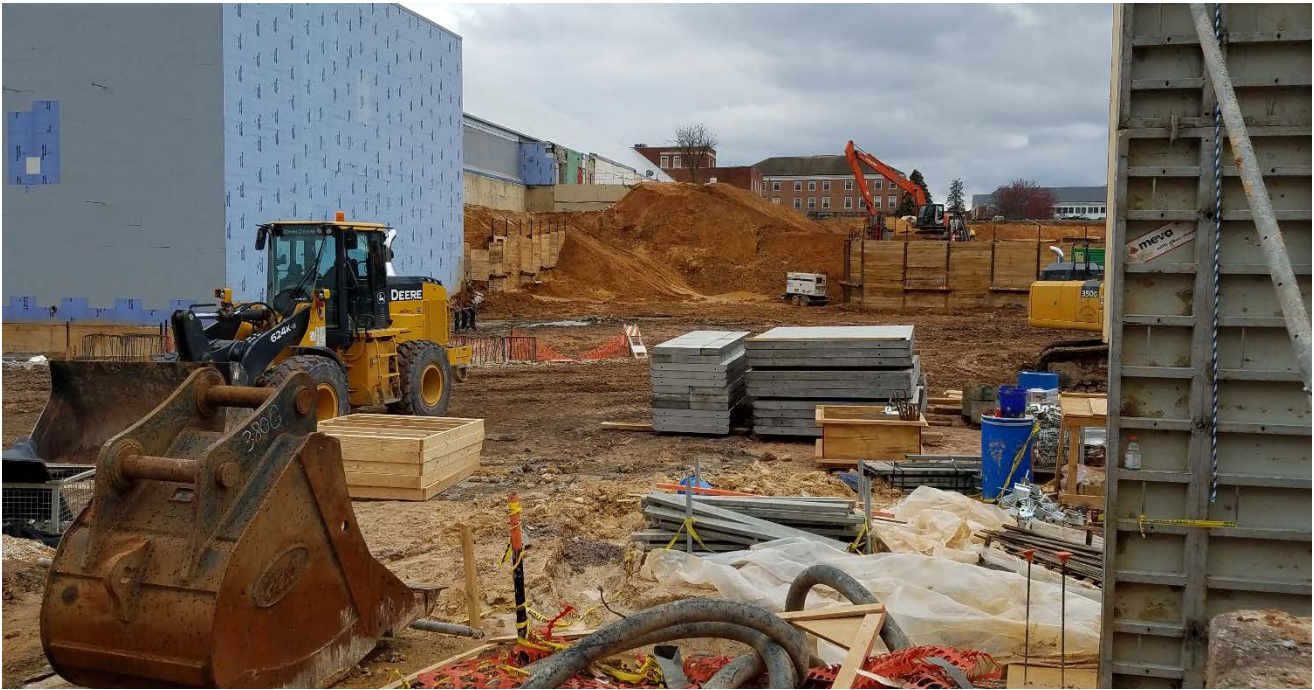
Top: looking south on Fieldhouse Drive, large amounts of disturbed, uncovered sediment.

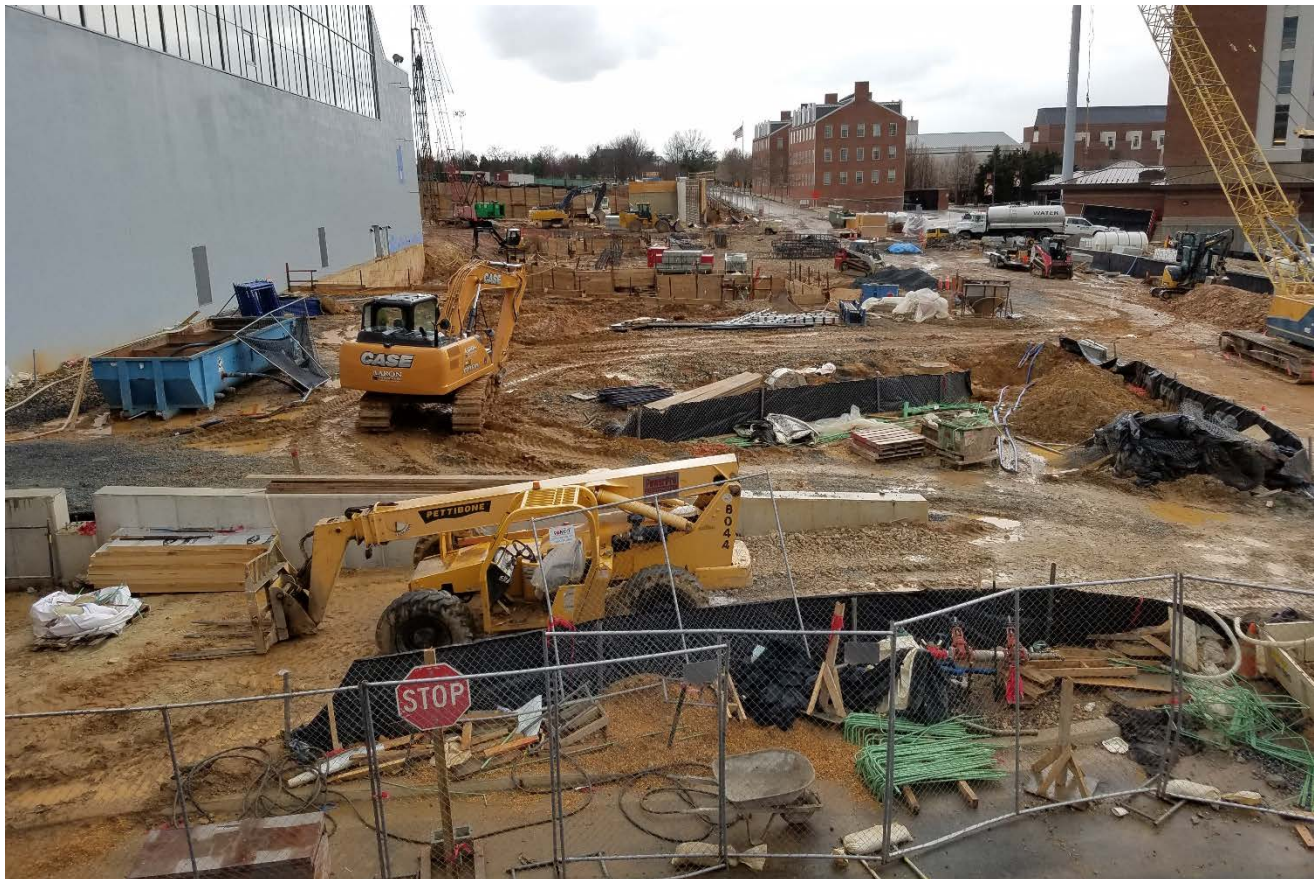
Bottom: facing west from the Union Lane Parking Garage, significant disturbed, uncovered sediment.

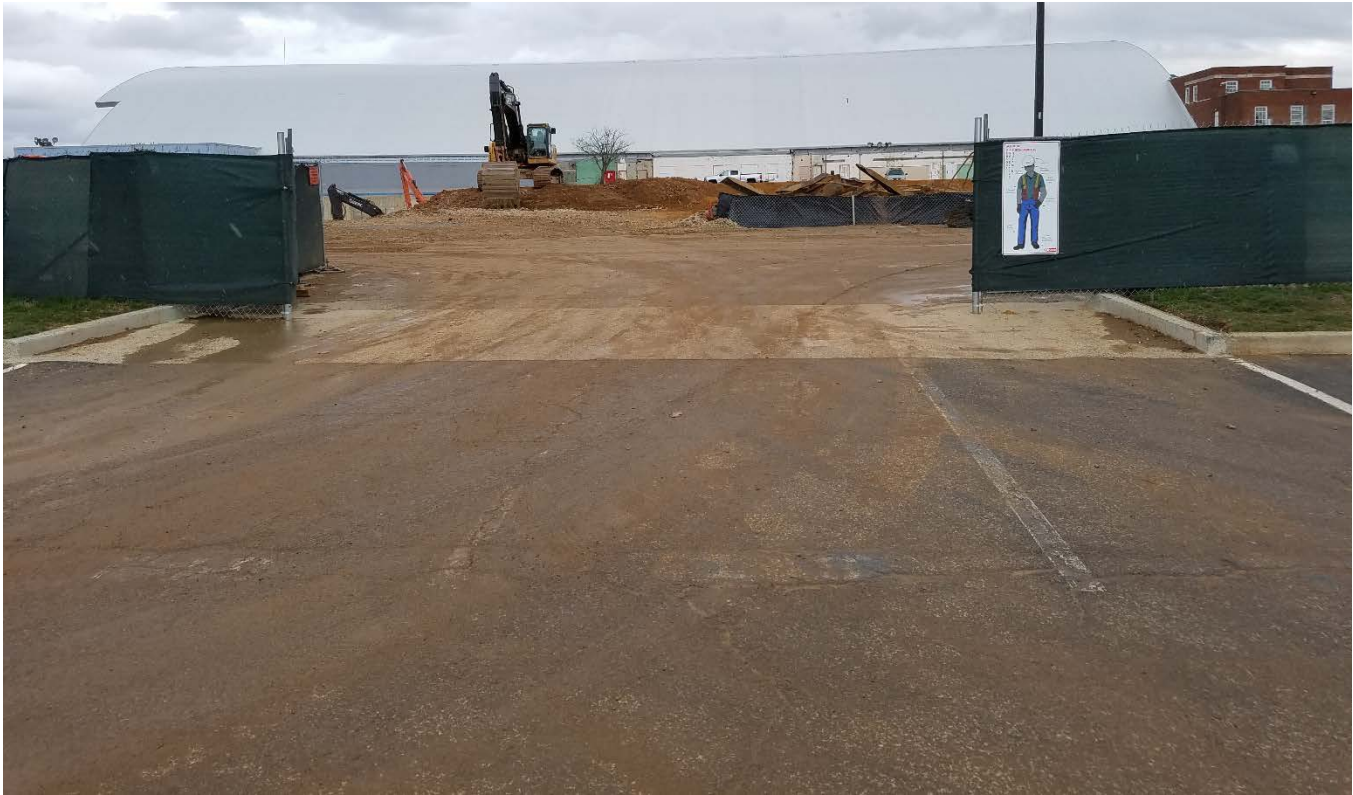
Top: Looking east from Lot Z, major sediment drag-out from the construction site.

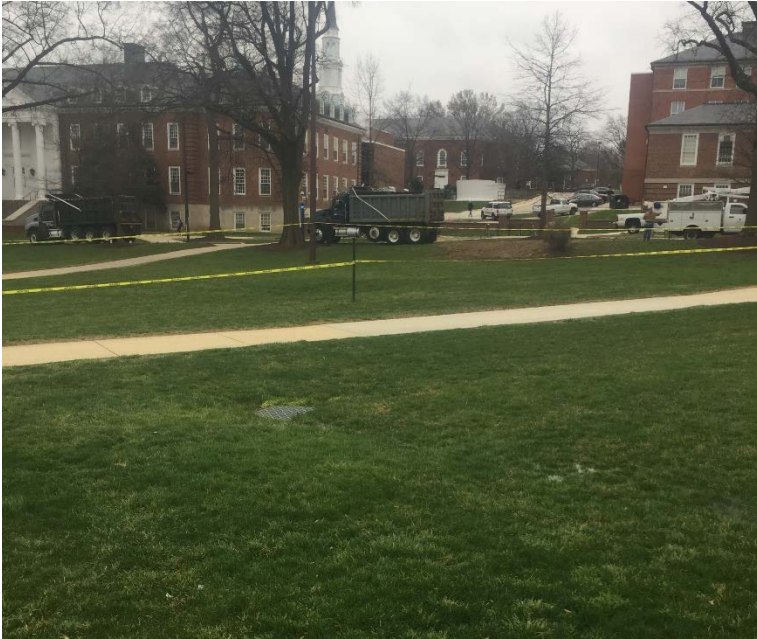
Top left: looking south towards Woods Hall at the overflow site. In addition to a campus wide notification via the “UMD Alerts” system, the contaminated area was blocked off with caution tape.

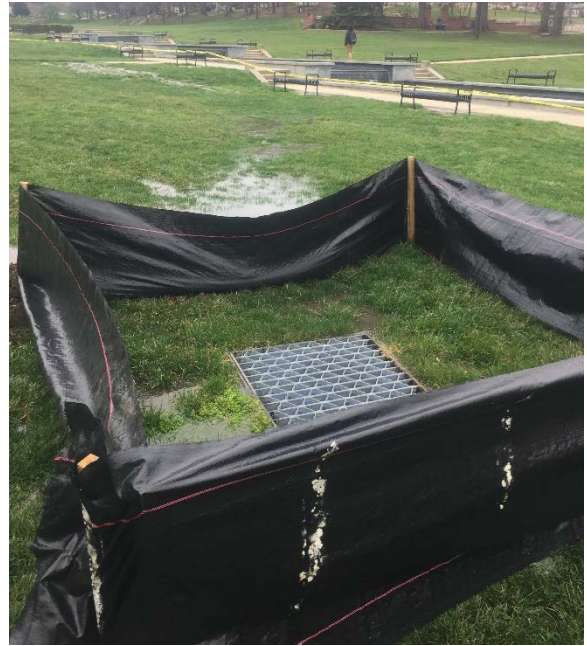
Top right: facing east on McKeldin Mall, silt fence installed to prevent biosolids from entering the storm drain system.

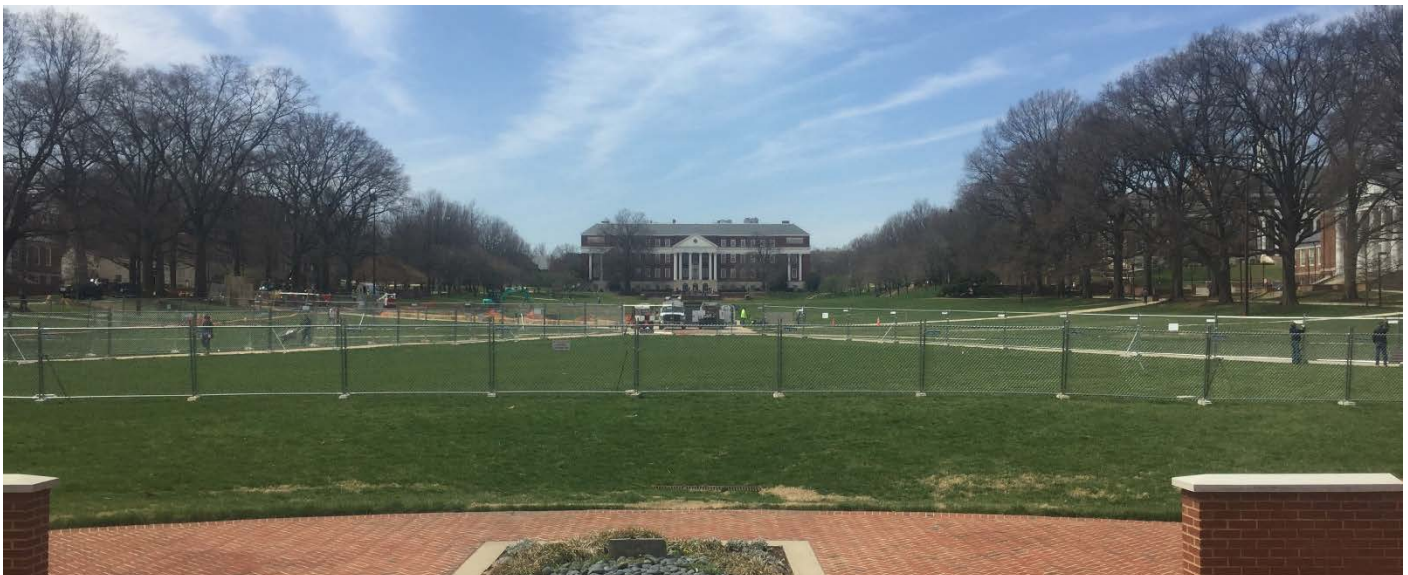
Bottom: looking east towards McKeldin Library, a fence was installed around the area that contacted sewage in order to prevent pedestrians from contacting the contaminated ground. This fencing will be left in place for ten (10) days. All ground surfaces that contacted sewage were treated with lime.

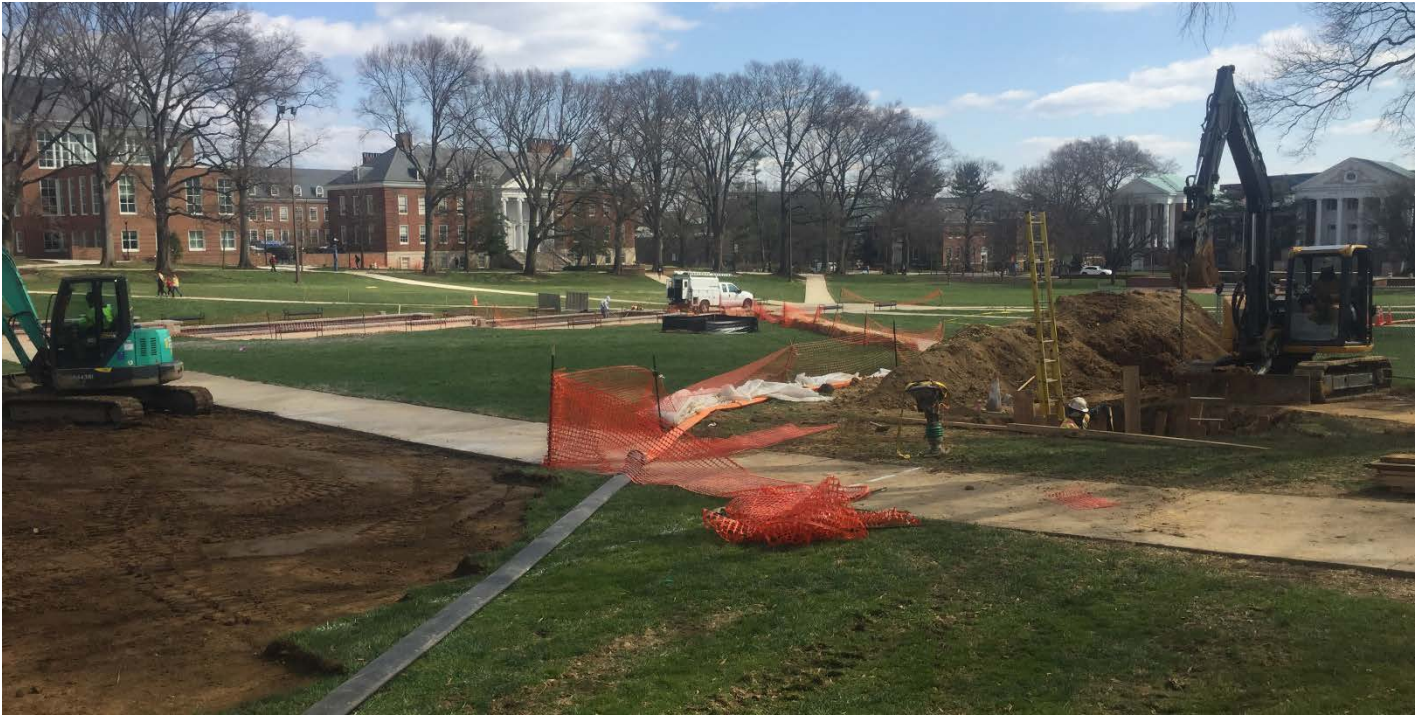
Top: looking northwest from Woods Hall, the ground cover that contacted biosolids was treated with lime to a pH of 12 and removed for disposal. The source of the sewage overflow was excavated to make the necessary repairs.

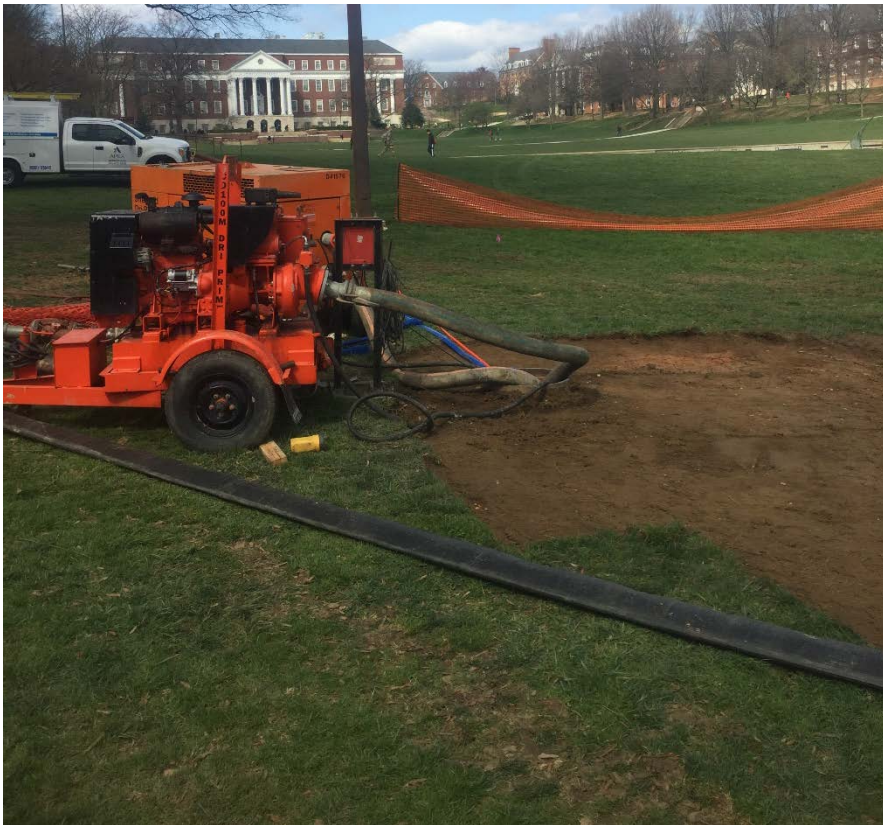
Left: facing north towards McKeldin Library, a pump was used to bypass sewage from an upgradient manhole around the blocked sanitary sewer line to a downgradient sanitary sewer line. A back up pump was also on site.
