Illicit Discharge Incident Tracking Sheet

University of Maryland Photo Log
9/03/2019 – Sewage Overflow at South Campus Dining Hall

PHOTOGRAPHIC LOG

Client Name: University of Maryland	Site Location: Capital One Stadium-Gate J Entrance	Project No. 09/27/19 Sewage Overflow
---	--	--

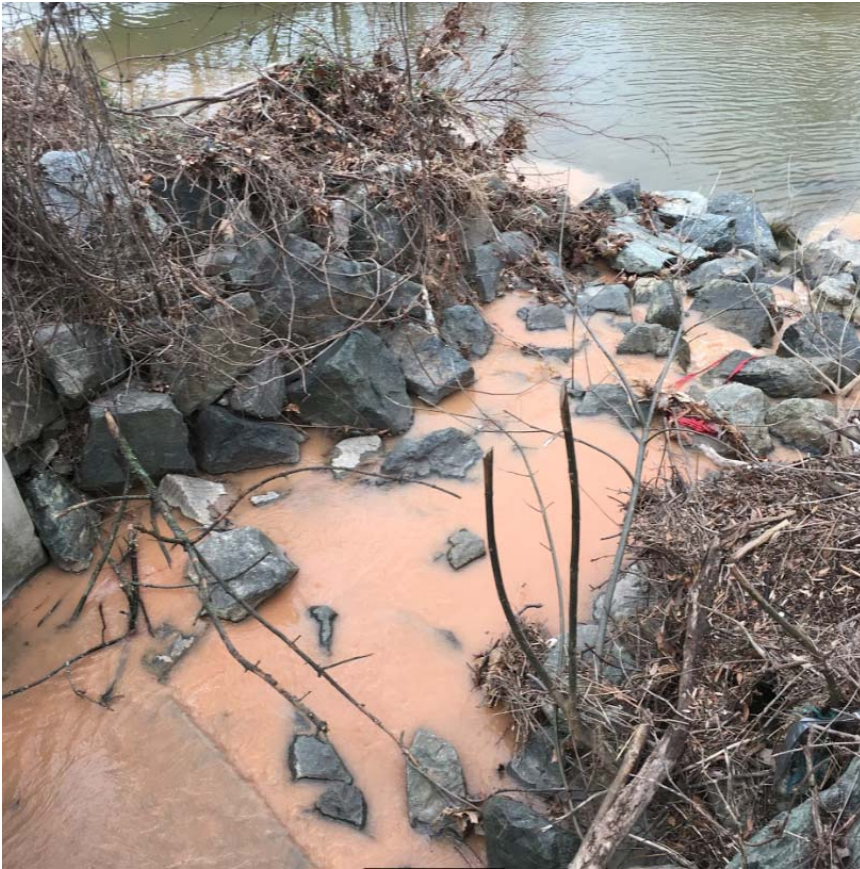
O & M has a utility break (scub 3 hot water lines) that is draining into the Cole site, the break is getting worse and Gilbane is trying to help contain the extra water. The below freezing temperatures is complicating the de-silting effort.

While conducting routine stormwater sampling, we observed sediment laden water discharging from Outfall #003 and #004.

We were unable to locate any other potential sources for the discharge, so we assume it was emanating from the Cole site. Please reach out to the contractor and inform them of the illicit discharge and let me know their corrective action(s). Thanks.

Description of actions: Cease discharge of sediment laden water from construction site

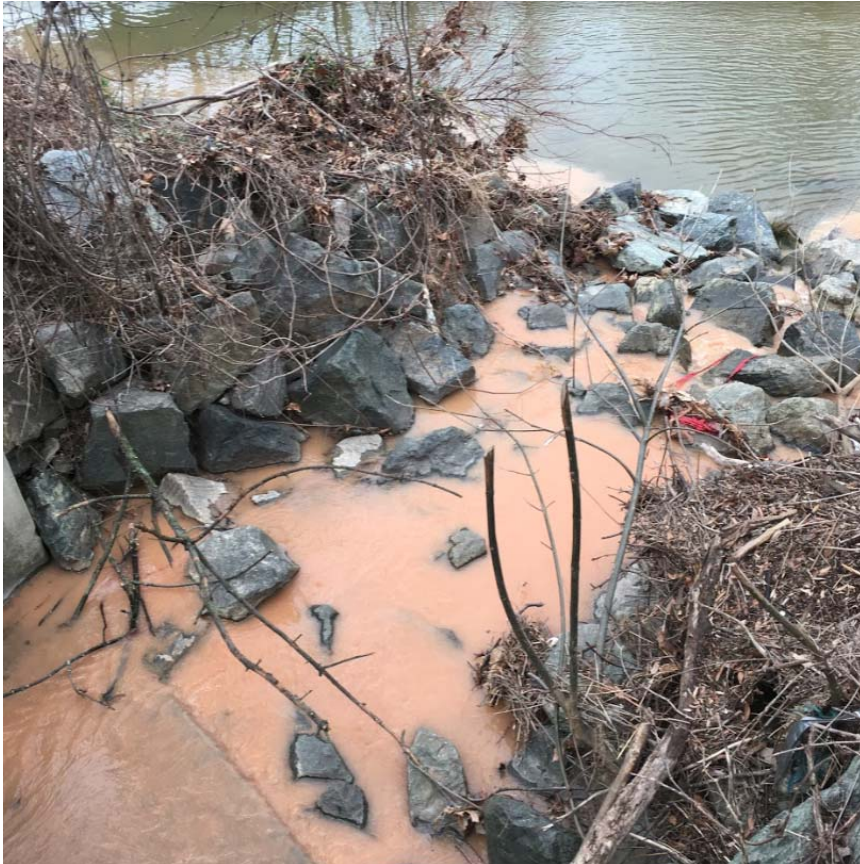
While conducting routine stormwater sampling, we observed sediment laden water discharging from Outfall #003 and #004.

We were unable to locate any other potential sources for the discharge, so we assume it was emanating from the Cole site. Please reach out to the contractor and inform them of the illicit discharge and let me know their corrective action(s). Thanks.

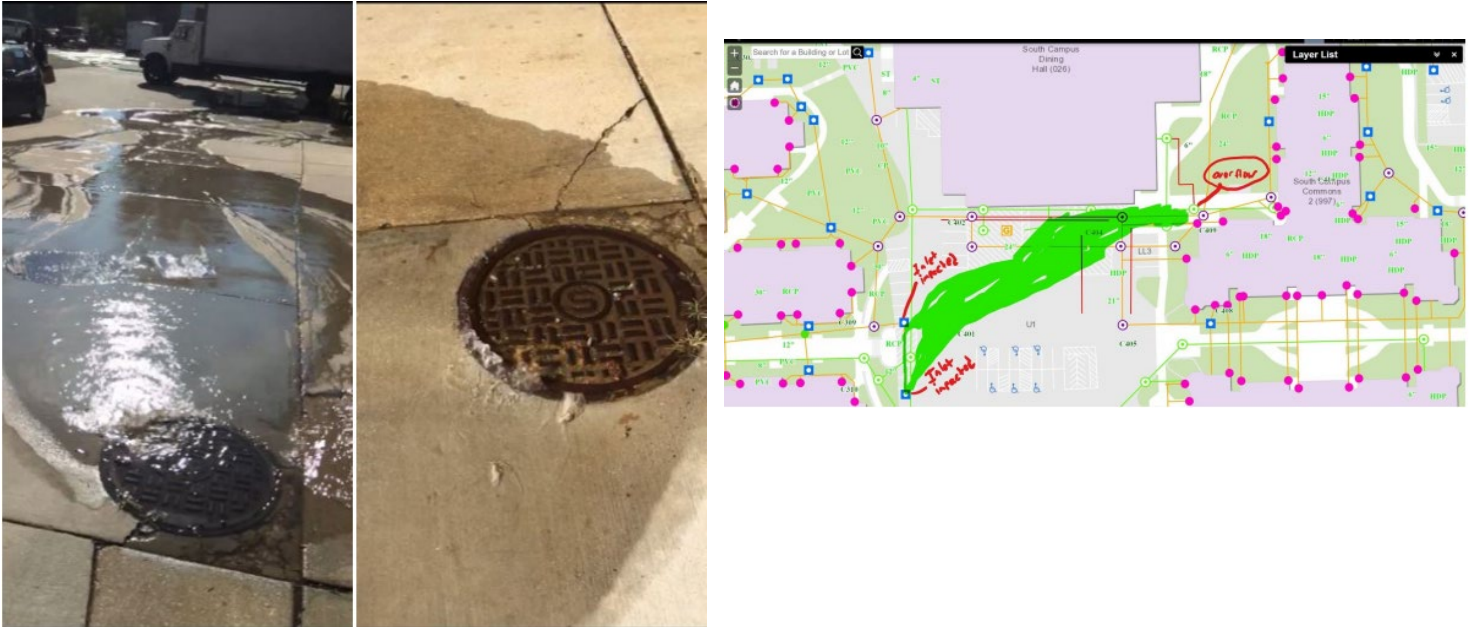
Top Left: The overflowing manhole in walk way between South Campus Dining Hall and South Campus Commons 2.

Top Right: A map indicating where the overflowing manhole was, the direction of the flow path, and the stormwater inlets affected.

Bottom Left: One (1) of the two (2) stormwater inlets affected. Most of the standing water in the parking lot evaporated before entering the storm system.

Bottom Right: Two (2) of the two (2) stormwater inlets affected. Most of the standing water in the parking lot evaporated before entering the storm system.

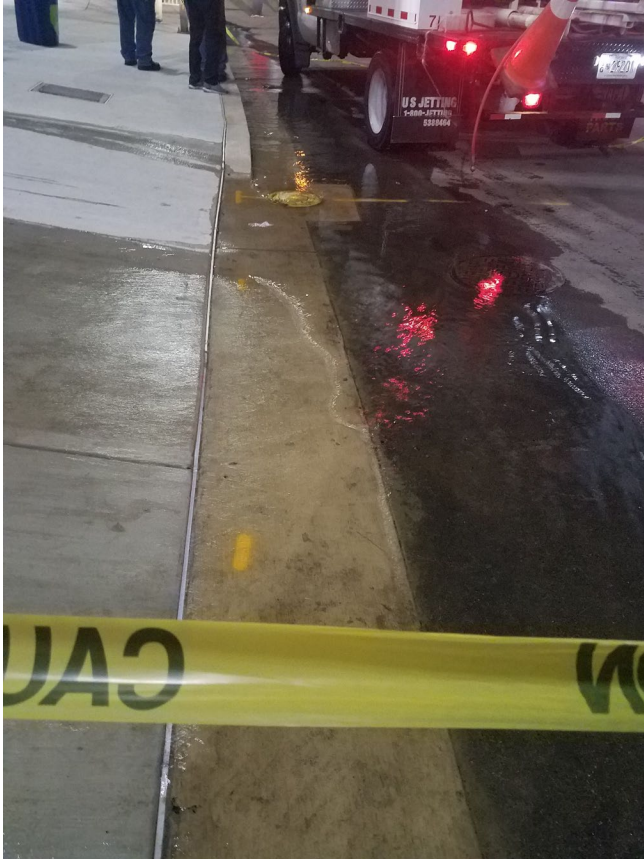
Photo No. 2	Date: 09/27/19

Photo No. 1	Date: 09/27/19	 
Direction Photo Taken: Facing overflowing sewer manhole		
Description: Overflowing sanitary manhole. Discharge began at approximately 10pm on Friday, 9/27/19. Flow rate initially approximated at 50 GPM for the initial 2.5 hours of discharge. Then was greatly reduced to 5 GPH. A total of 7,550 gallons was estimated of being discharged.

Direction Photo Taken: Facing downhill of sanitary manhole towards stormwater inlet.		
Description: Picture showing the pathway of the sewer discharge into the stormwater inlet. Initially, the discharge entered the stormwater system via an inlet, but was eventually redirected to a nearby sanitary manhole. The photo shows UMD's sewer jet truck.

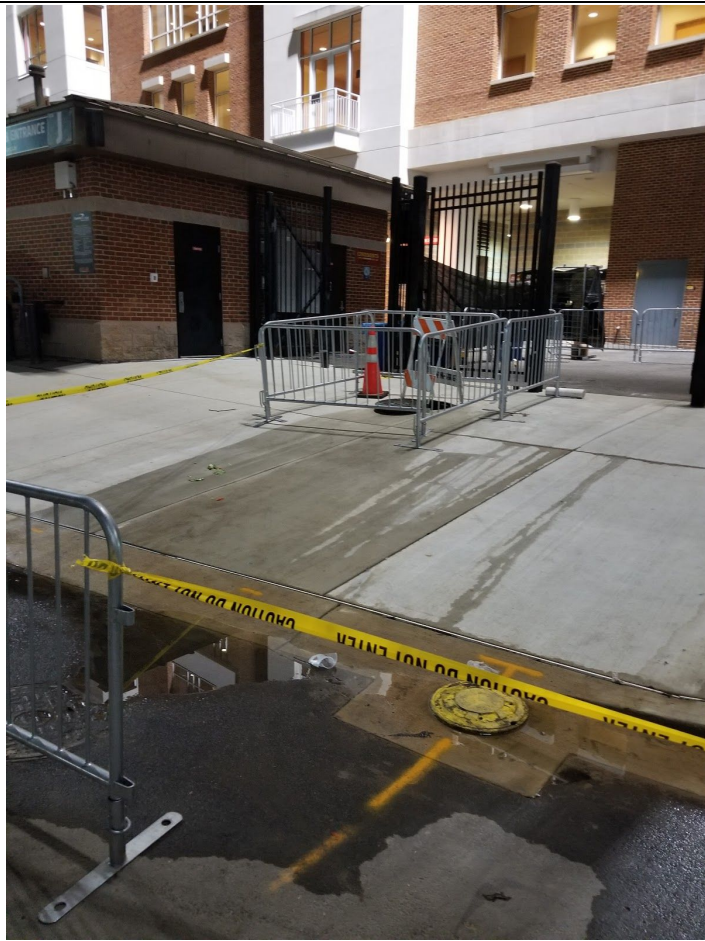
Photo No.
3

Impacted area was cordoned off to the public to eliminate the impact to the public.

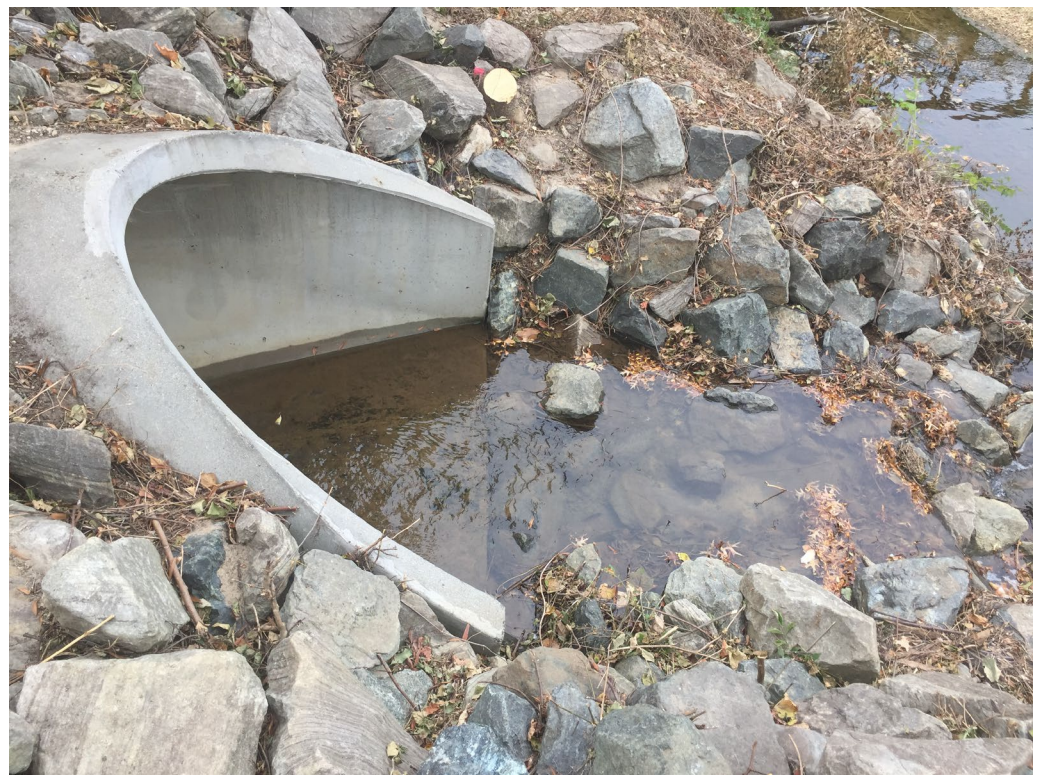
Photo No.
4

Outfall 003 is the receiving outfall for the drainage area that was impacted by the sewage release. Photo was taken to demonstrate that the water discharging from outfall 003 has no visible suds or solids and is clear.

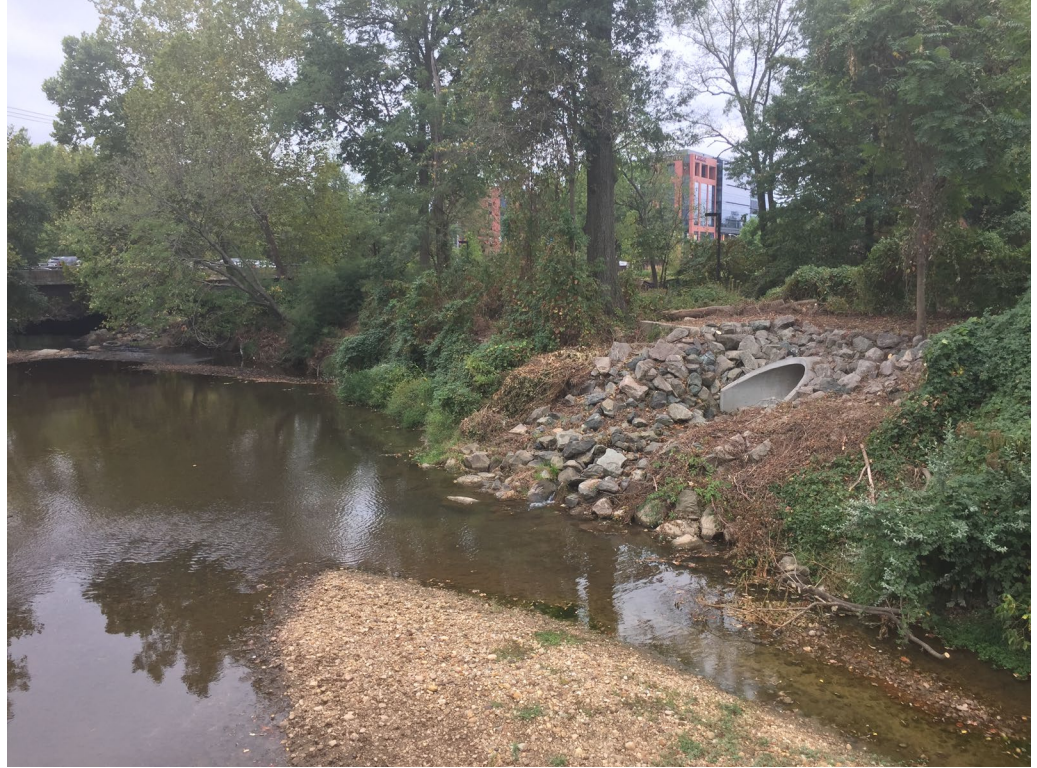
Photo No.
5

Picture demonstrates the location of the receiving outfall for the impacted drainage area. Access to the creek is limited by topography, fencing, and heavy vegetation, thereby reducing the risk of human contact with the release.

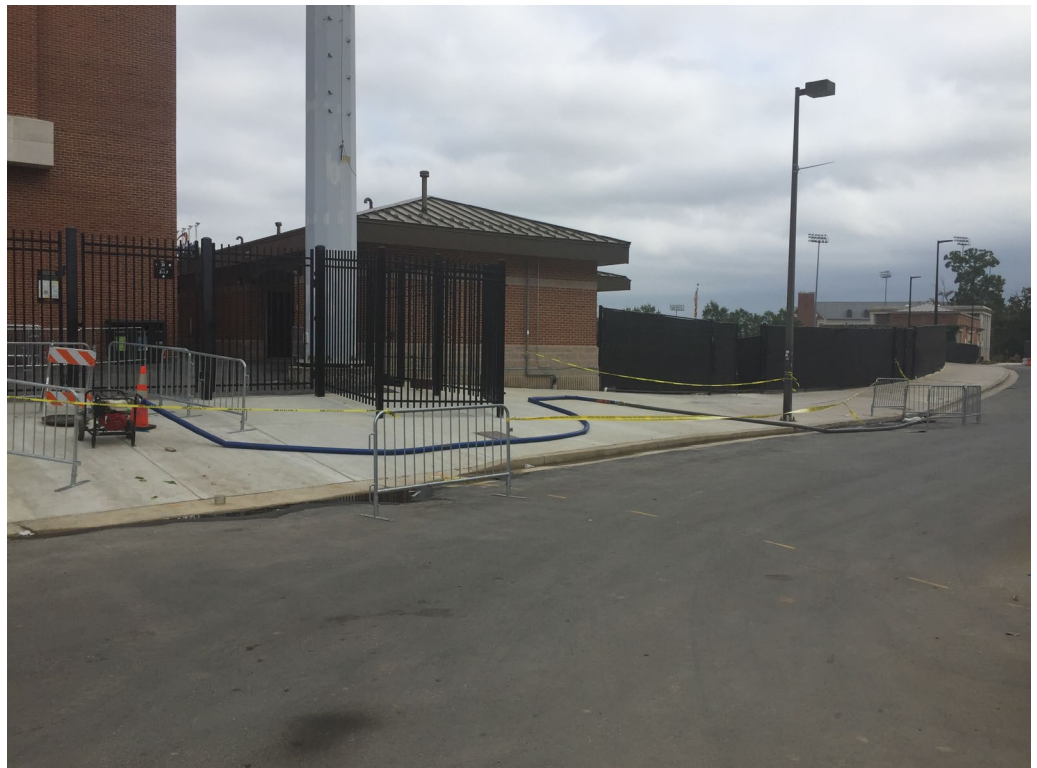
Photo No.
6

Picture of the area impacted by the sewage overflow. The manhole to which the discharge was redirected is at the topographic low point of the road. The impacted stormwater inlet is approximately 6 inches higher elevation than the manhole. The photo also shows the bypass pumping system deployed by UMD staff.

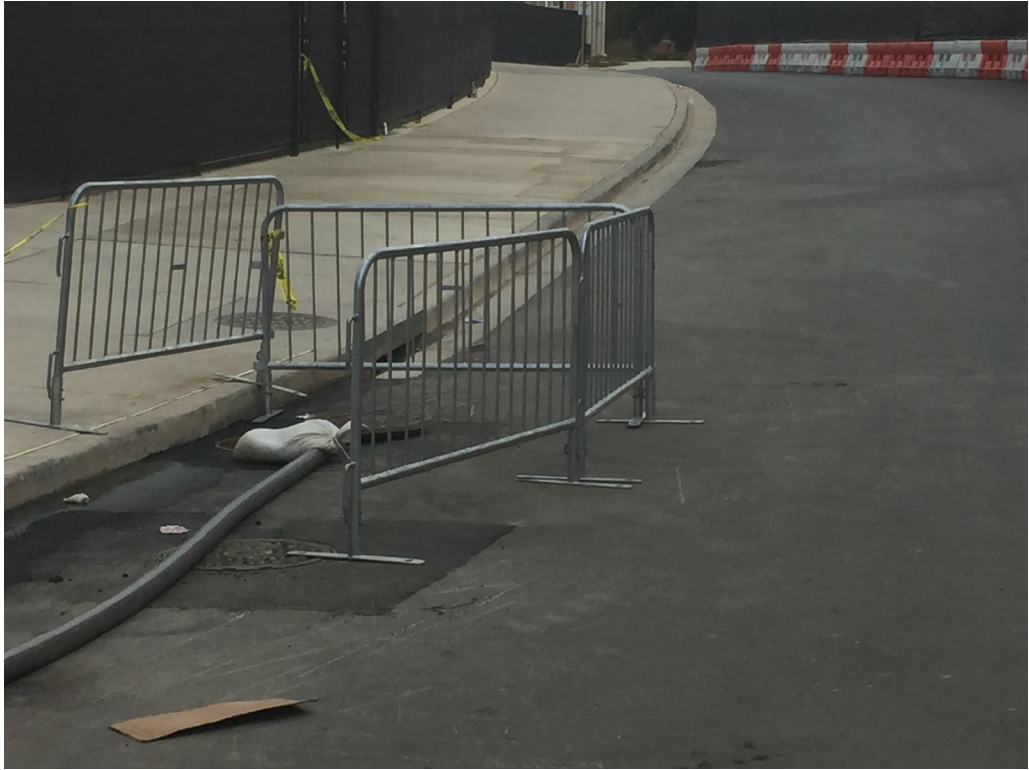
Photo No. 7	Date: 09/28/19
-----------------------	--------------------------

Description:
Picture of the area impacted by the sewage overflow. The topography of the site has the sanitary manhole the discharge was redirected to at the bottom of the hill in either direction.

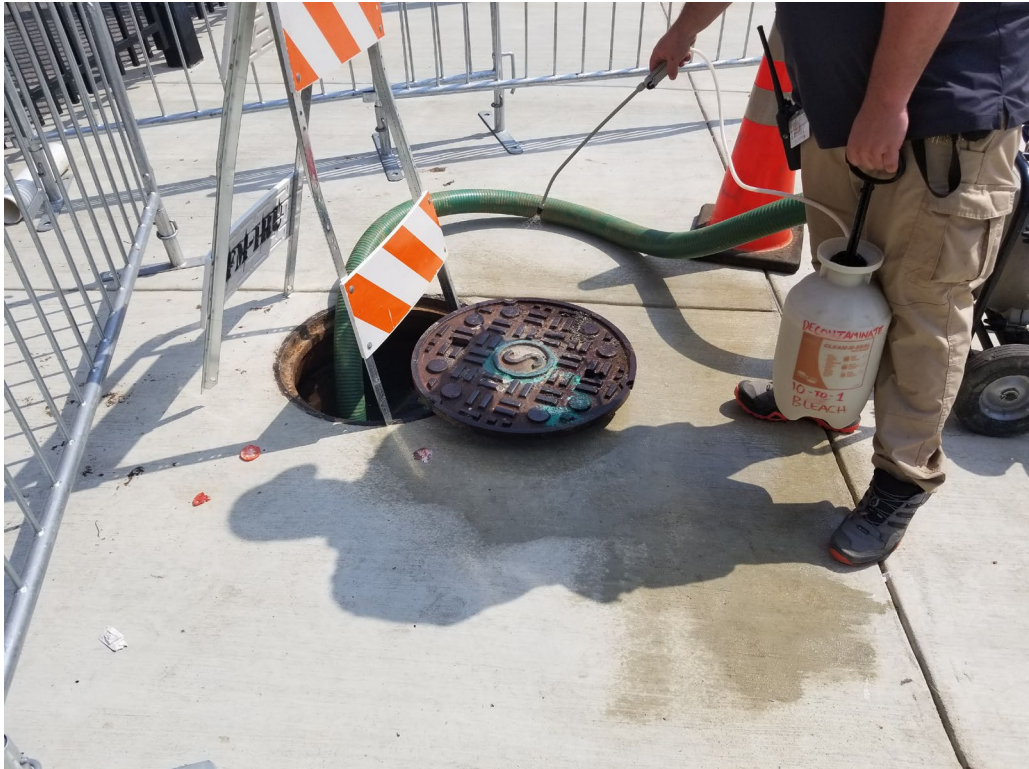
Photo No. 8	Date: 09/28/19
-----------------------	--------------------------

Description:
Picture of a solution of 10% bleach being applied to the impacted area to disinfect the surfaces impacted.

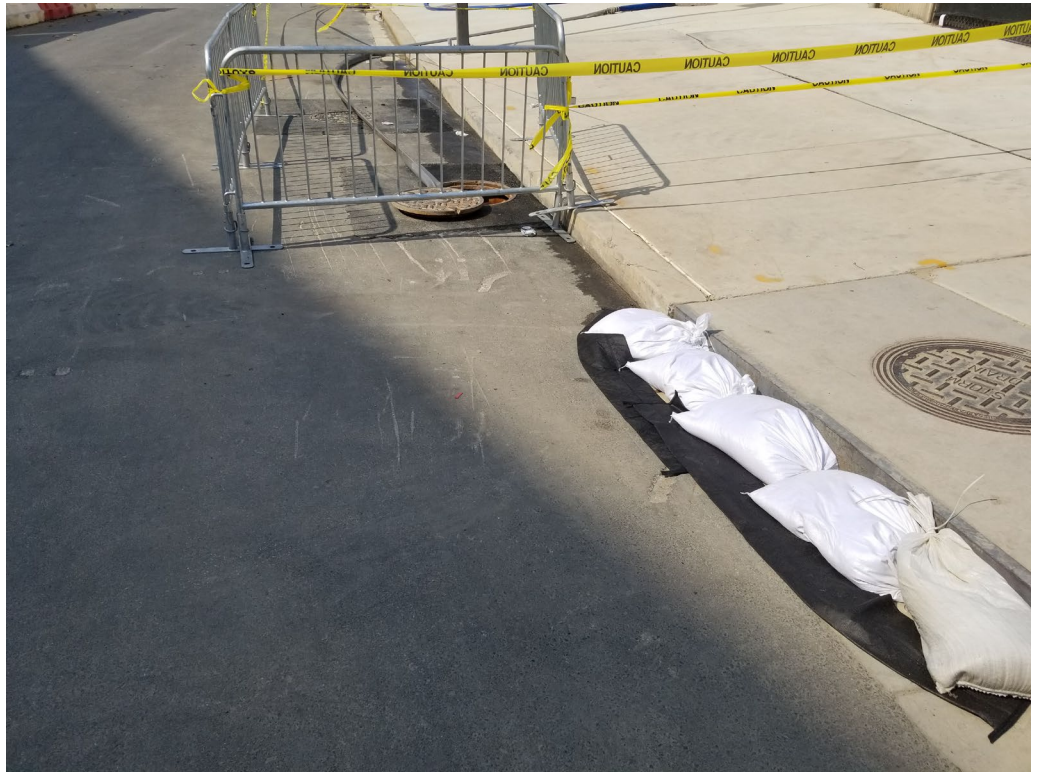
Photo No.
9

Picture of the impacted stormwater inlet sealed with liners and sandbags to prevent the 10% bleach disinfectant solution from entering the stormwater system.
