Maryland Department of Environment
Water and Science Administration
Compliance Program - Western Division
91 Eastern Blvd, Hagerstown, MD 21740
301-665-2850

Site Name: New Cole Fieldhouse
Facility Address: 4090 Union Dr, College Park, MD 20742
County: Prince George's County

Inspection Date: November 5, 2018 **Start Date/Time:** November 5, 2018, 09:00 AM
End Date/Time: November 5, 2018, 10:00 AM

Media Type(s): NPDES Construction Activity, State/federal SWM

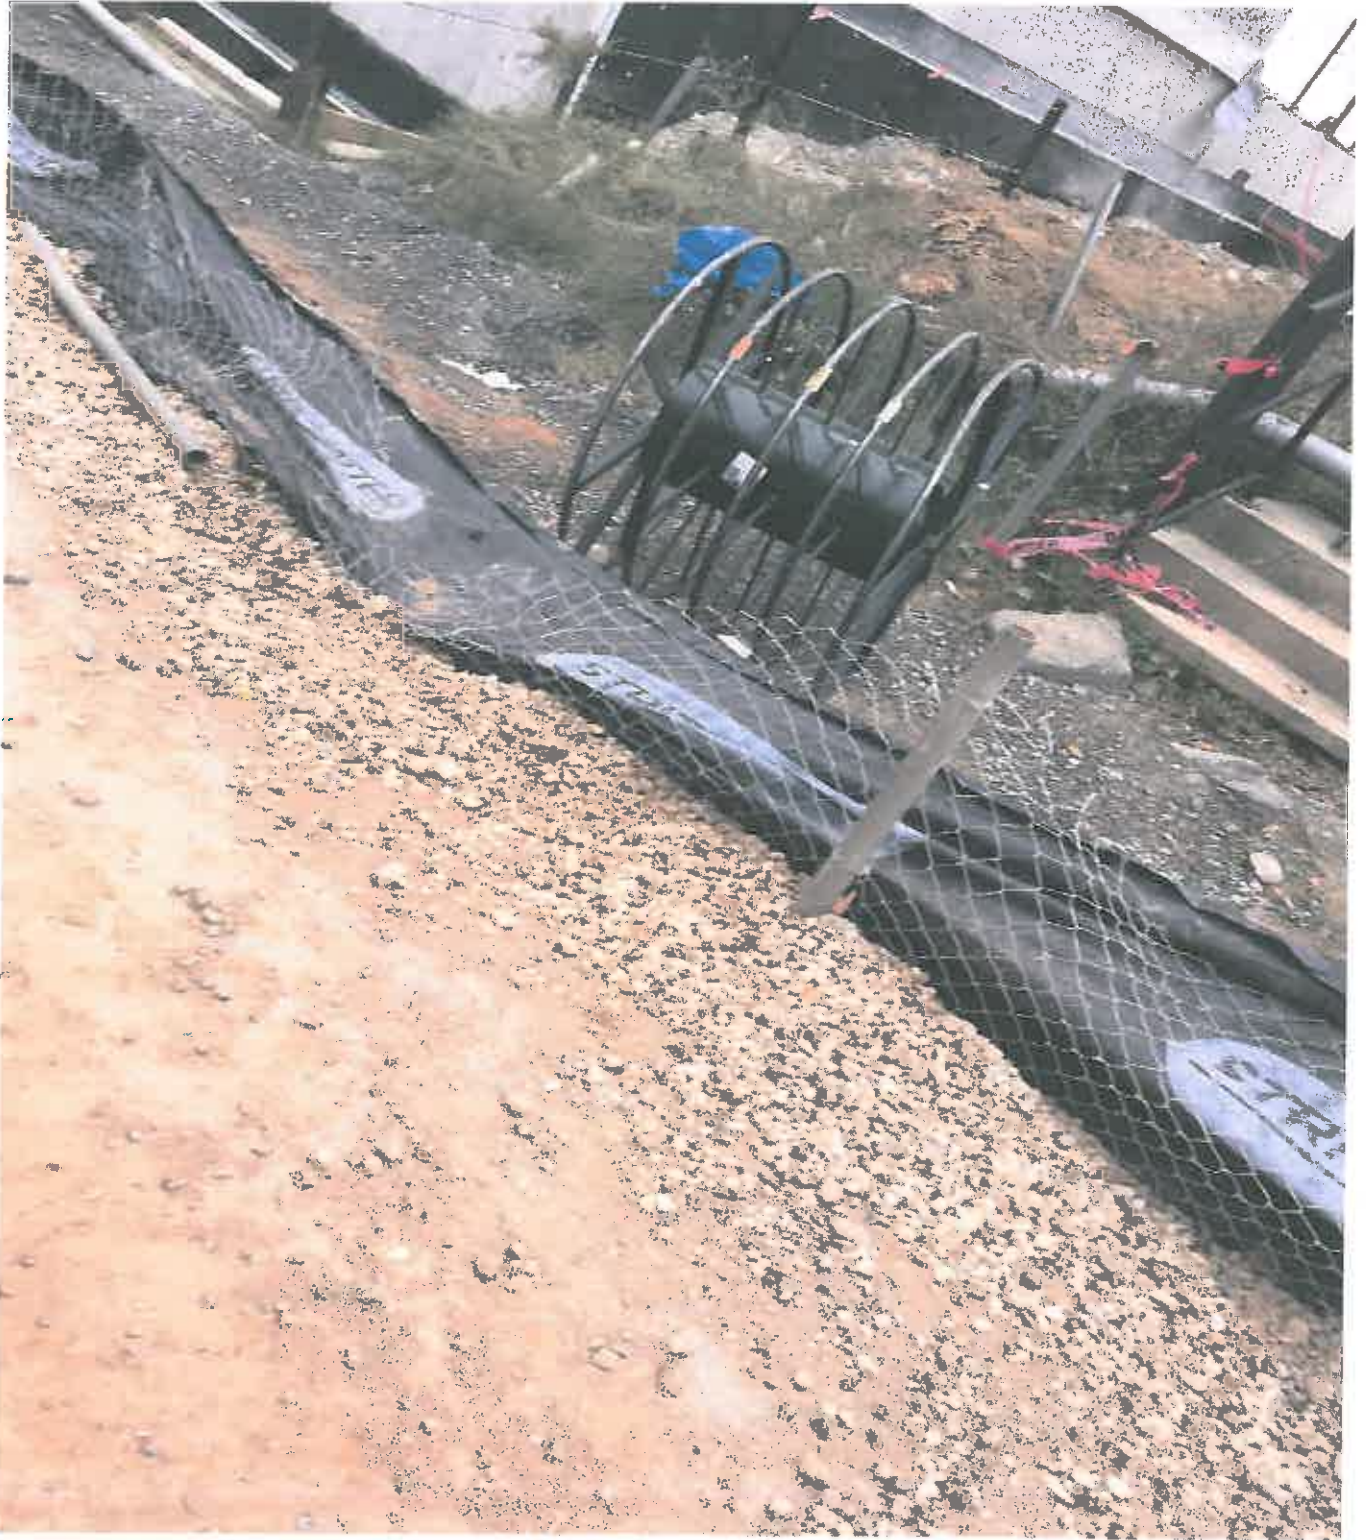
Photo 2. Shows Unmaintained and Compromised Super Silt Fence (SSF) off Cole Field House Drive

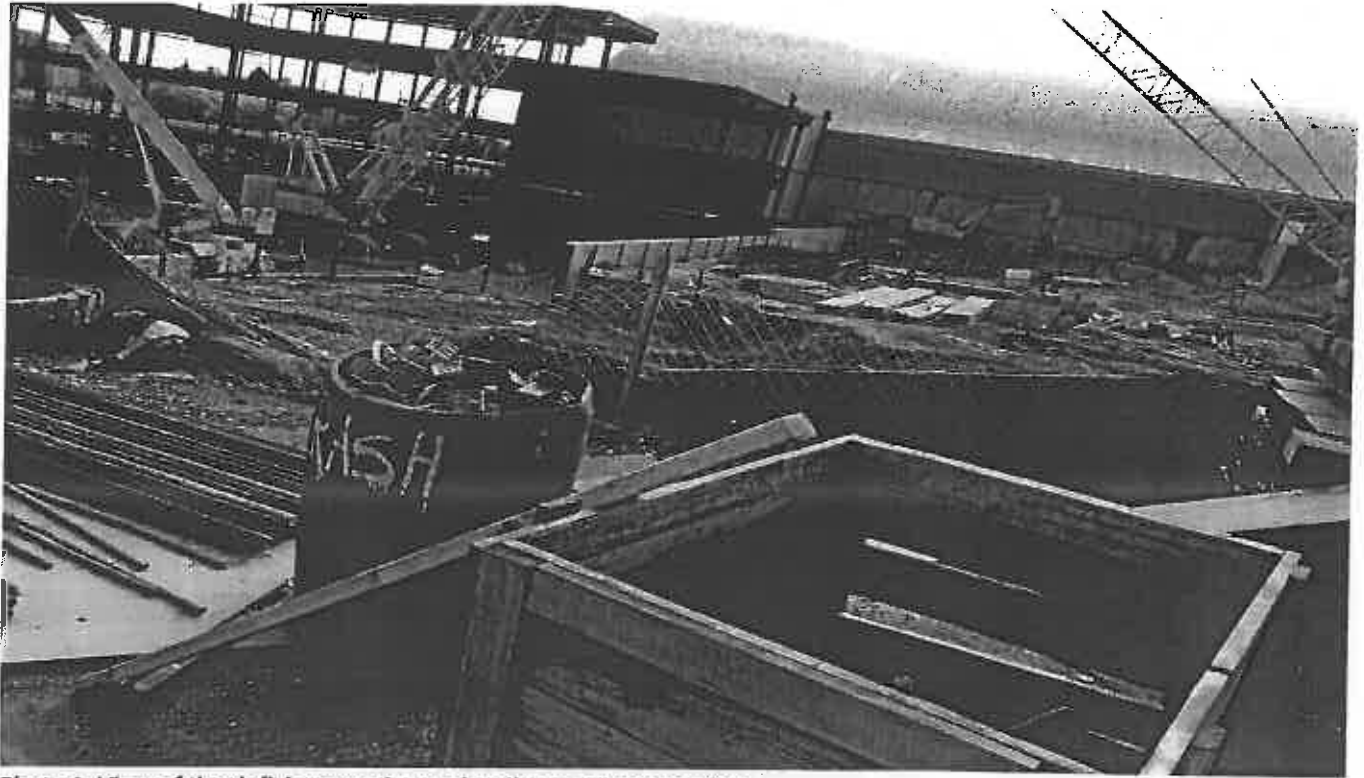
Photo 1. View of the deficient erosion and sediment control South of the site

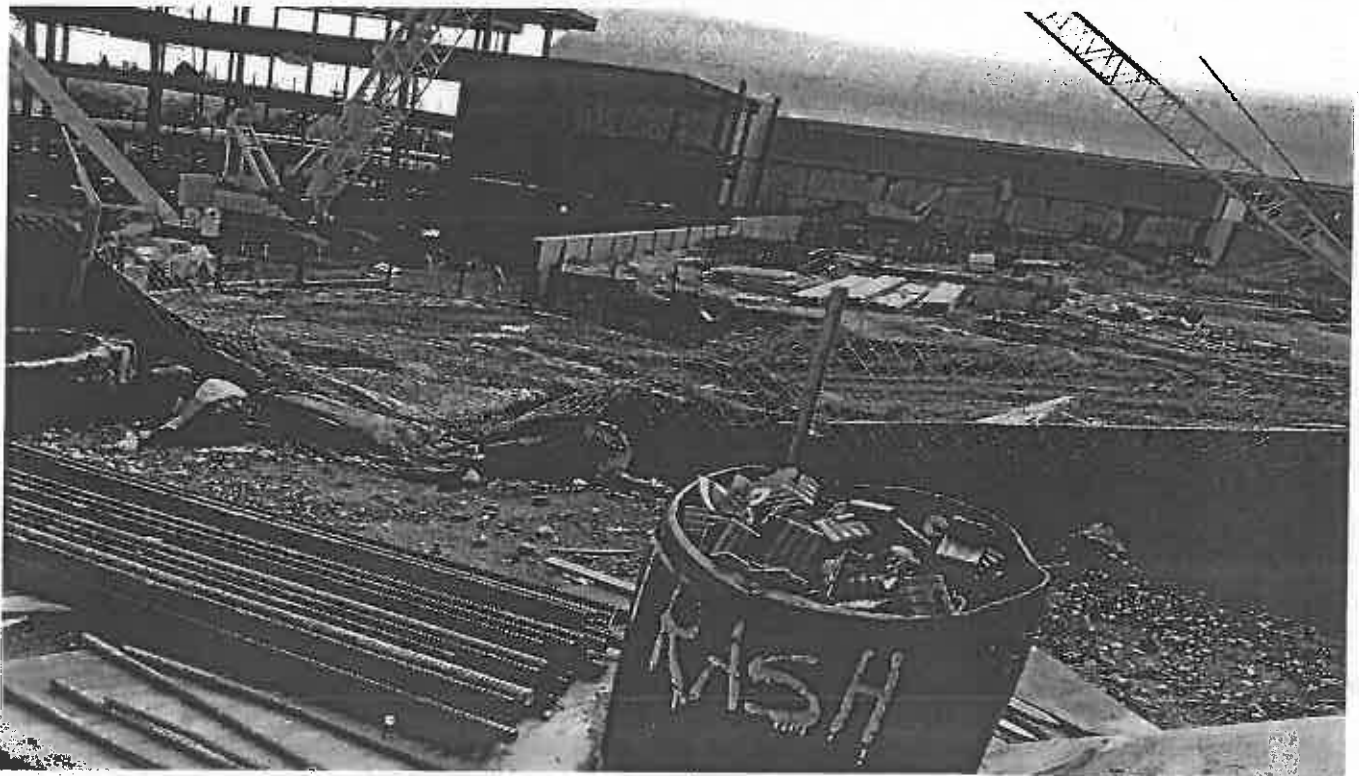
Photo 2. View of the deficient erosion and sediment control South of the site

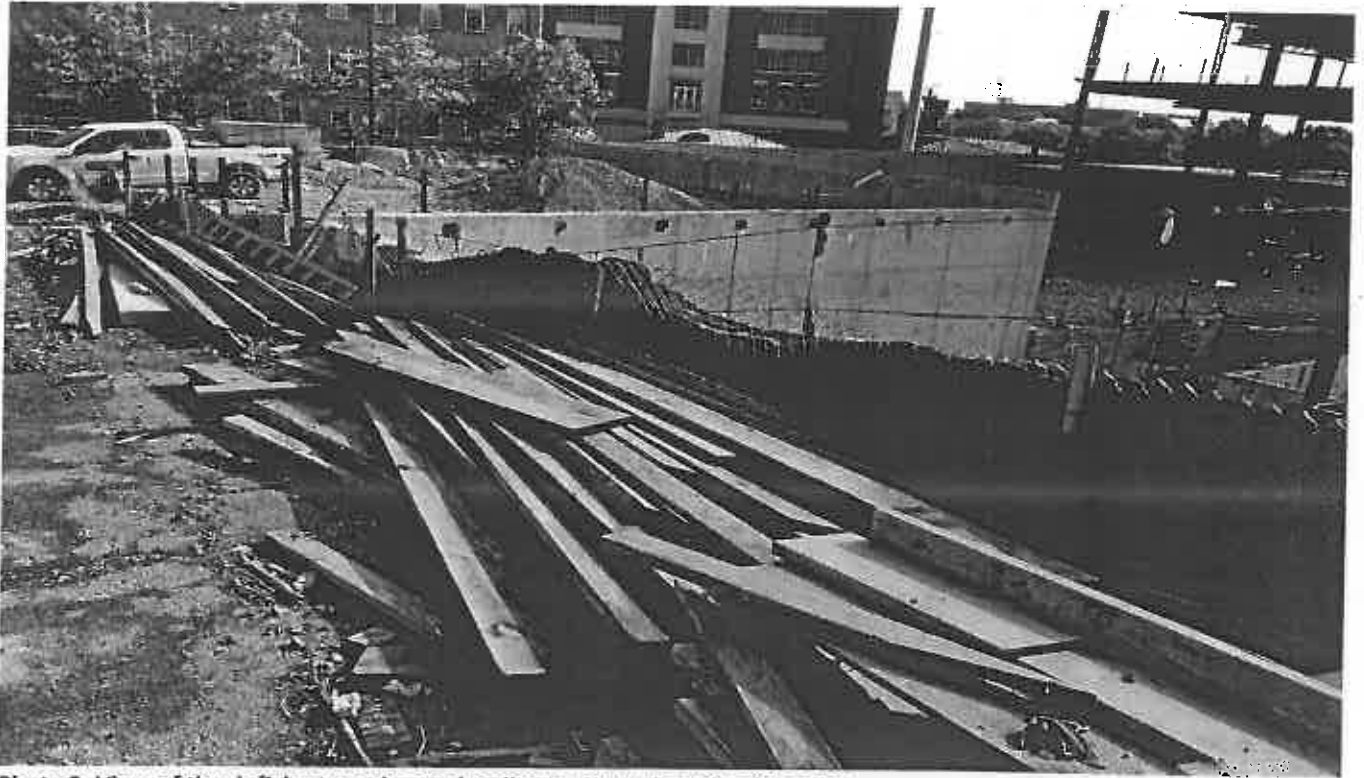
Photo 3. View of the deficient erosion and sediment control South of the site

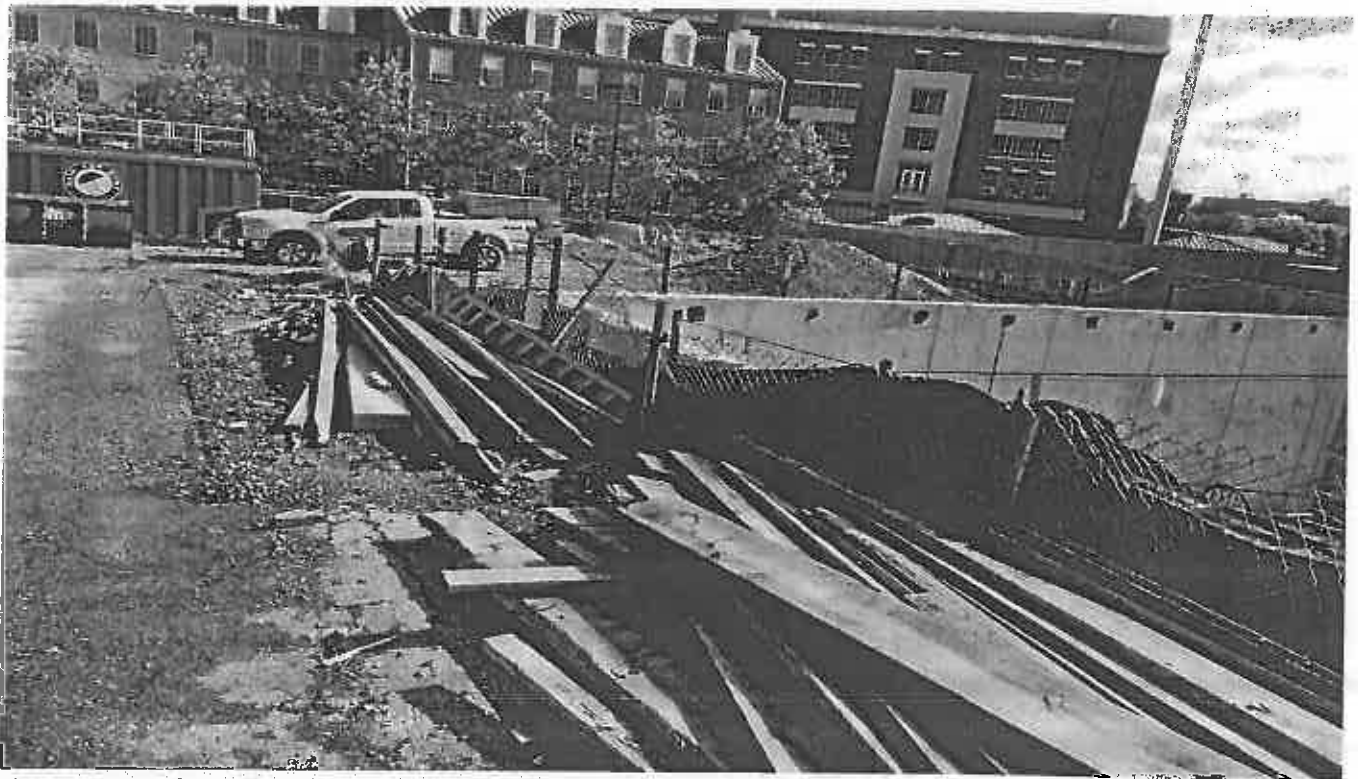
Photo 4. View of the deficient erosion and sediment control South of the site

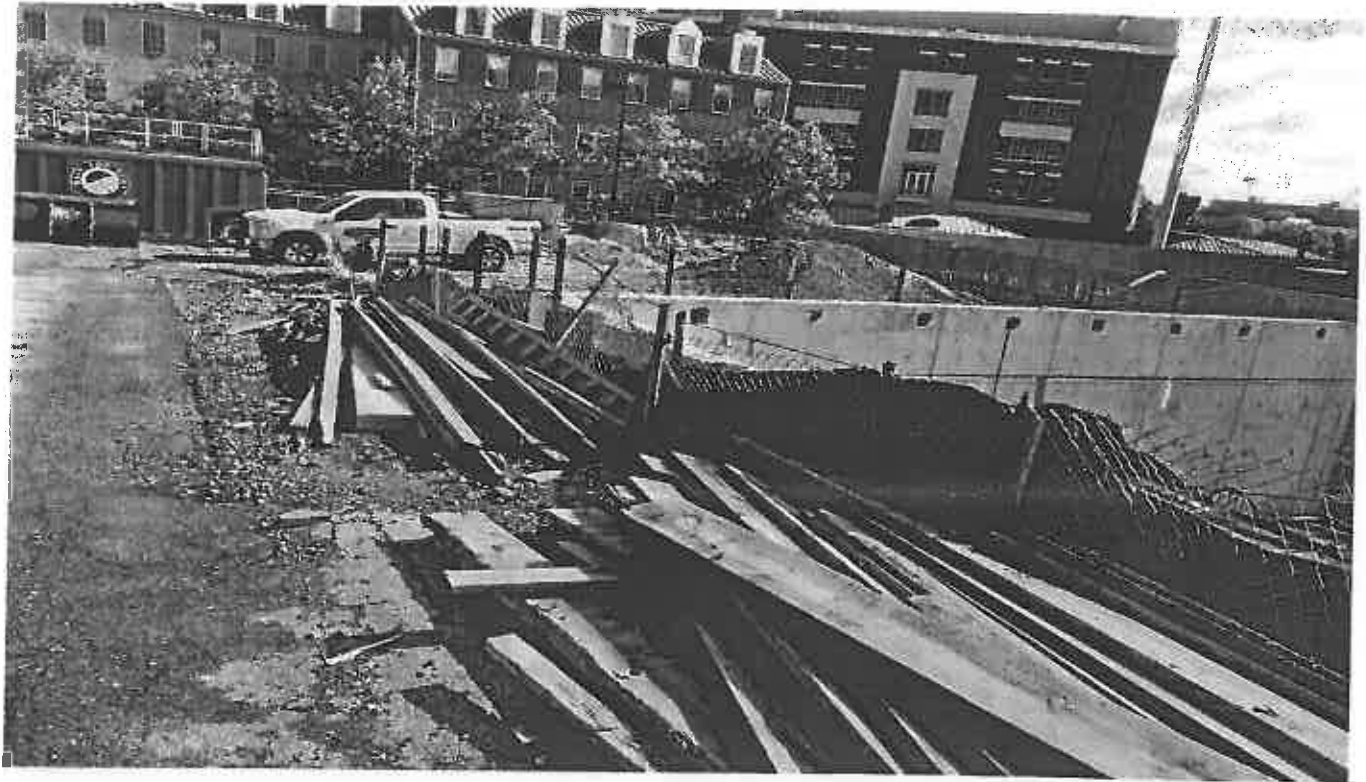
Photo 5. View of the deficient erosion and sediment control South of the site

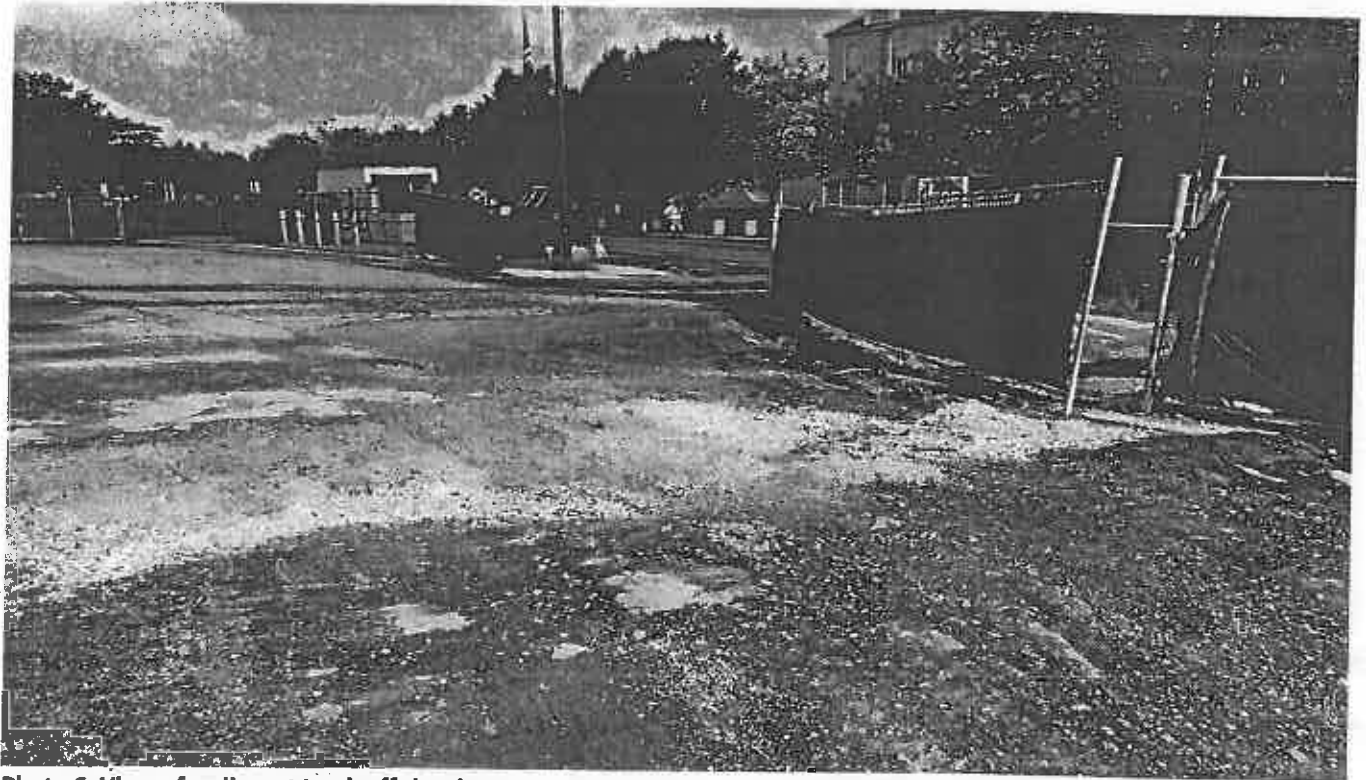
Photo 6. View of sediment track off the site

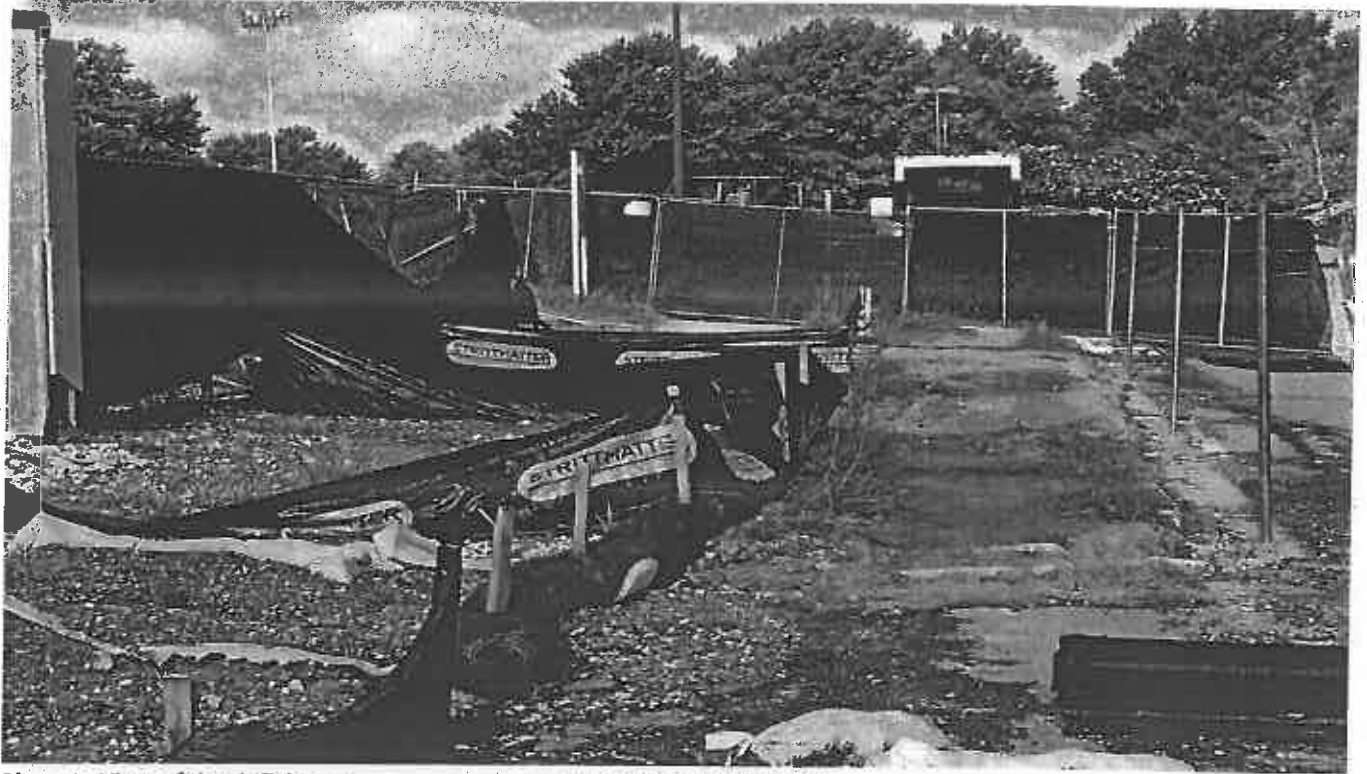
Photo 7. View of the deficient erosion and sediment control SW of the site

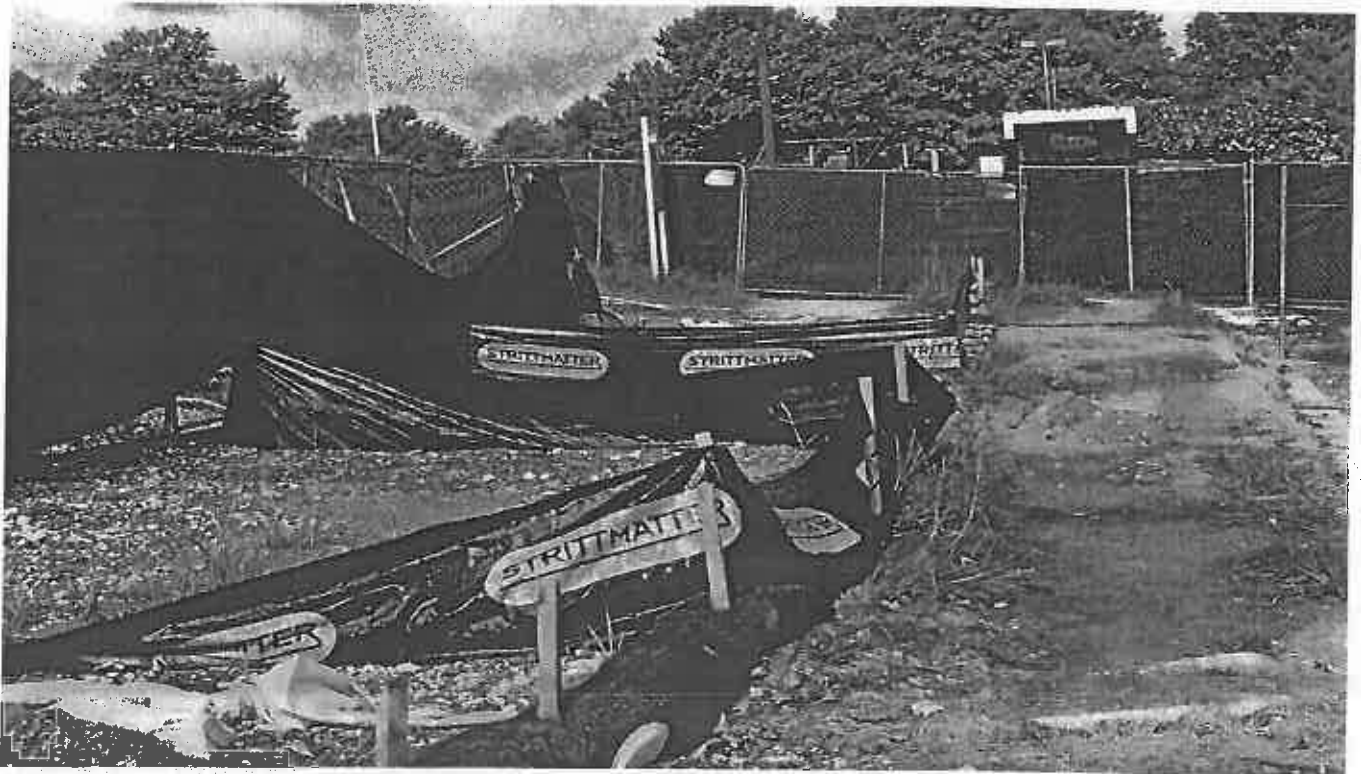
Photo 8. View of the deficient erosion and sediment control SW of the site

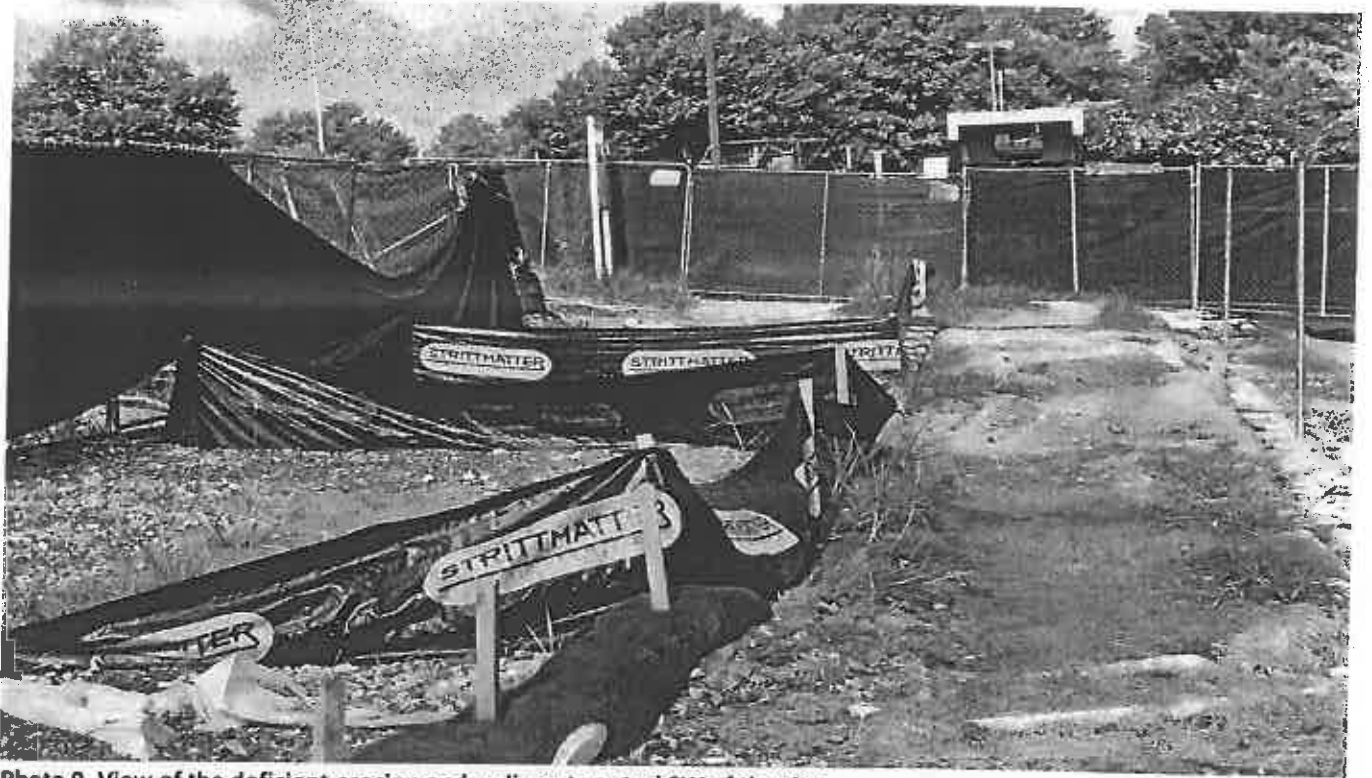
Photo 9. View of the deficient erosion and sediment control SW of the site

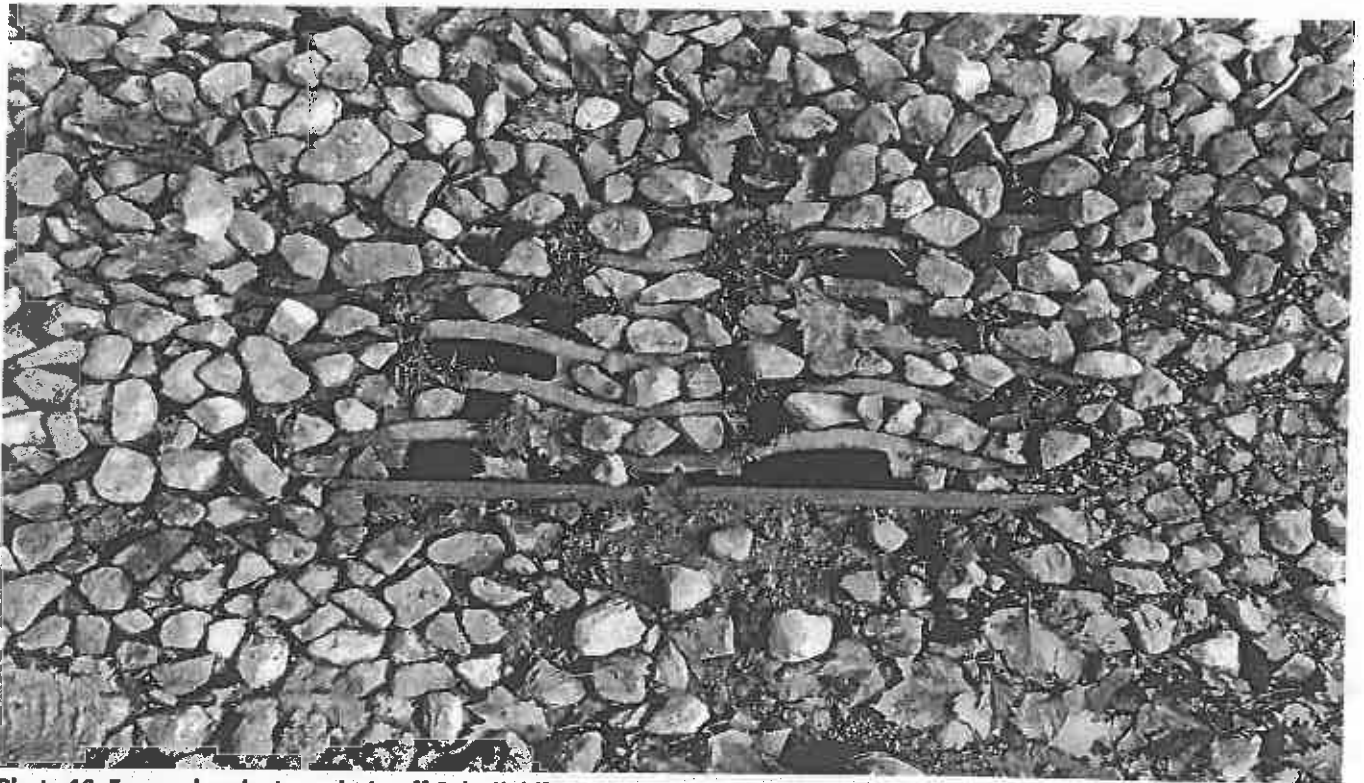
Photo 10. Exposed curb stormdrain off Cole Fieldhouse Road downhill from site

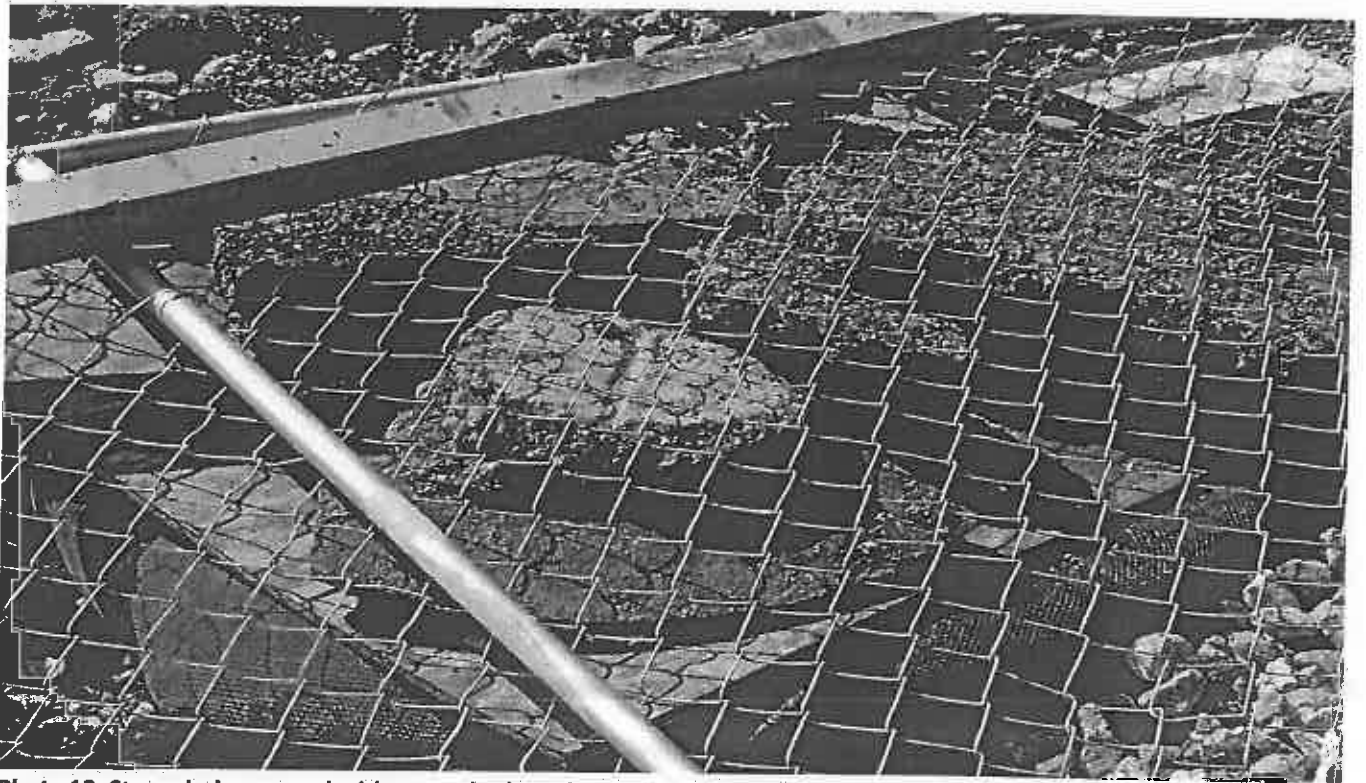
Photo 12. Stormdrain covered with gutter body and rustic metal plate

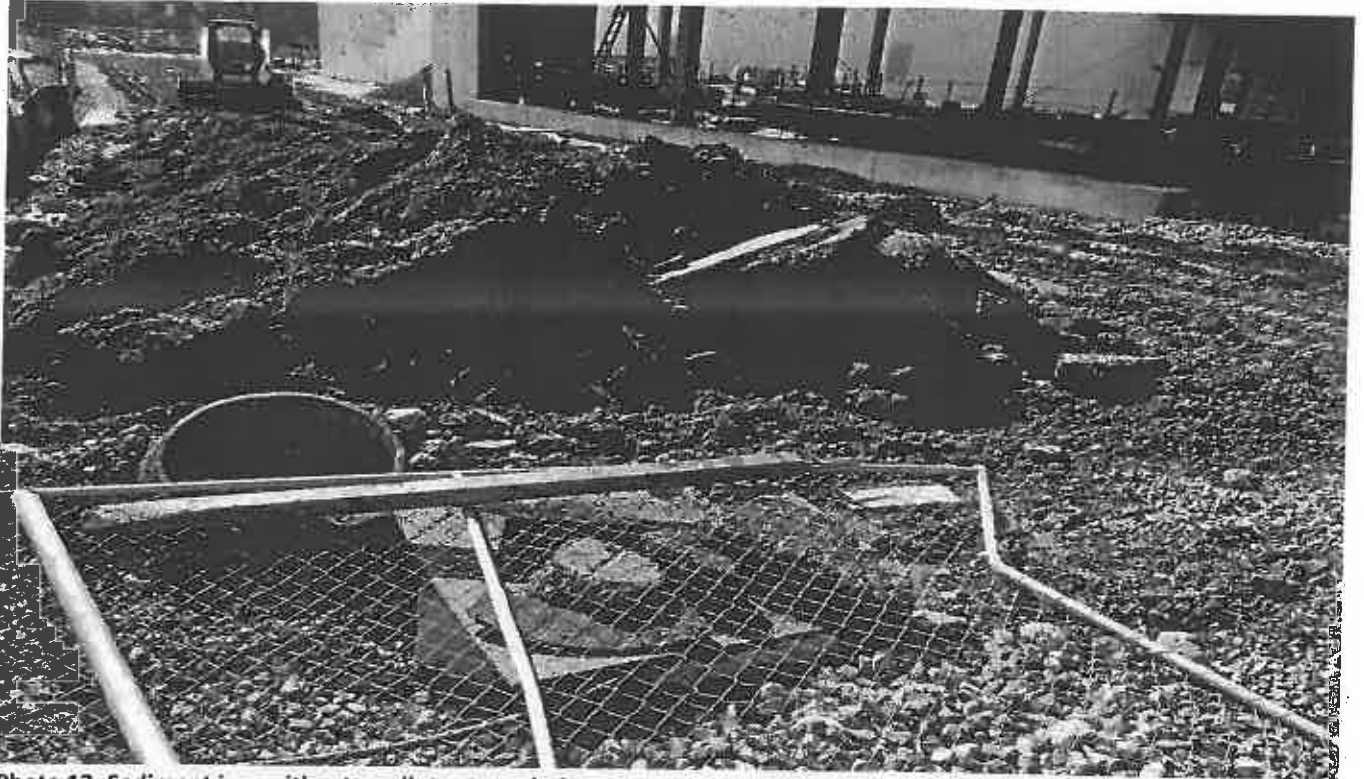
Photo 13. Sediment in position to pollute stormdrain.

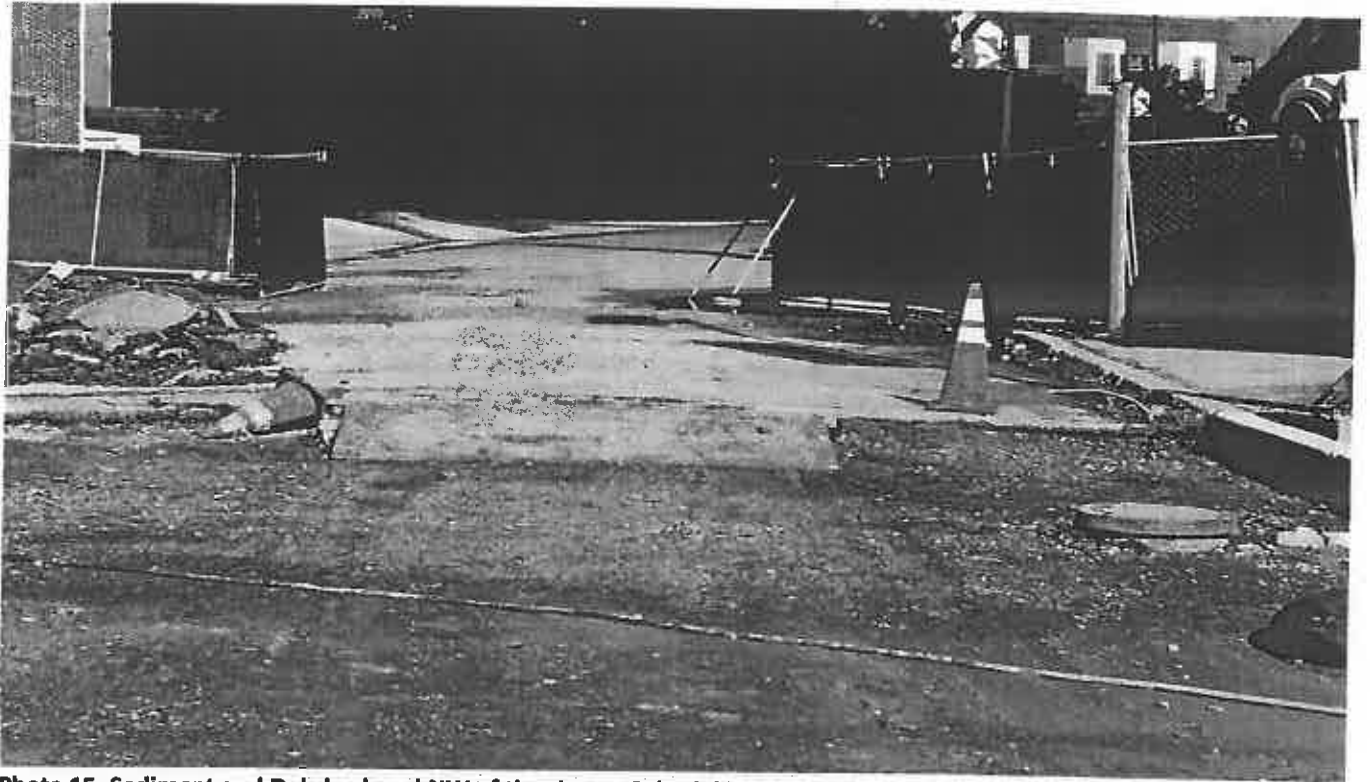
Photo 15. Sediment and Debris placed NW of the site on Cole Fieldhouse Drive.

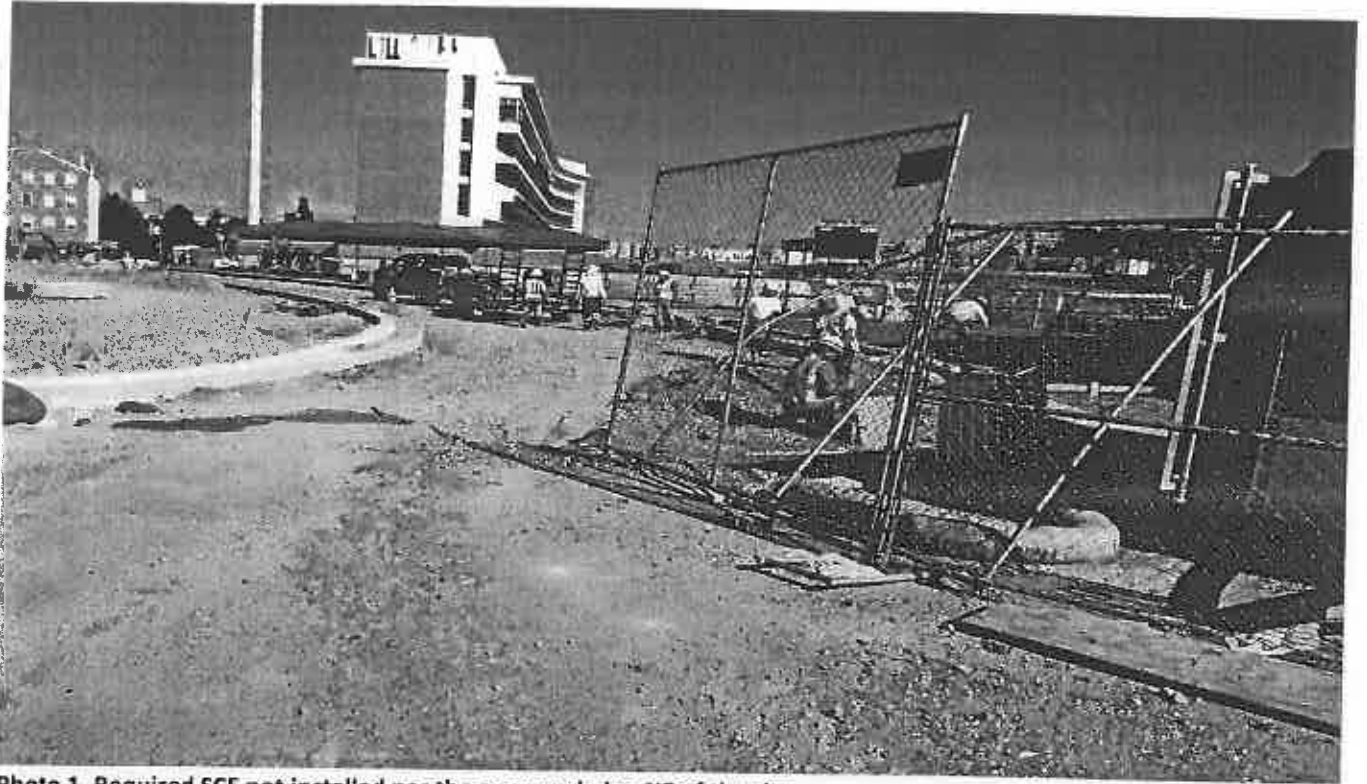
Photo 1. Required SCE not installed per the approved plan NE of the site.

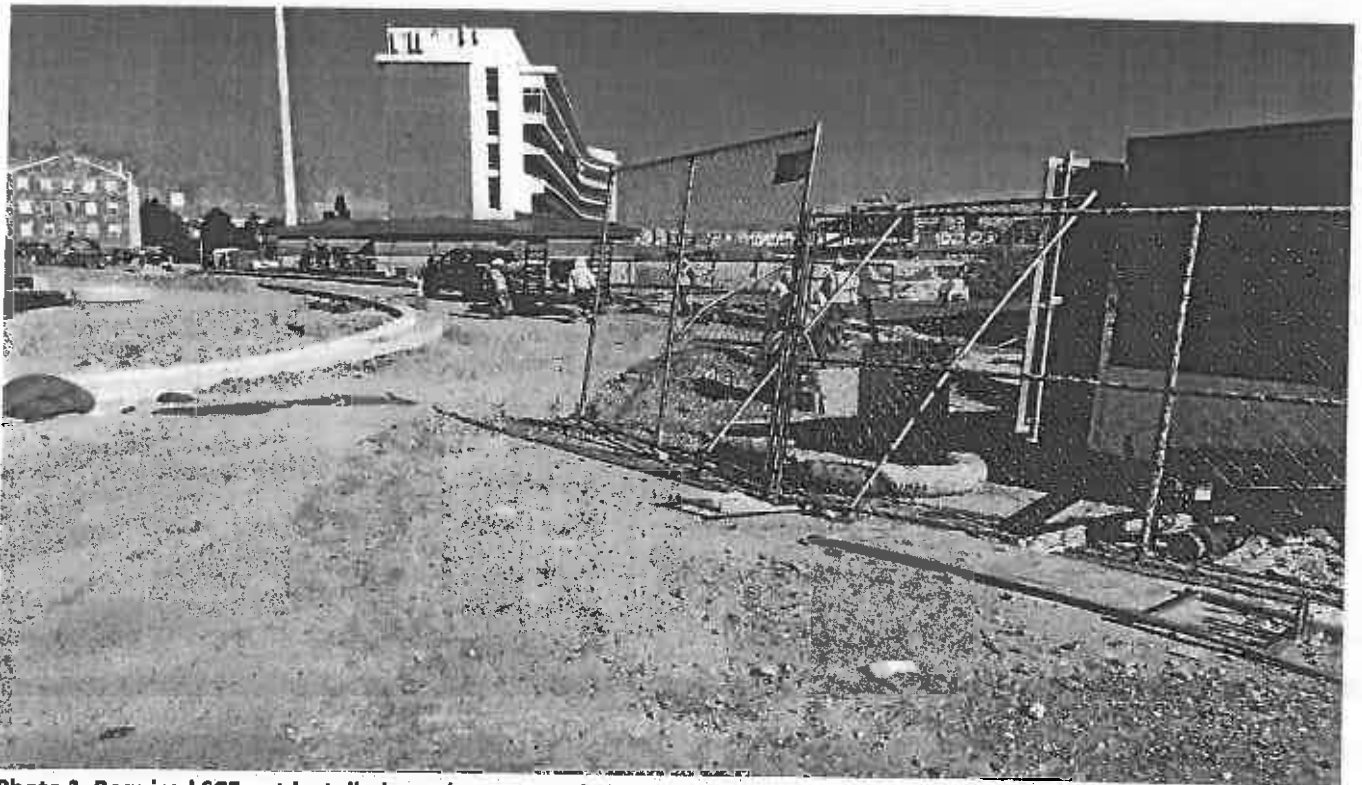
Photo 2. Required SCE not installed per the approved plan NE of the site.

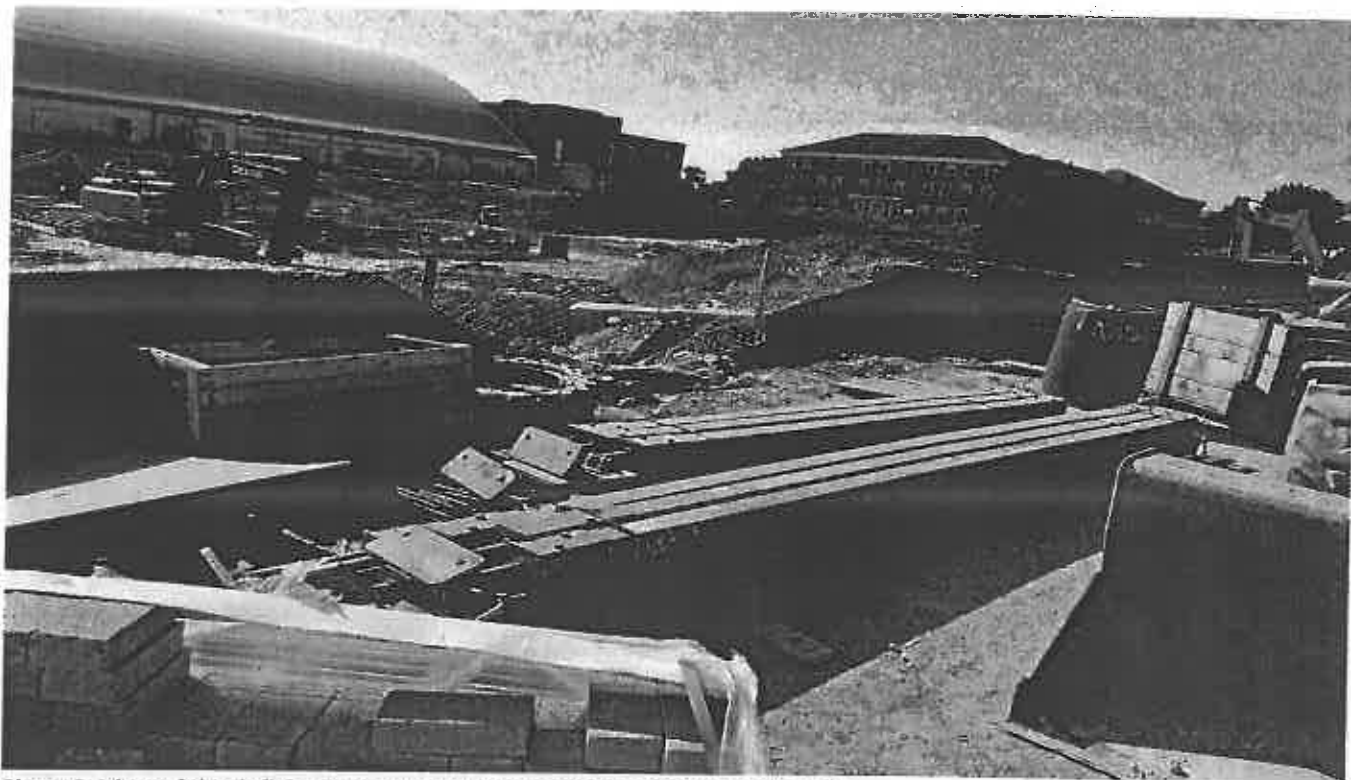
Photo 9. View of the deficient erosion and sediment control South of the site

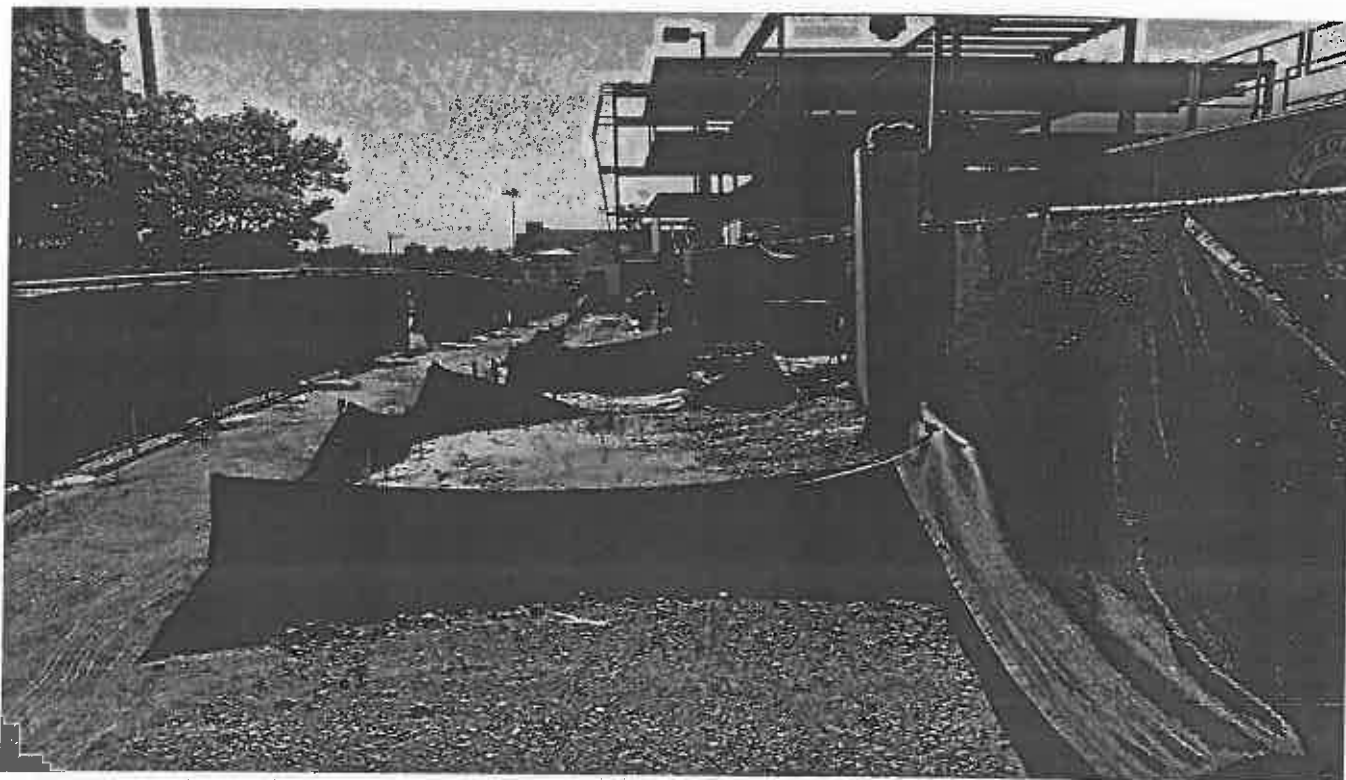
Photo 10. View of the deficient erosion and sediment control SW of the site

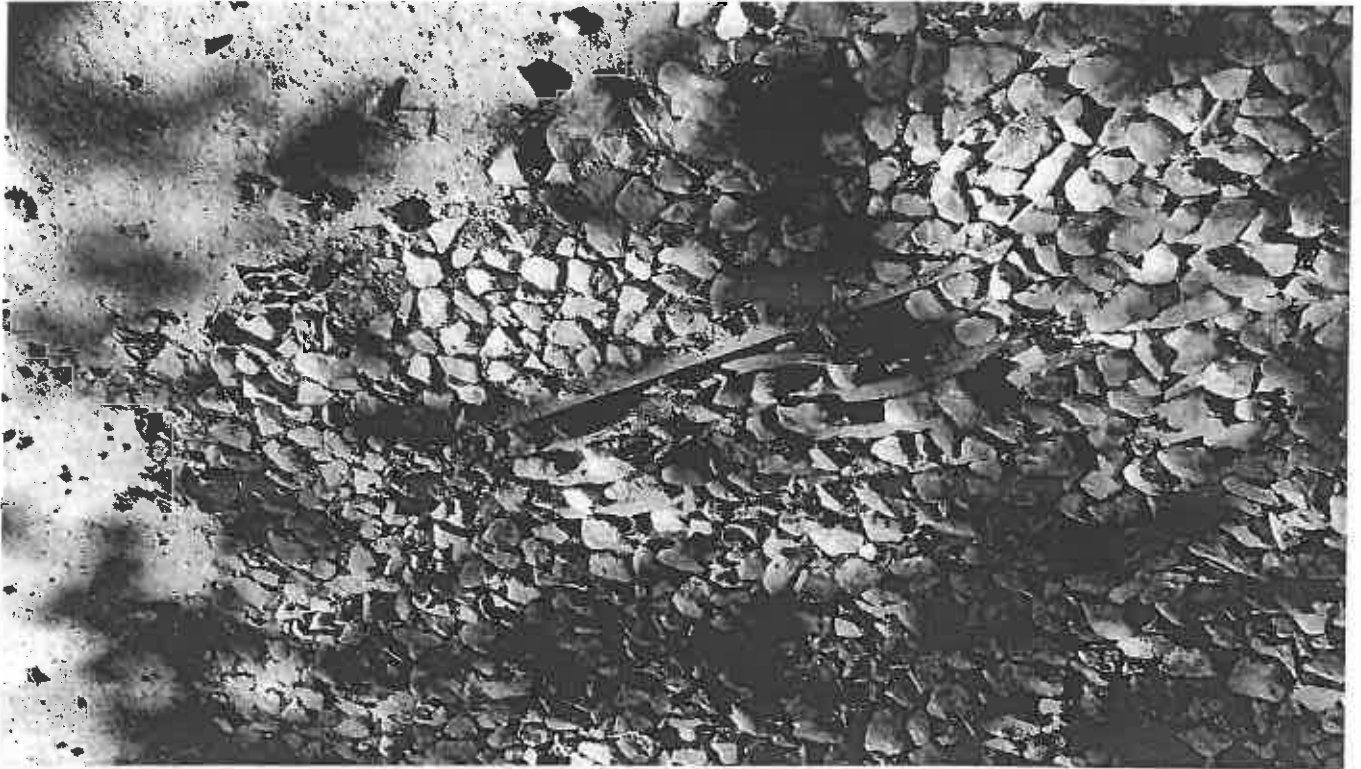
Photo 11. Exposed curb stormdrain off Cole Fieldhouse Road downhill from site

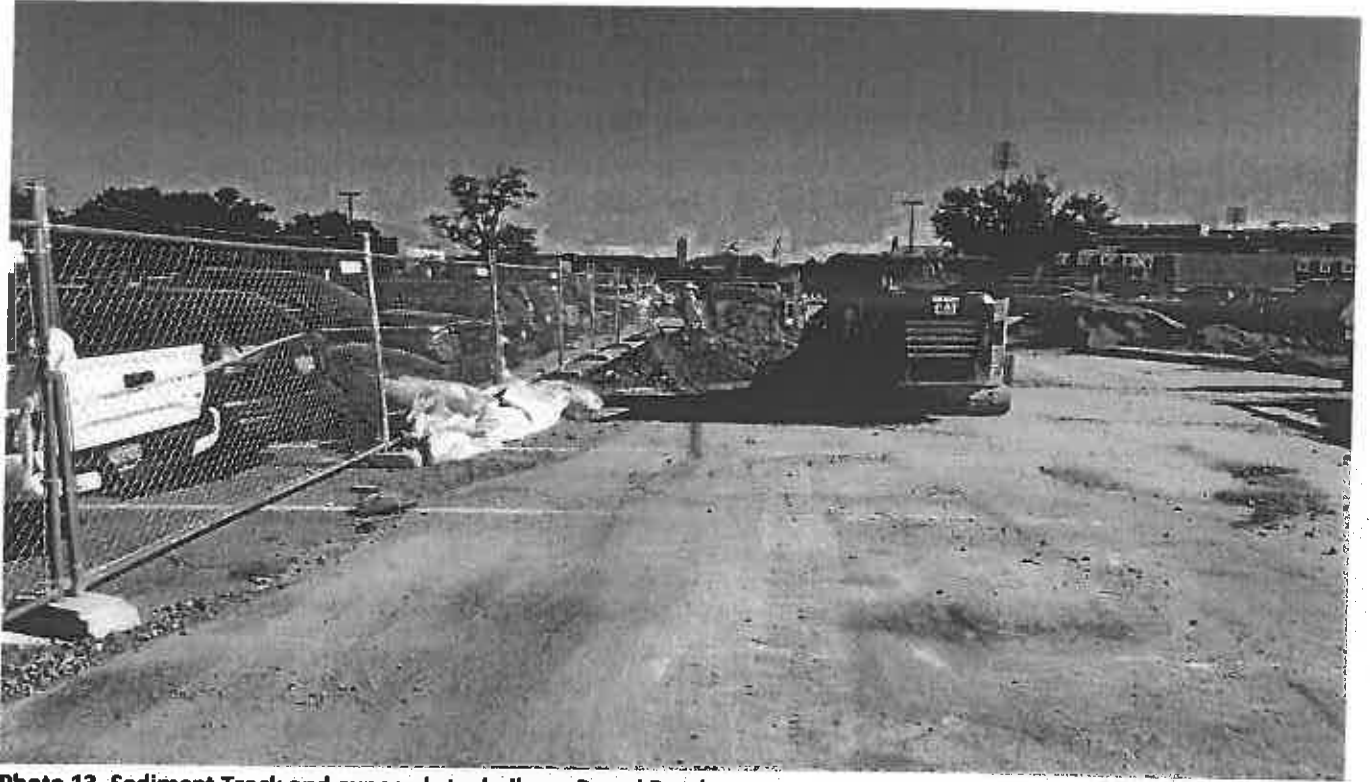
Photo 13. Sediment Track and exposed stockpile on Paved Road
