Maryland Department of Environment
Water and Science Administration
Compliance Program - Western Division
91 Eastern Blvd, Hagerstown, MD 21740
301-665-2850

Site Name: New Cole Fieldhouse
Facility Address: 4090 Union Dr, College Park, MD 20742
County: Prince George's County

Inspection Date: November 5, 2018 **Start Date/Time:** November 5, 2018, 09:00 AM
End Date/Time: November 5, 2018, 10:00 AM

Media Type(s): NPDES Construction Activity, State/federal SWM

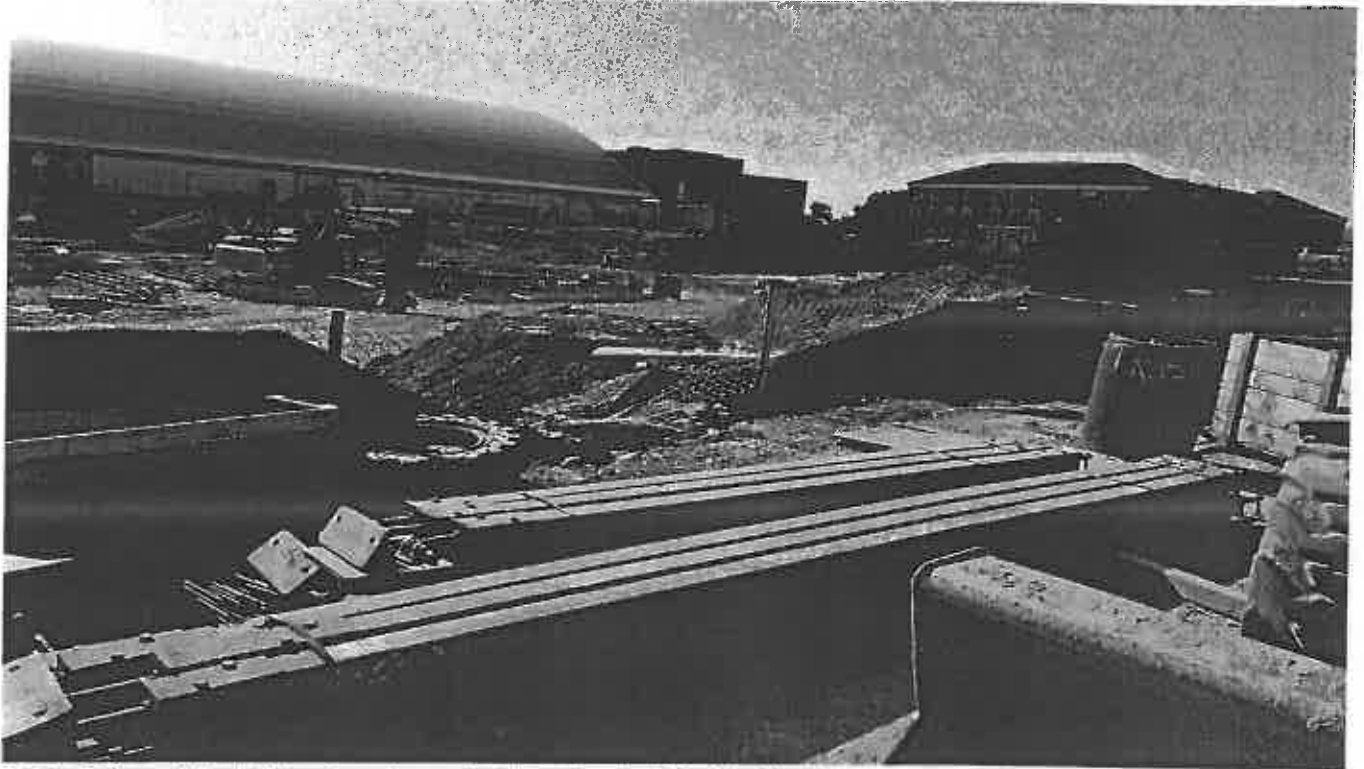
Photo 7. View of the deficient erosion and sediment control South of the site

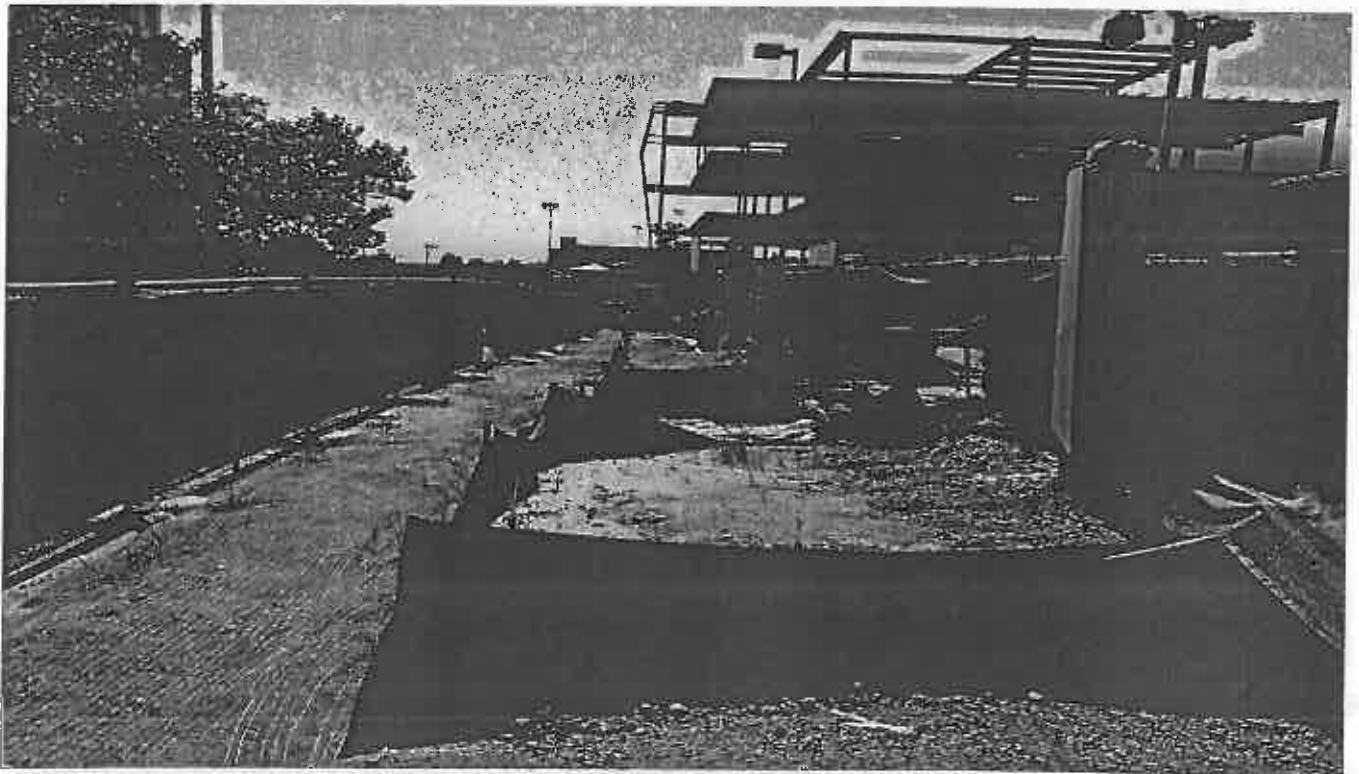
Photo 8. View of the deficient erosion and sediment control SW of the site

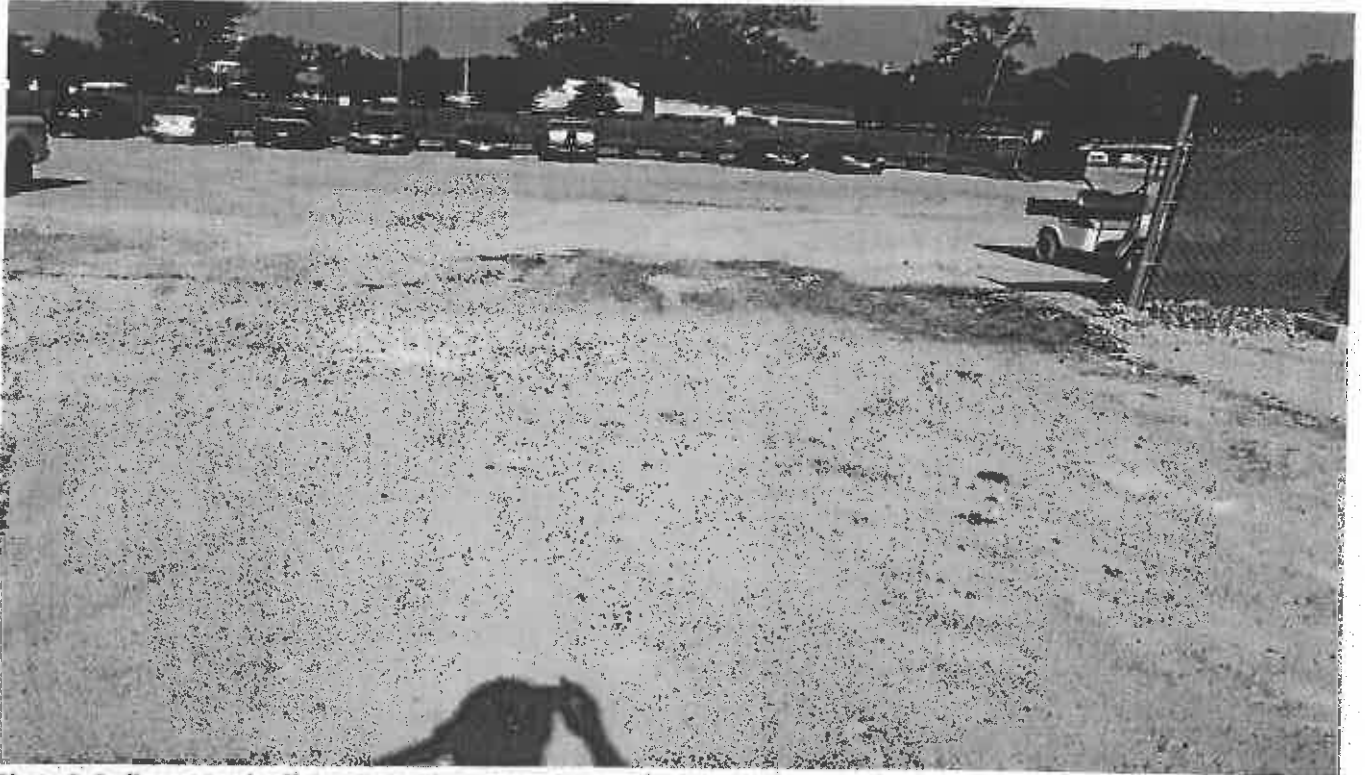
Photo 9. Sediment track off the site to the parking lot South of the site

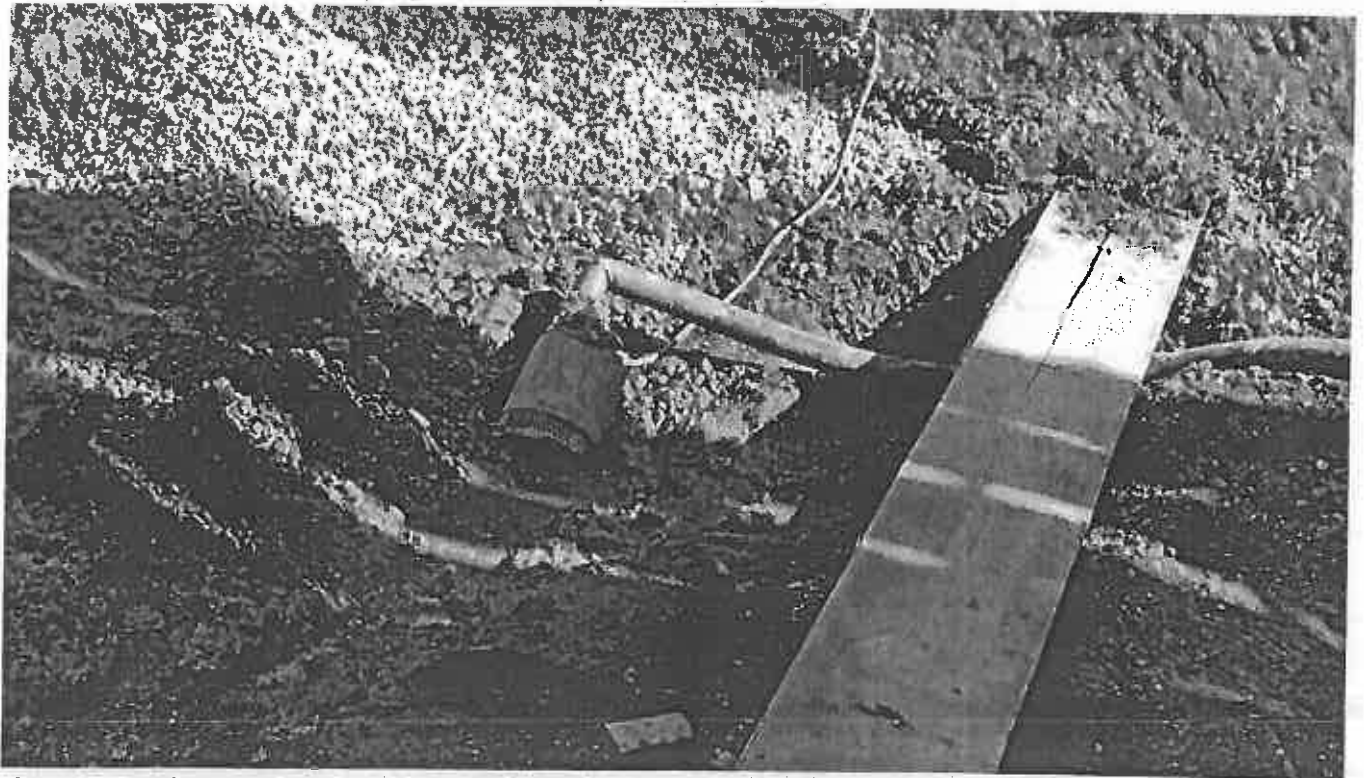
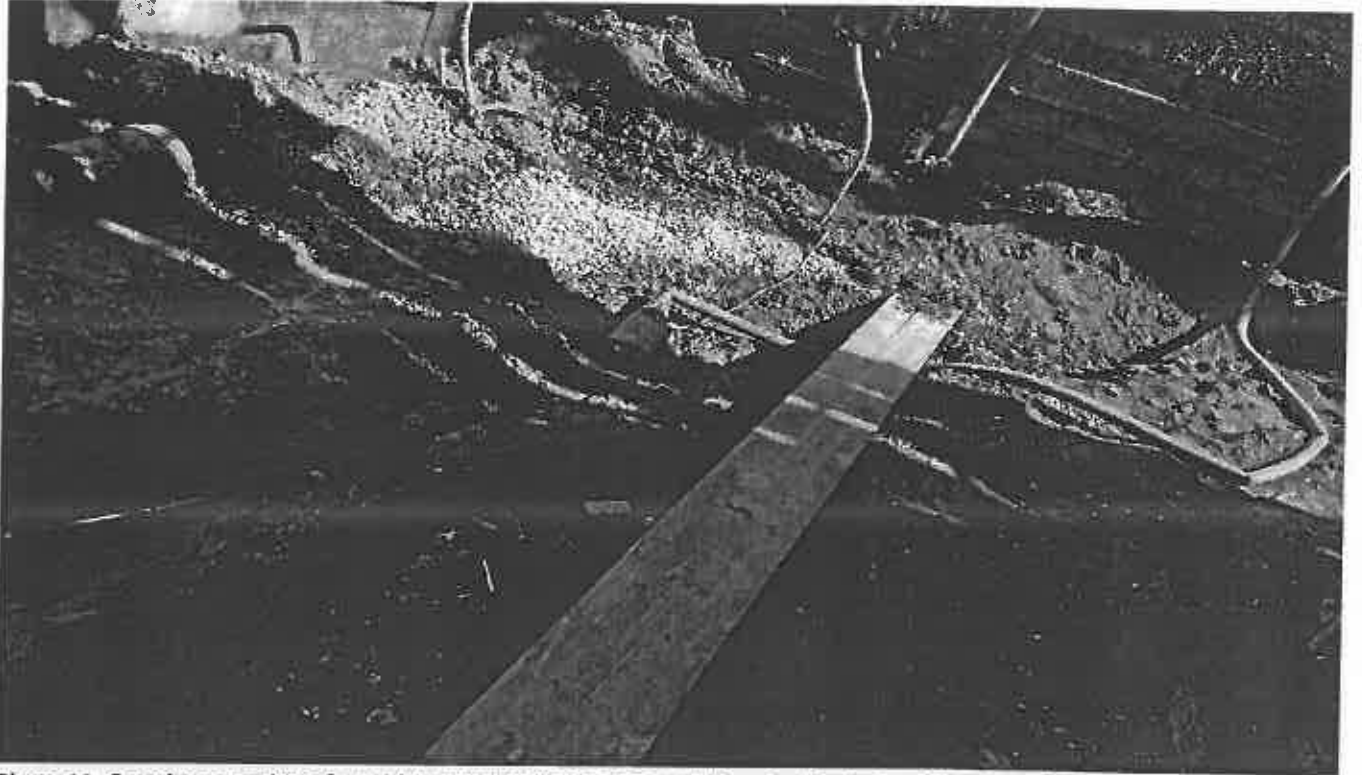
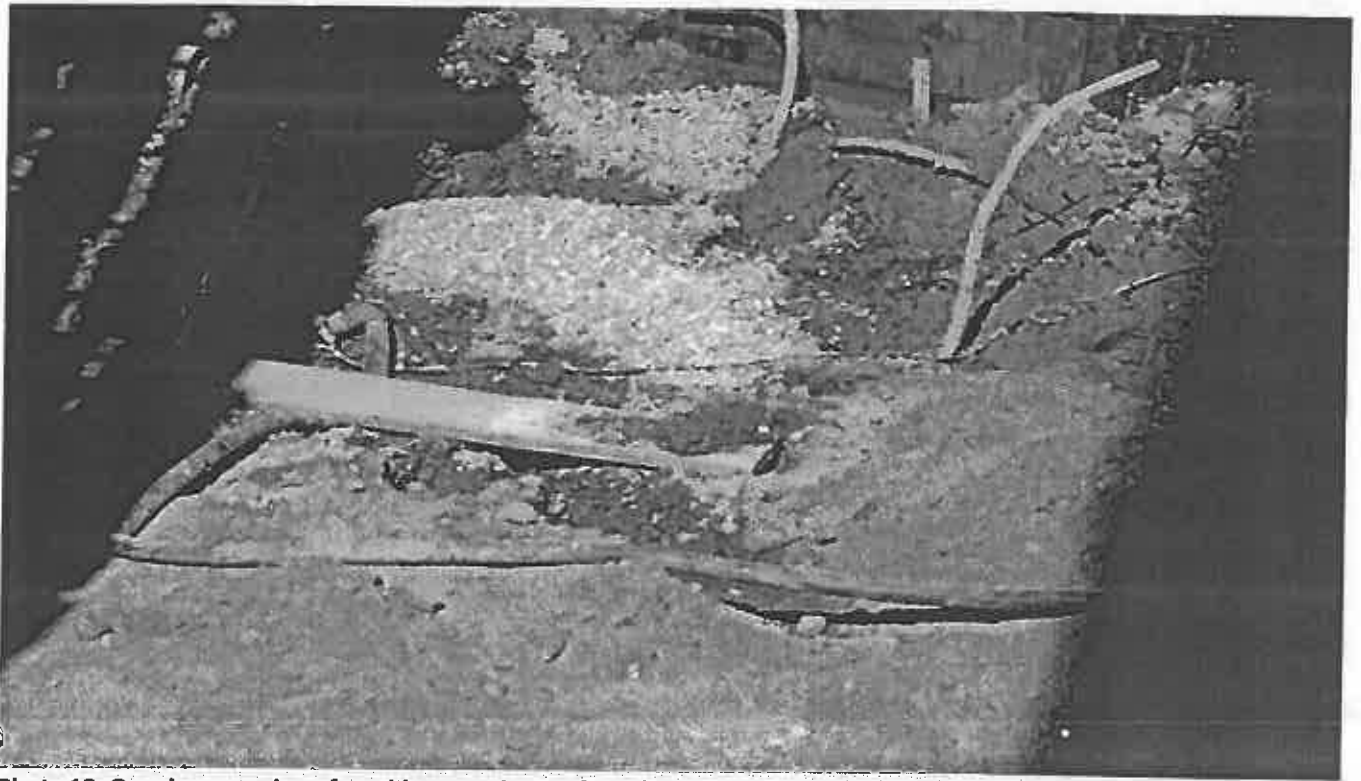
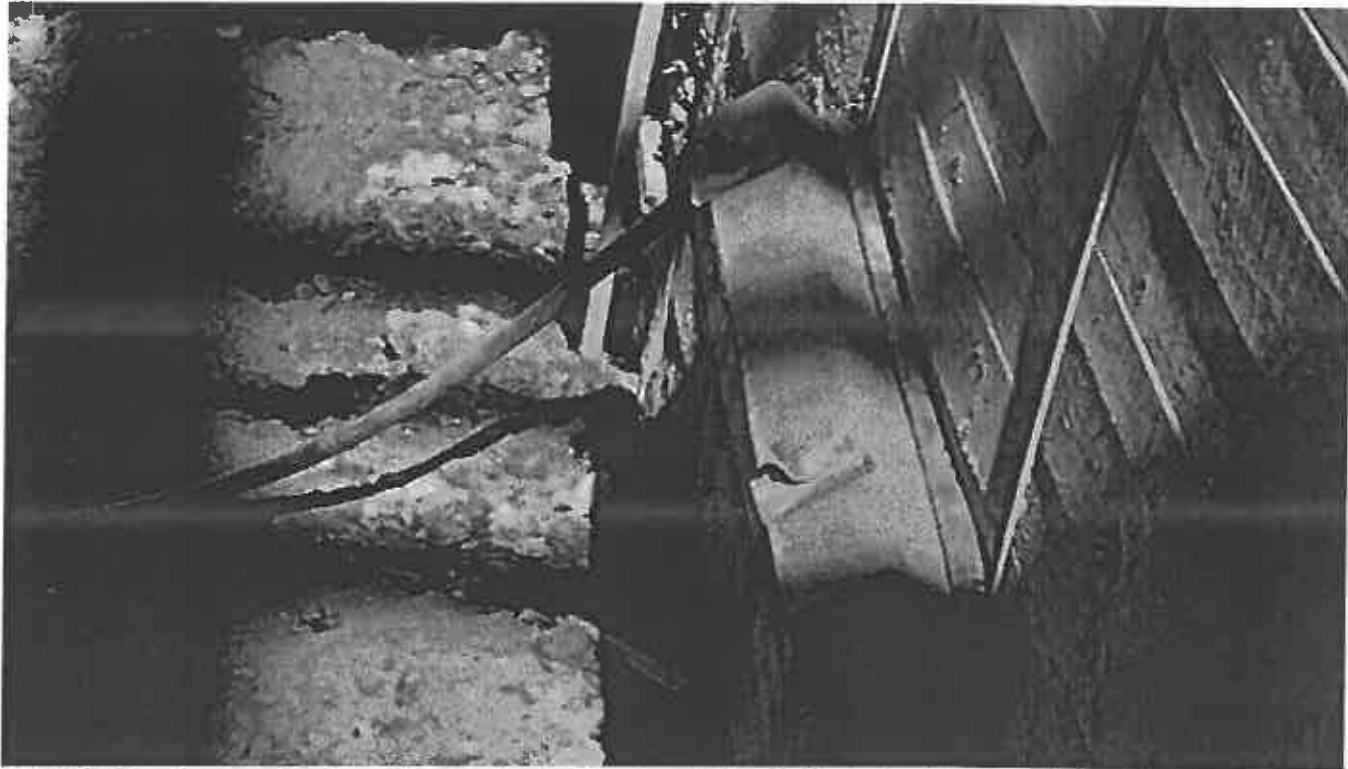
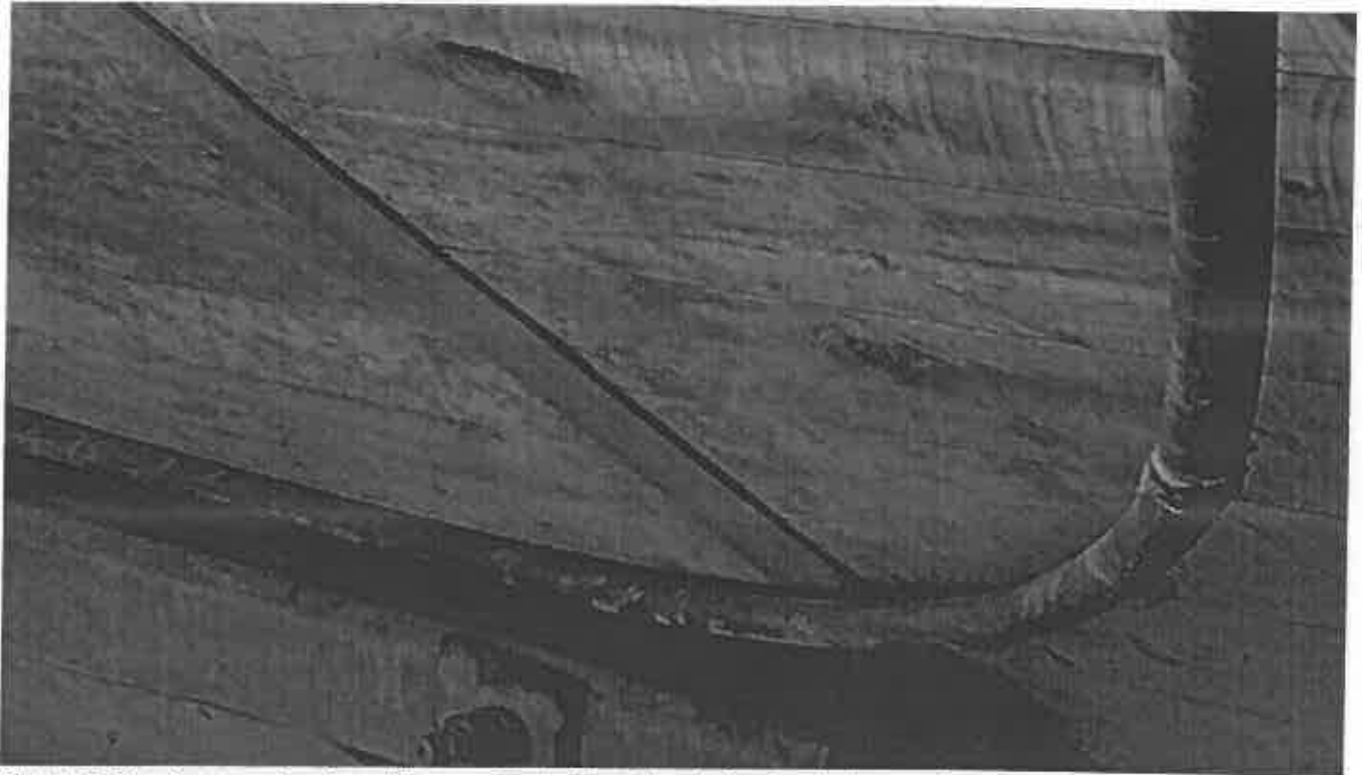
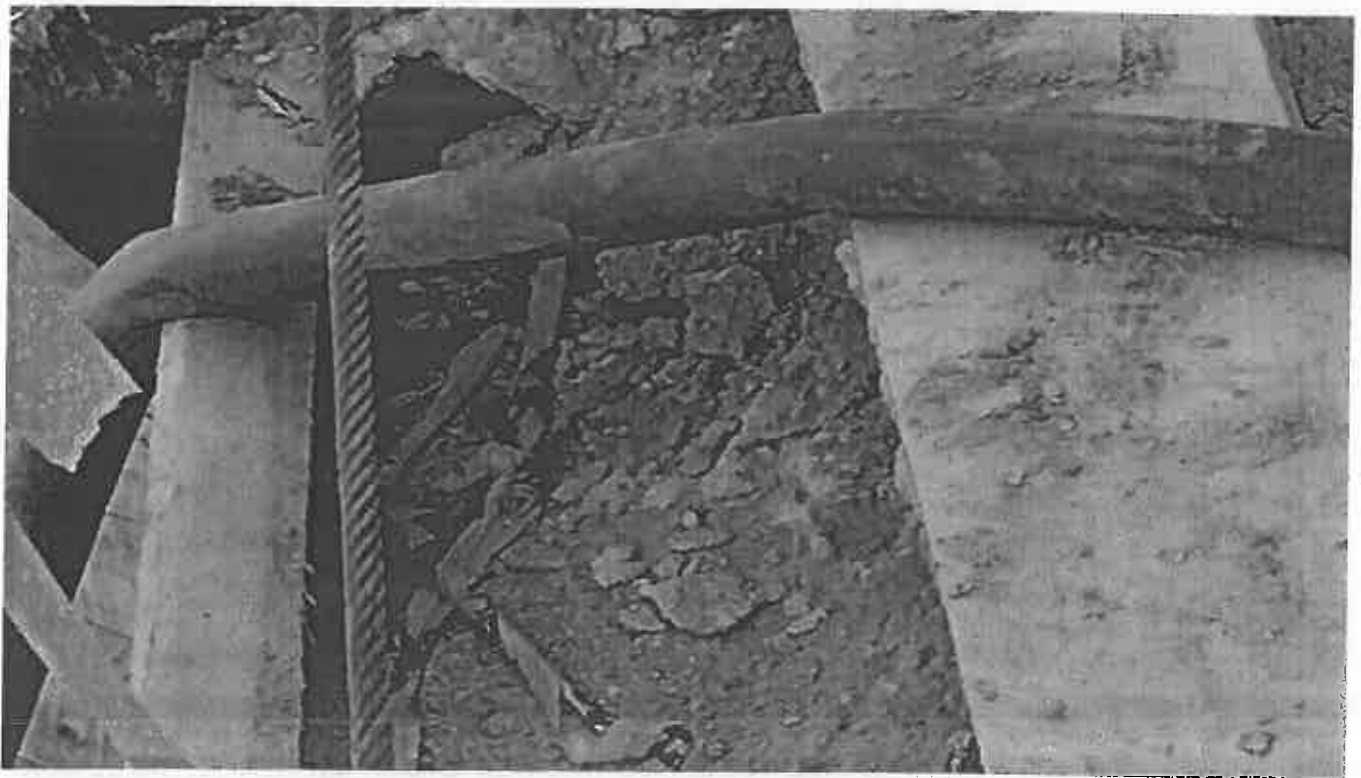
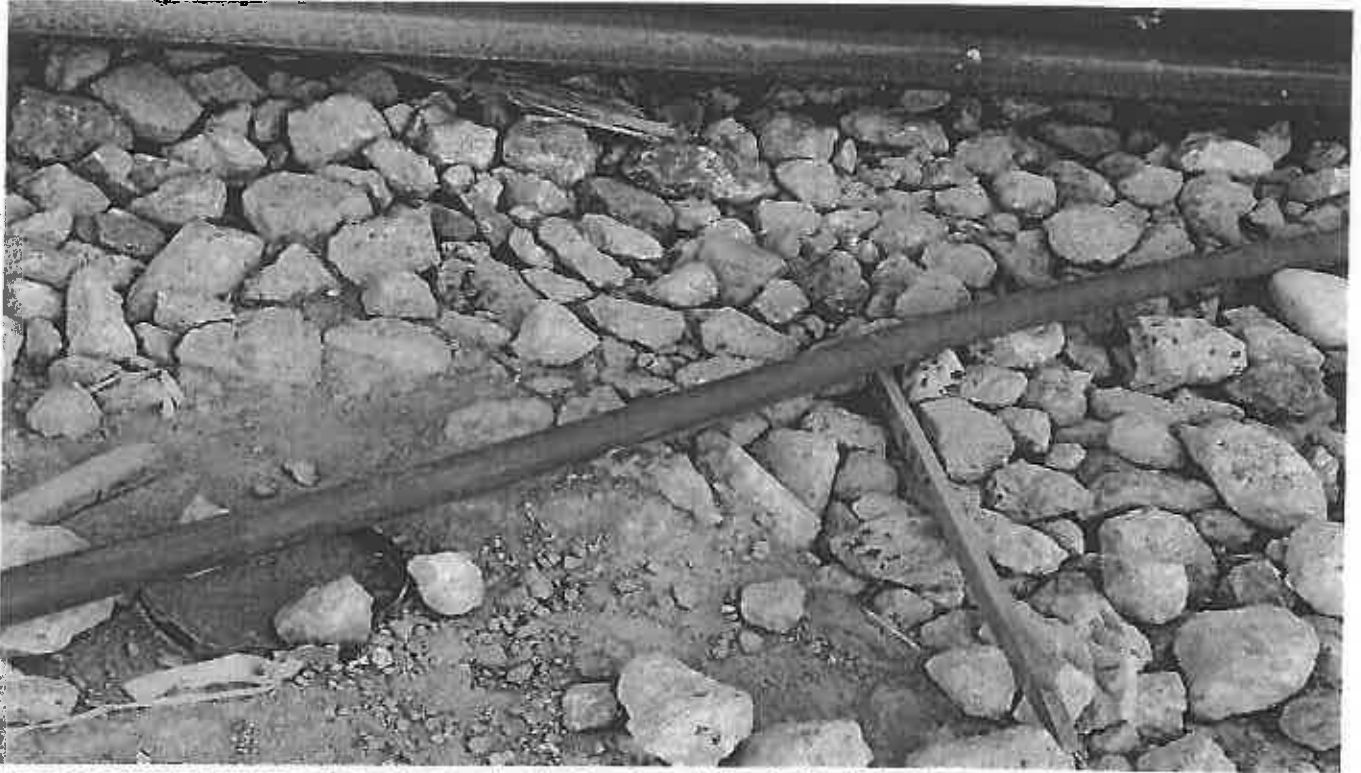
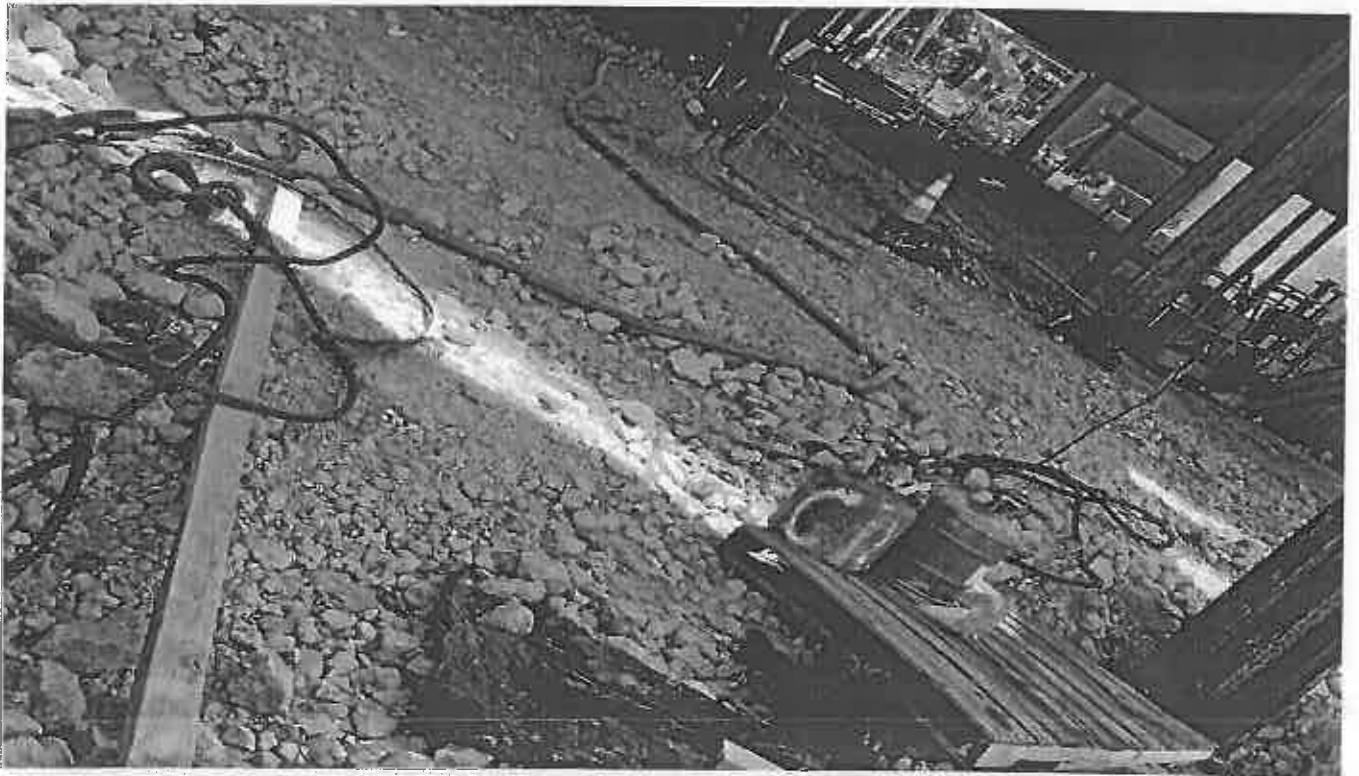
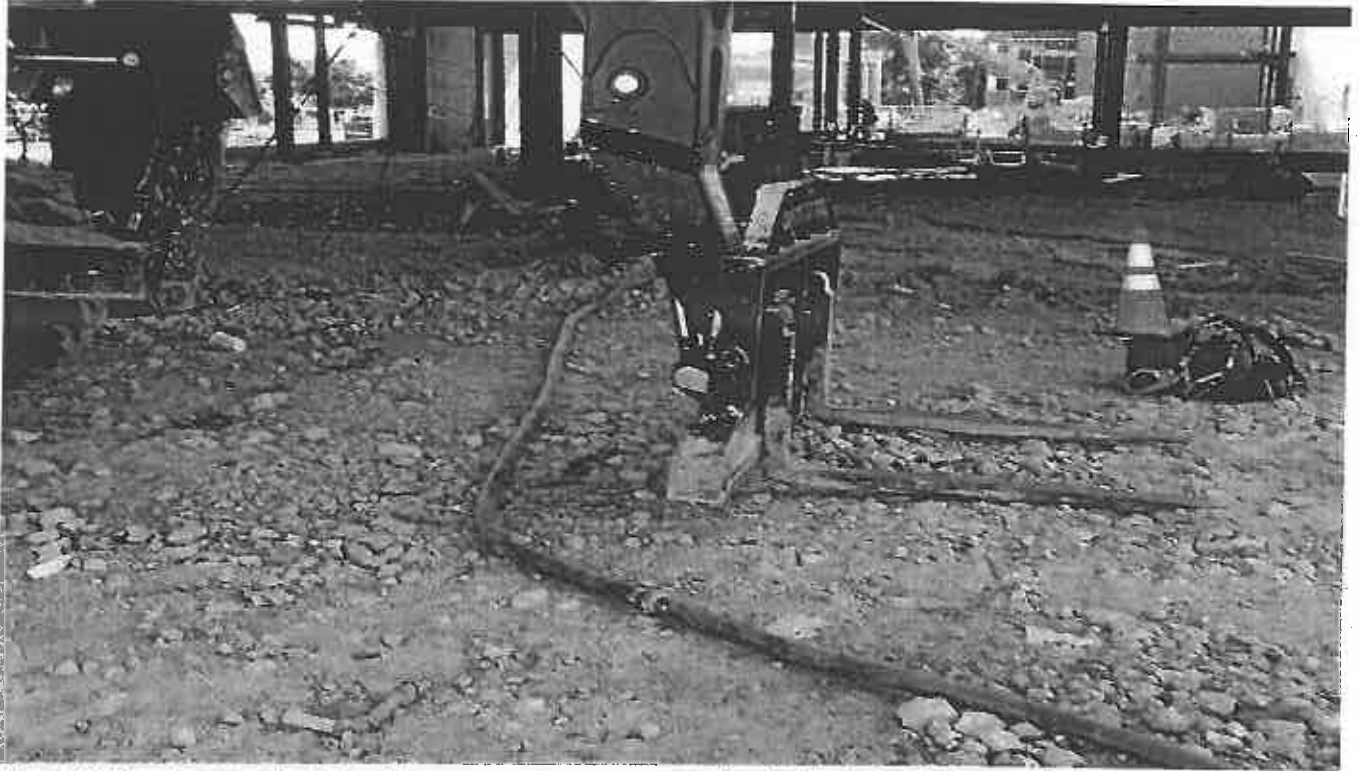
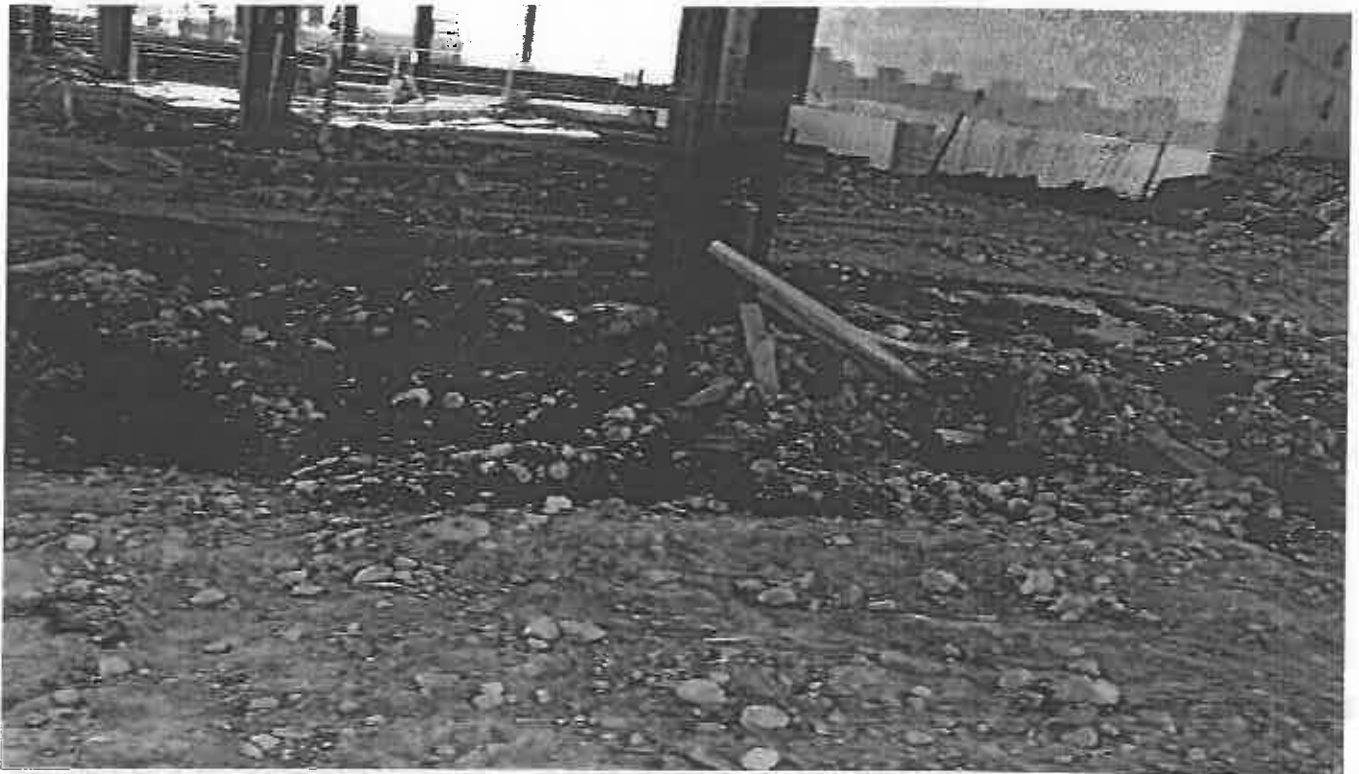
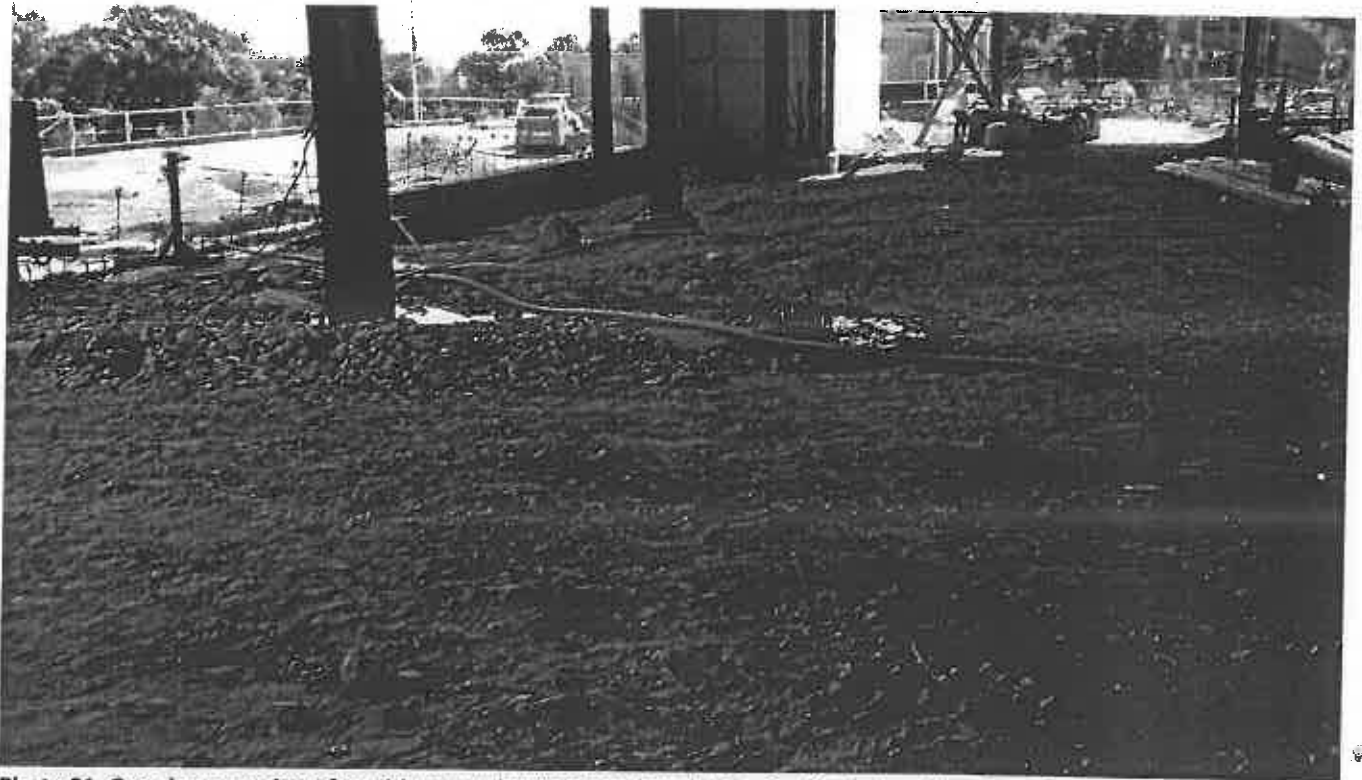
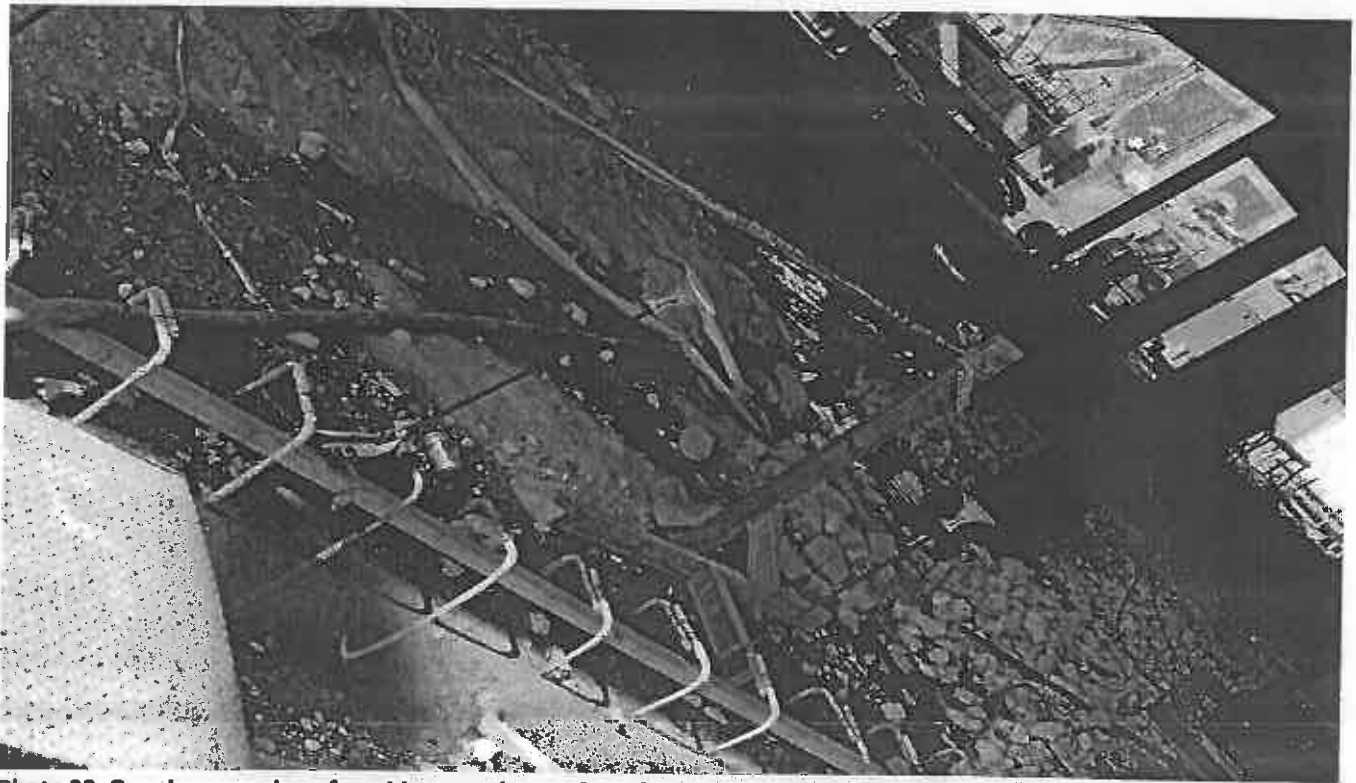
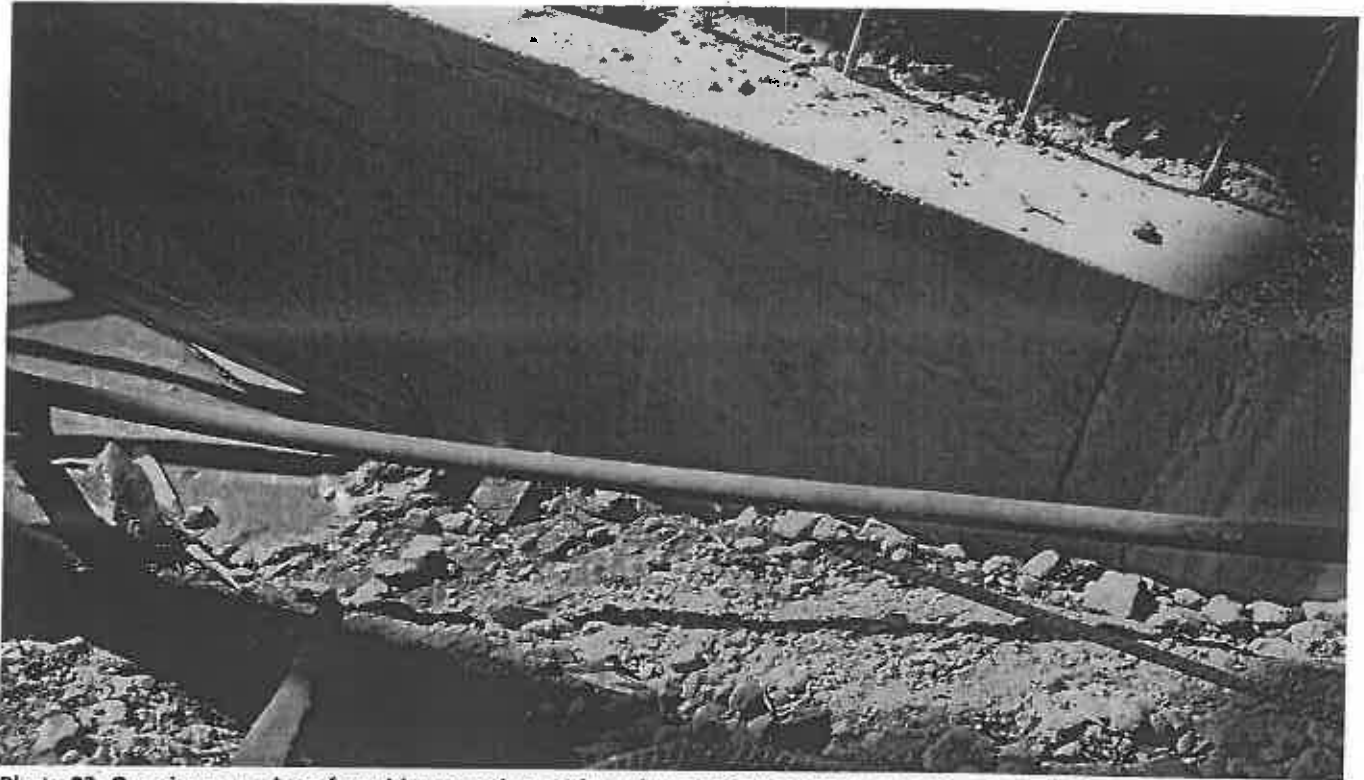
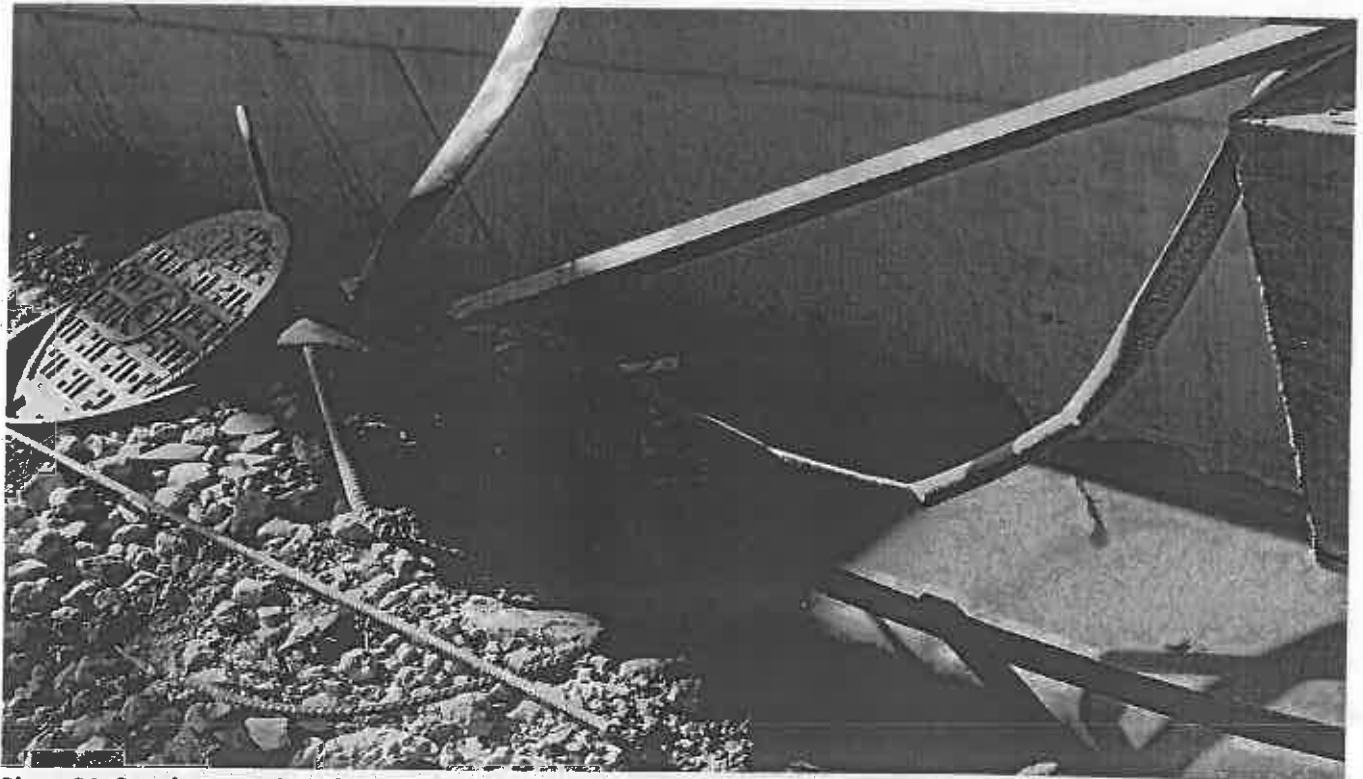
Photo 10. Ongoing pumping of muddy groundwater from foundation footing into active stormdrain onsite.

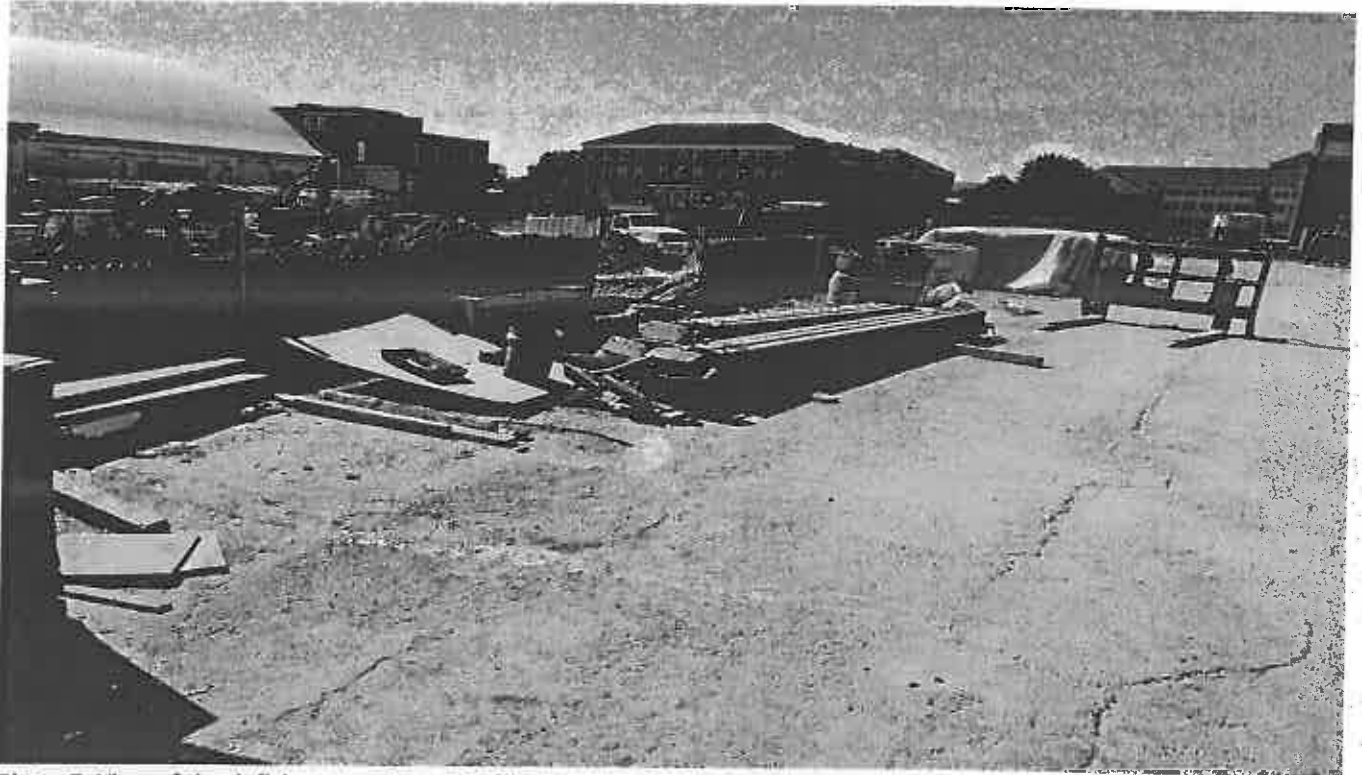
Photo 7. View of the deficient erosion and sediment control South of the site

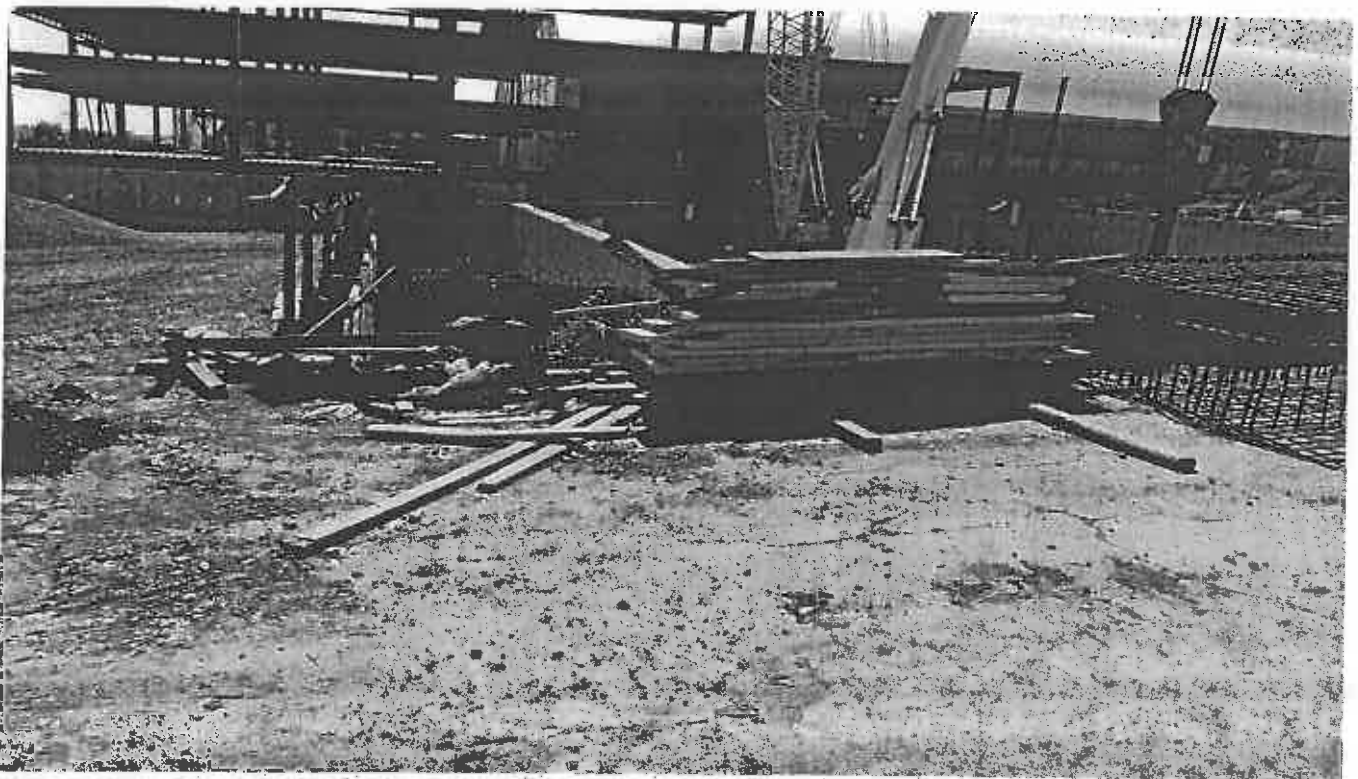
Photo 8. View of the deficient erosion and sediment control South of the site

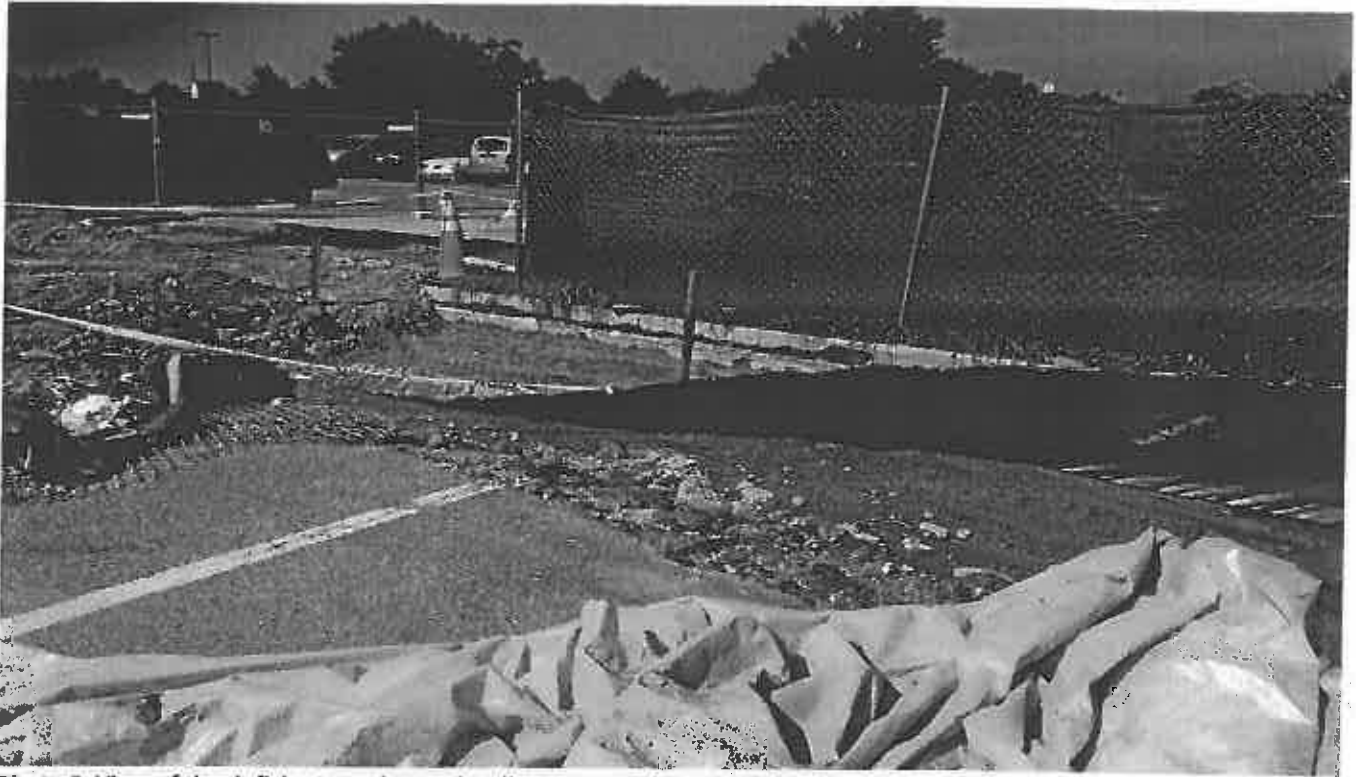
Photo 9. View of the deficient erosion and sediment control South of the site

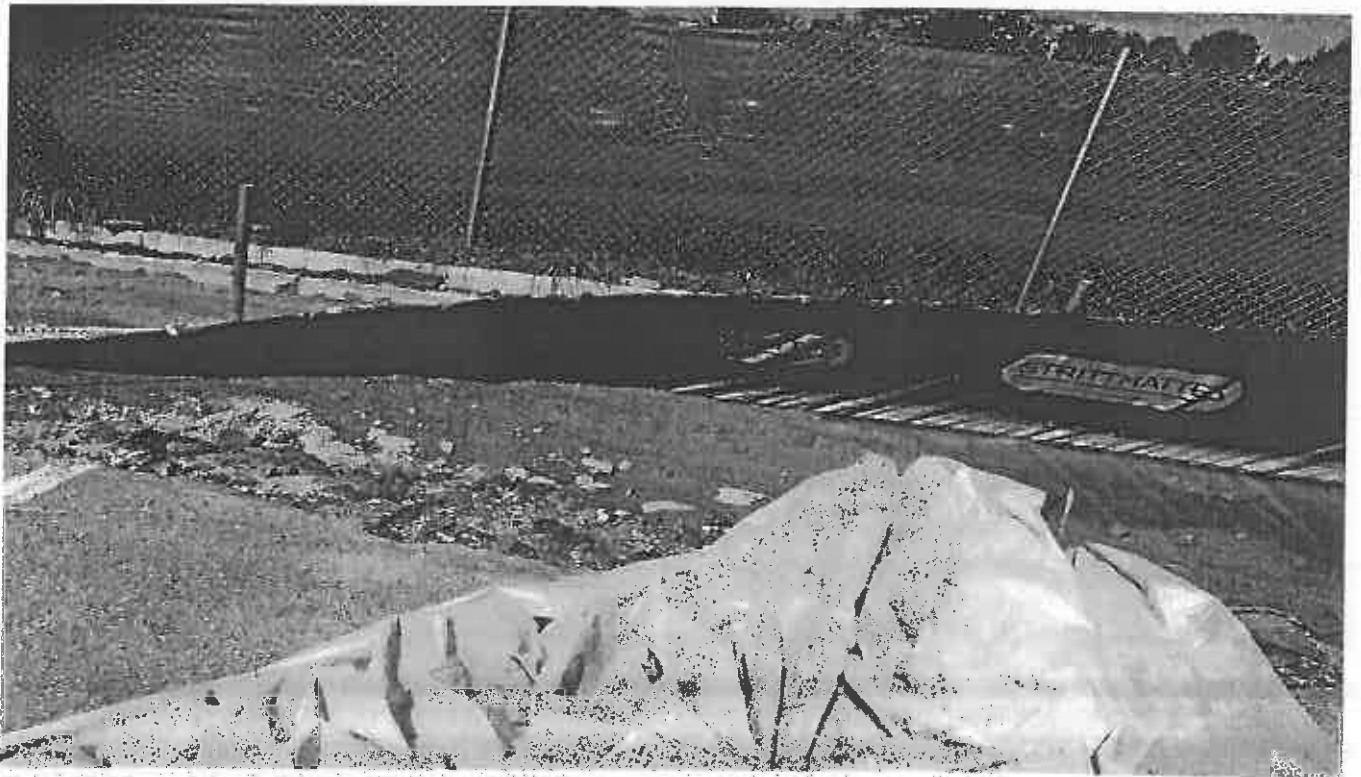
Photo 10. View of the deficient erosion and sediment control South of the site
