Maryland Department of Environment
Water and Science Administration
Compliance Program - Western Division
91 Eastern Blvd, Hagerstown, MD 21740
301-665-2850

Site Name: New Cole Fieldhouse
Facility Address: 4090 Union Dr, College Park, MD 20742
County: Prince George's County

Inspection Date: November 5, 2018 **Start Date/Time:** November 5, 2018, 09:00 AM
End Date/Time: November 5, 2018, 10:00 AM

Media Type(s): NPDES Construction Activity, State/federal SWM

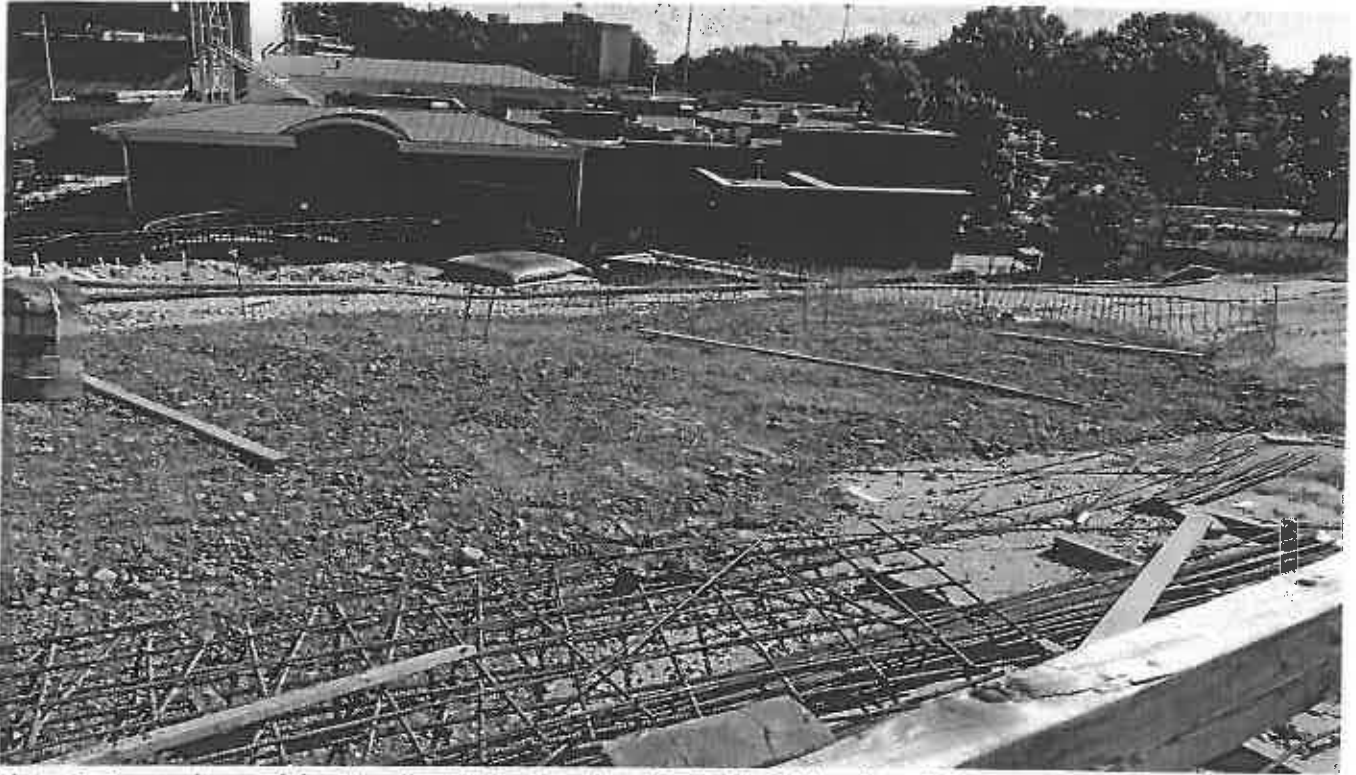
Photo 11. Exposed area of the site adjacent the Tunnel project N side, with a view of the Gosette Building

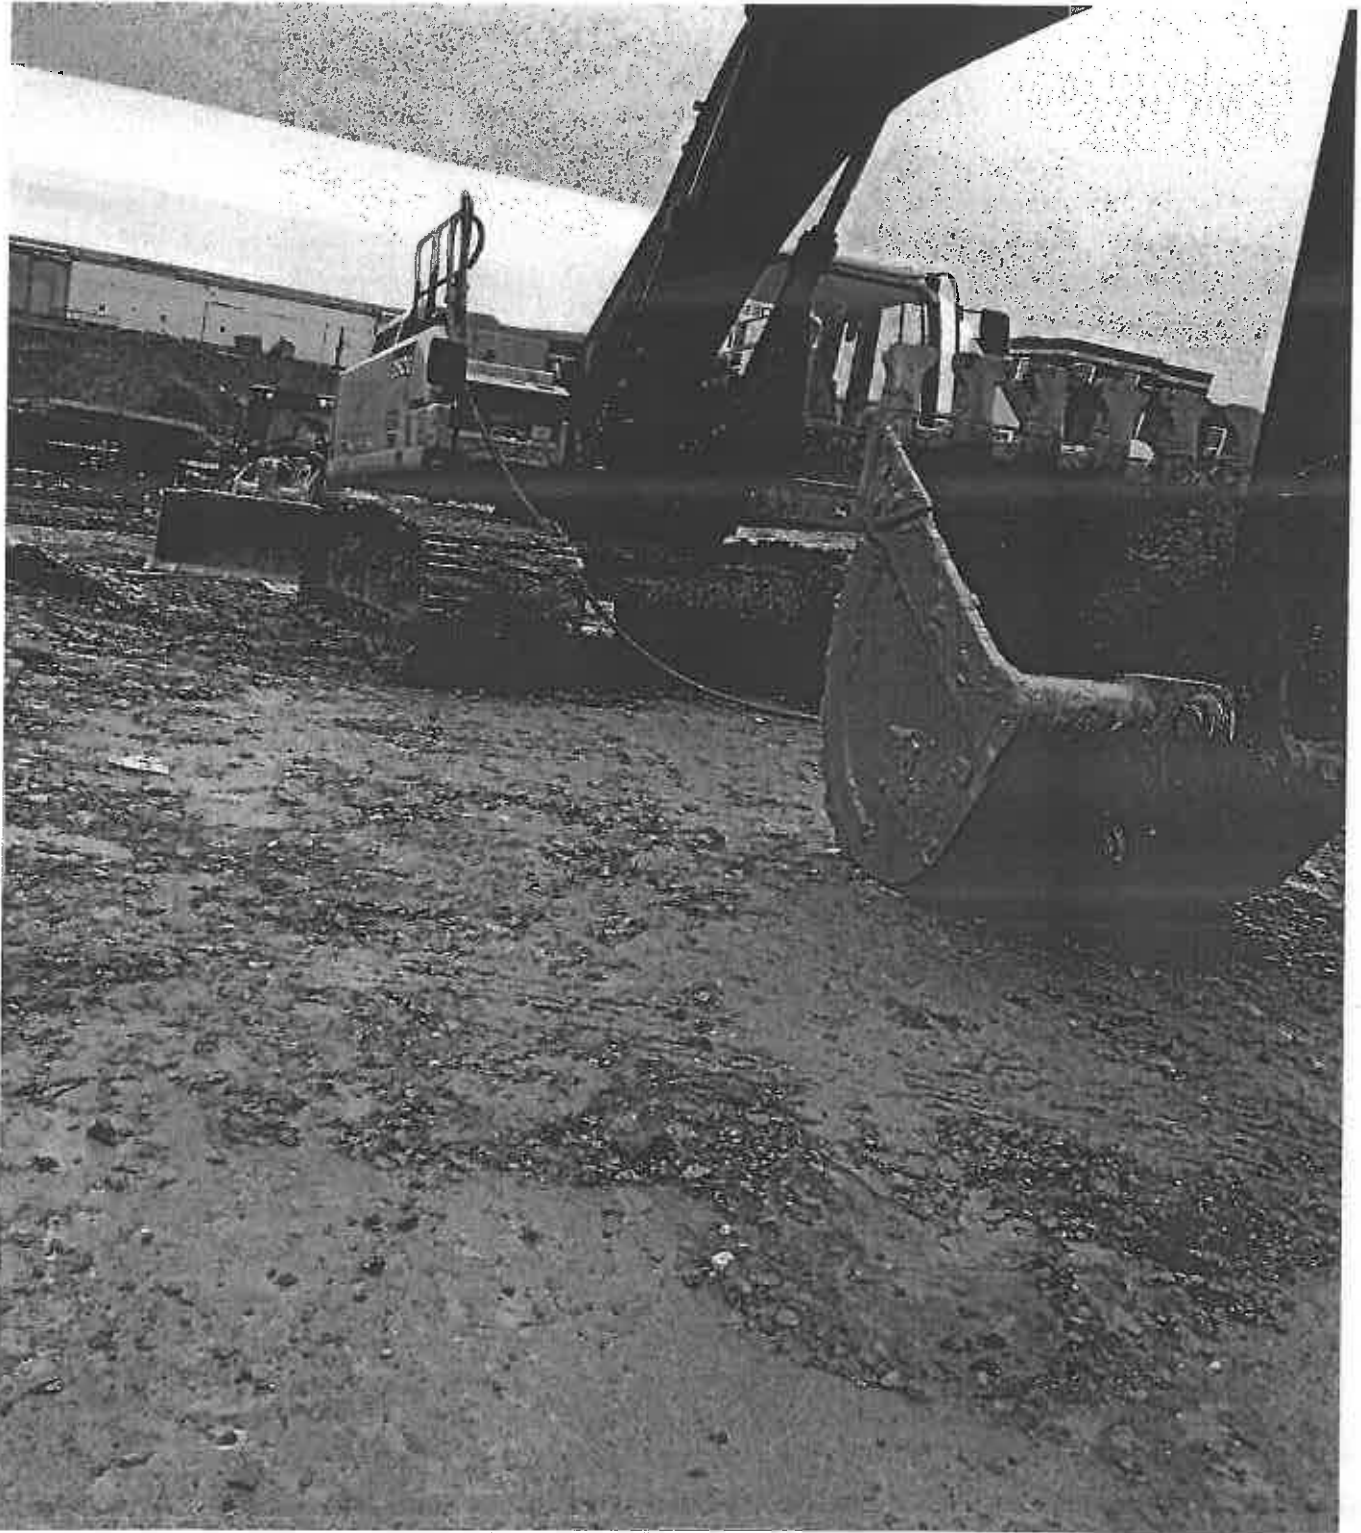
Photo 13. Stabilized Construction Entrance with little or no stones despite ongoing rain event.

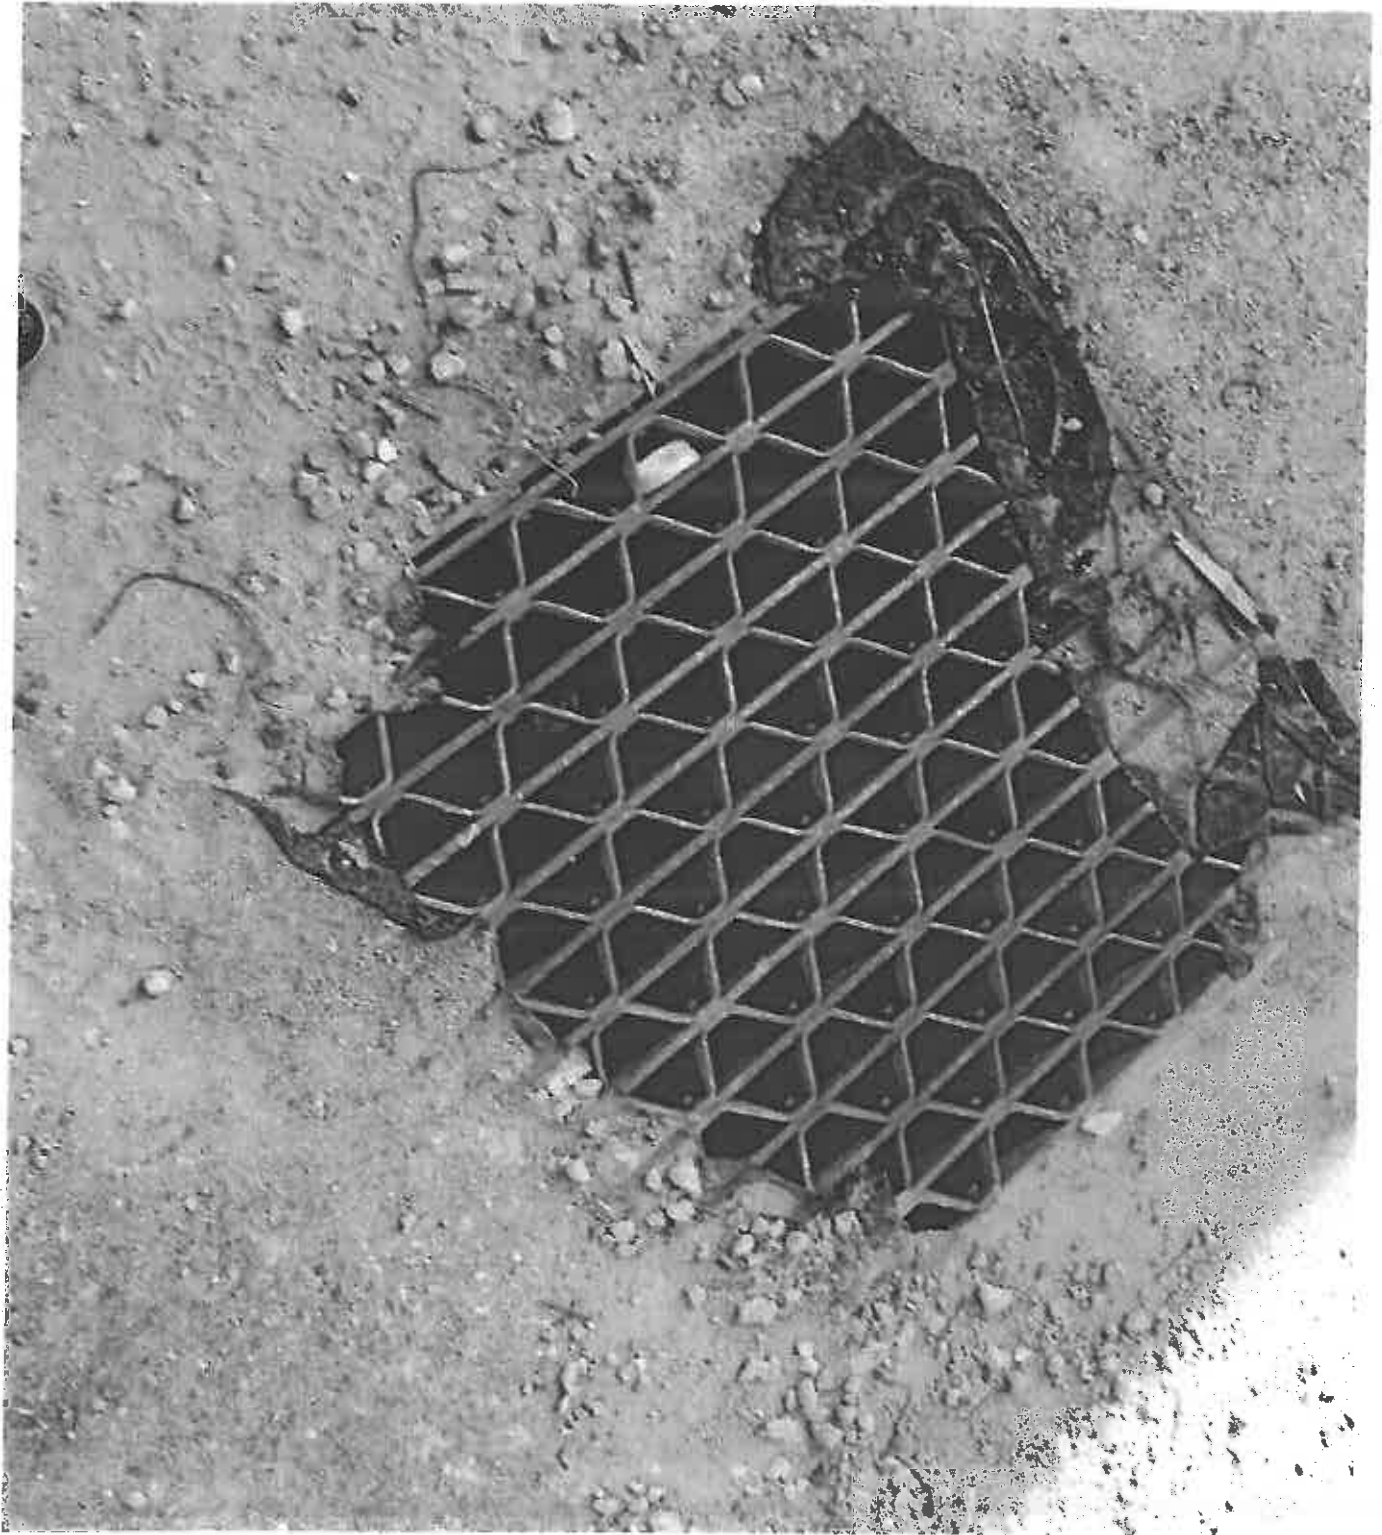
Photo 7. Exposed and unmaintained E and S (Atgrade inlet protection) North of the Site

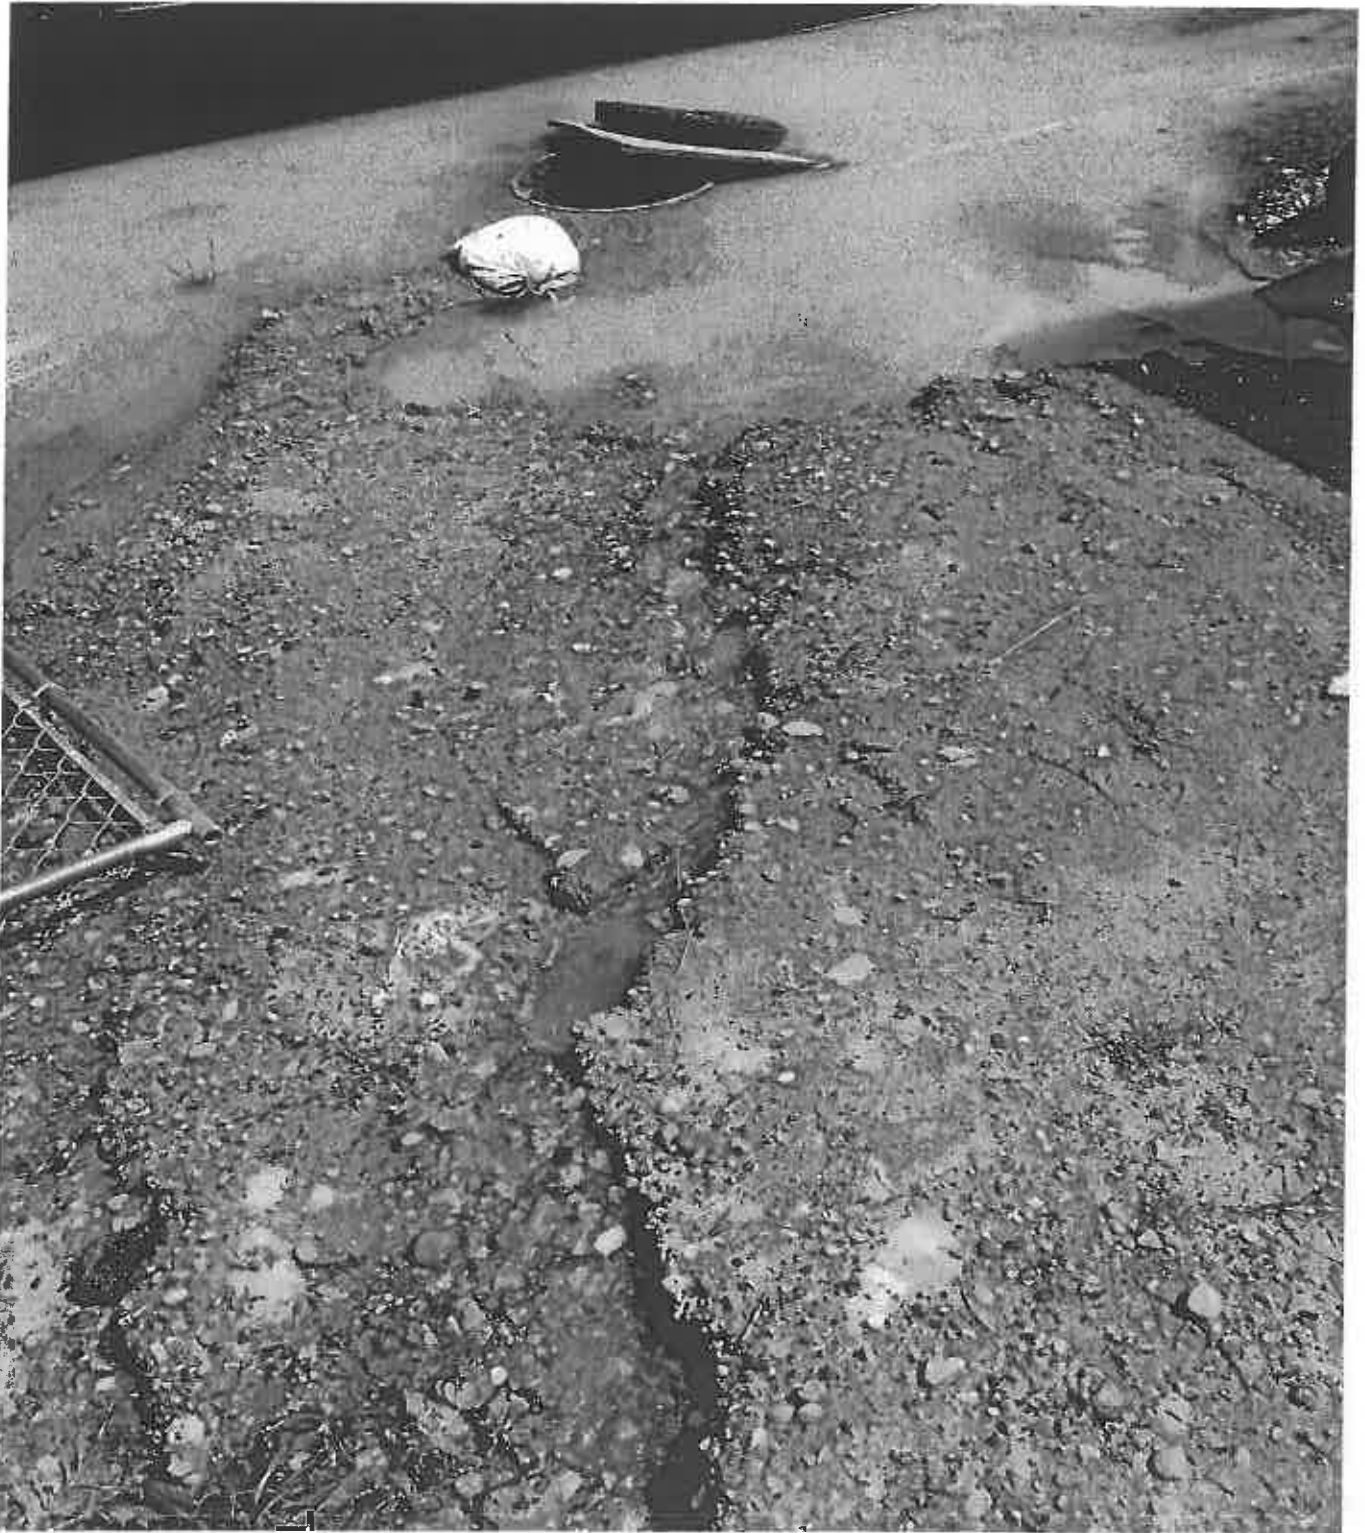
Photo 5. Sediment filter bag placed on exposed soil NW of the site near the sediment tank going into stormdrain

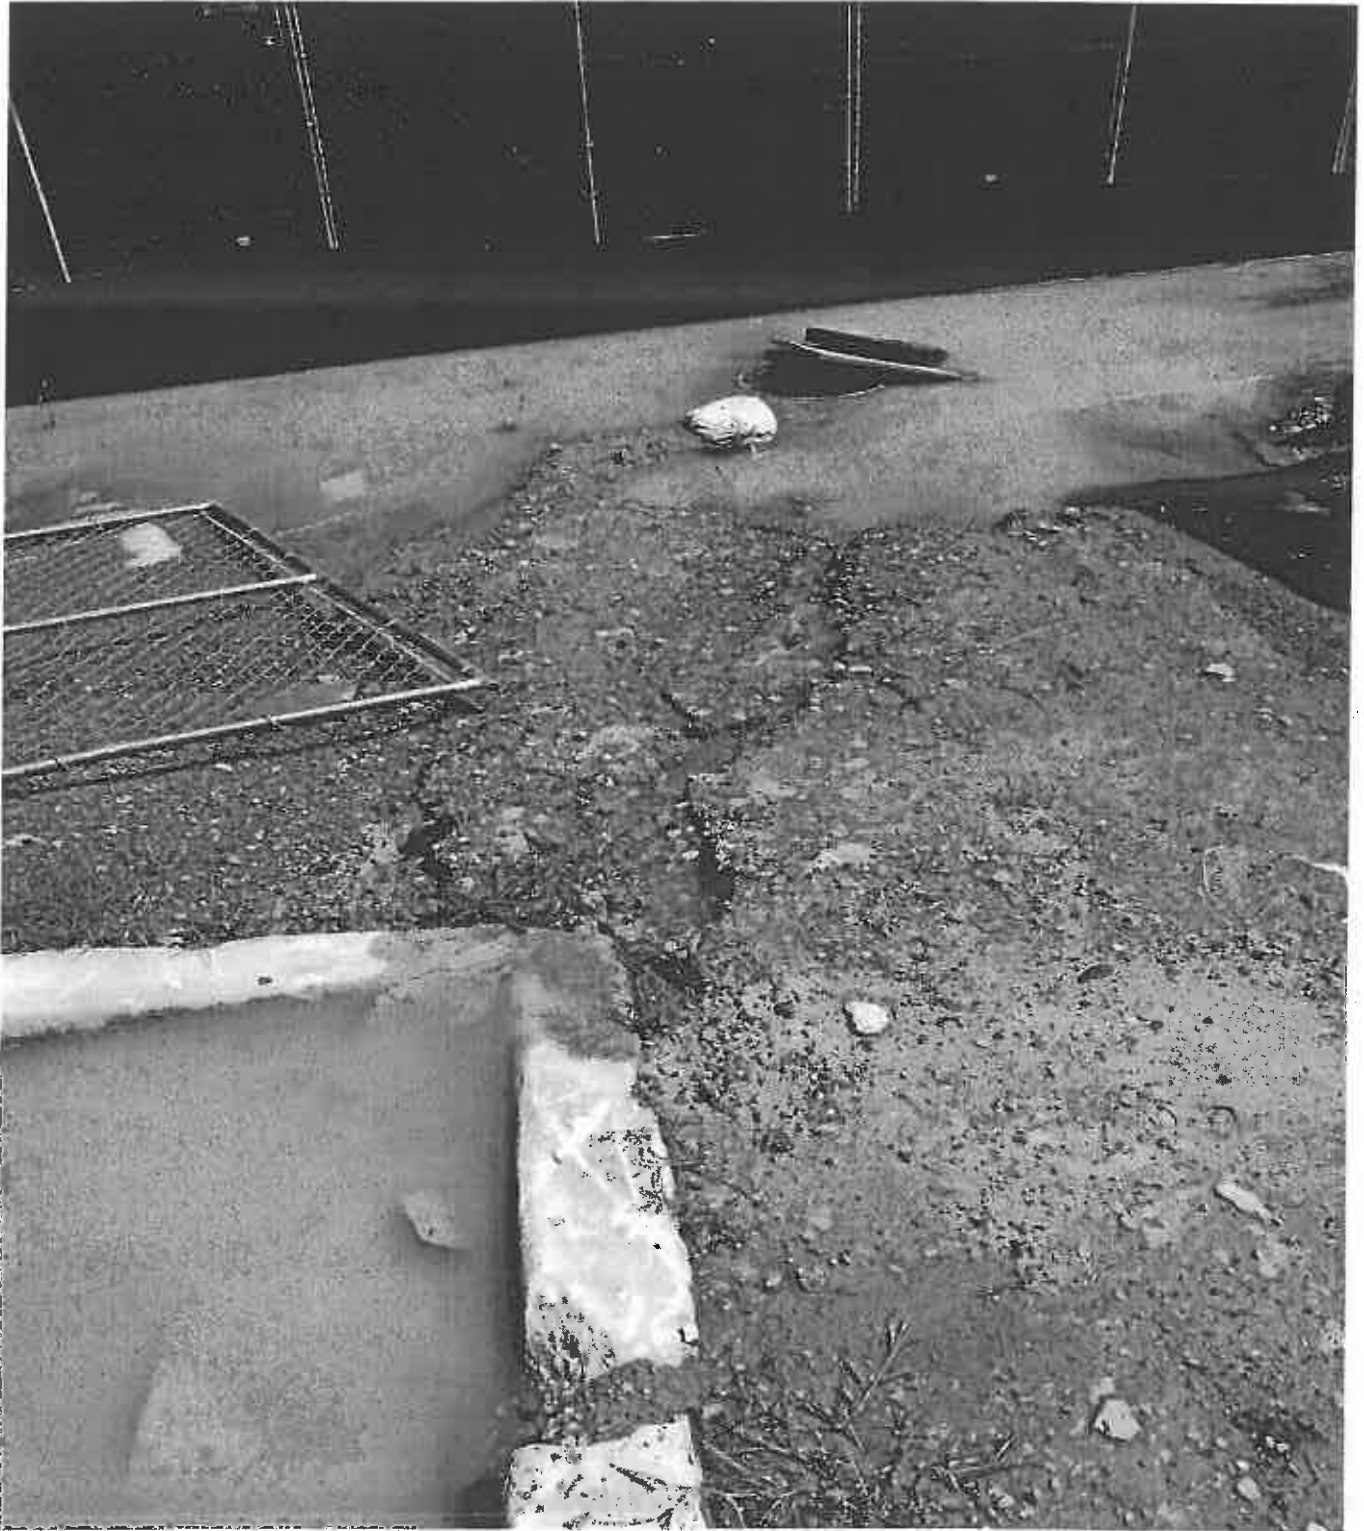
Photo 6. Sediment laden runoff from site to stormdrain on Cole Field Drive in photo 1 off the site.

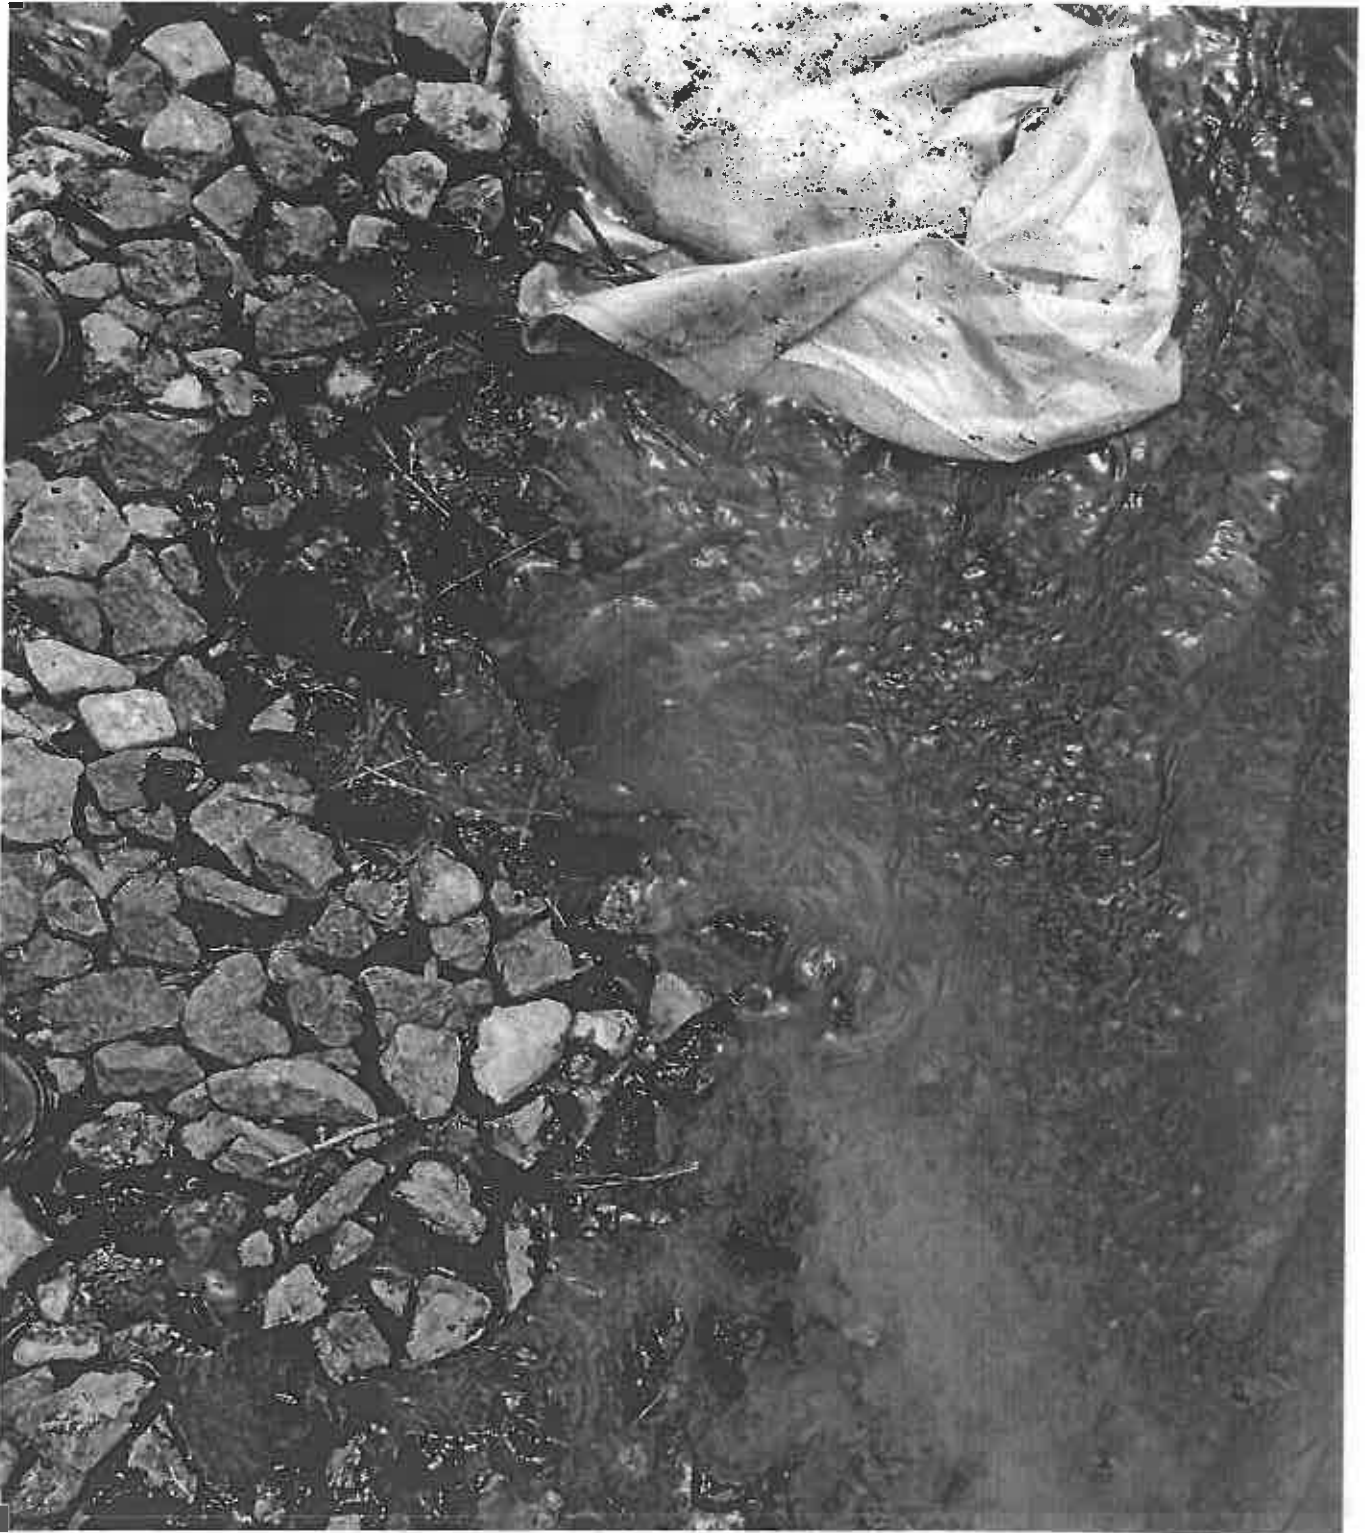
Photo 11. Sediment laden runoff from site to stormdrain on Cole Field Drive in photo 1 off the site.

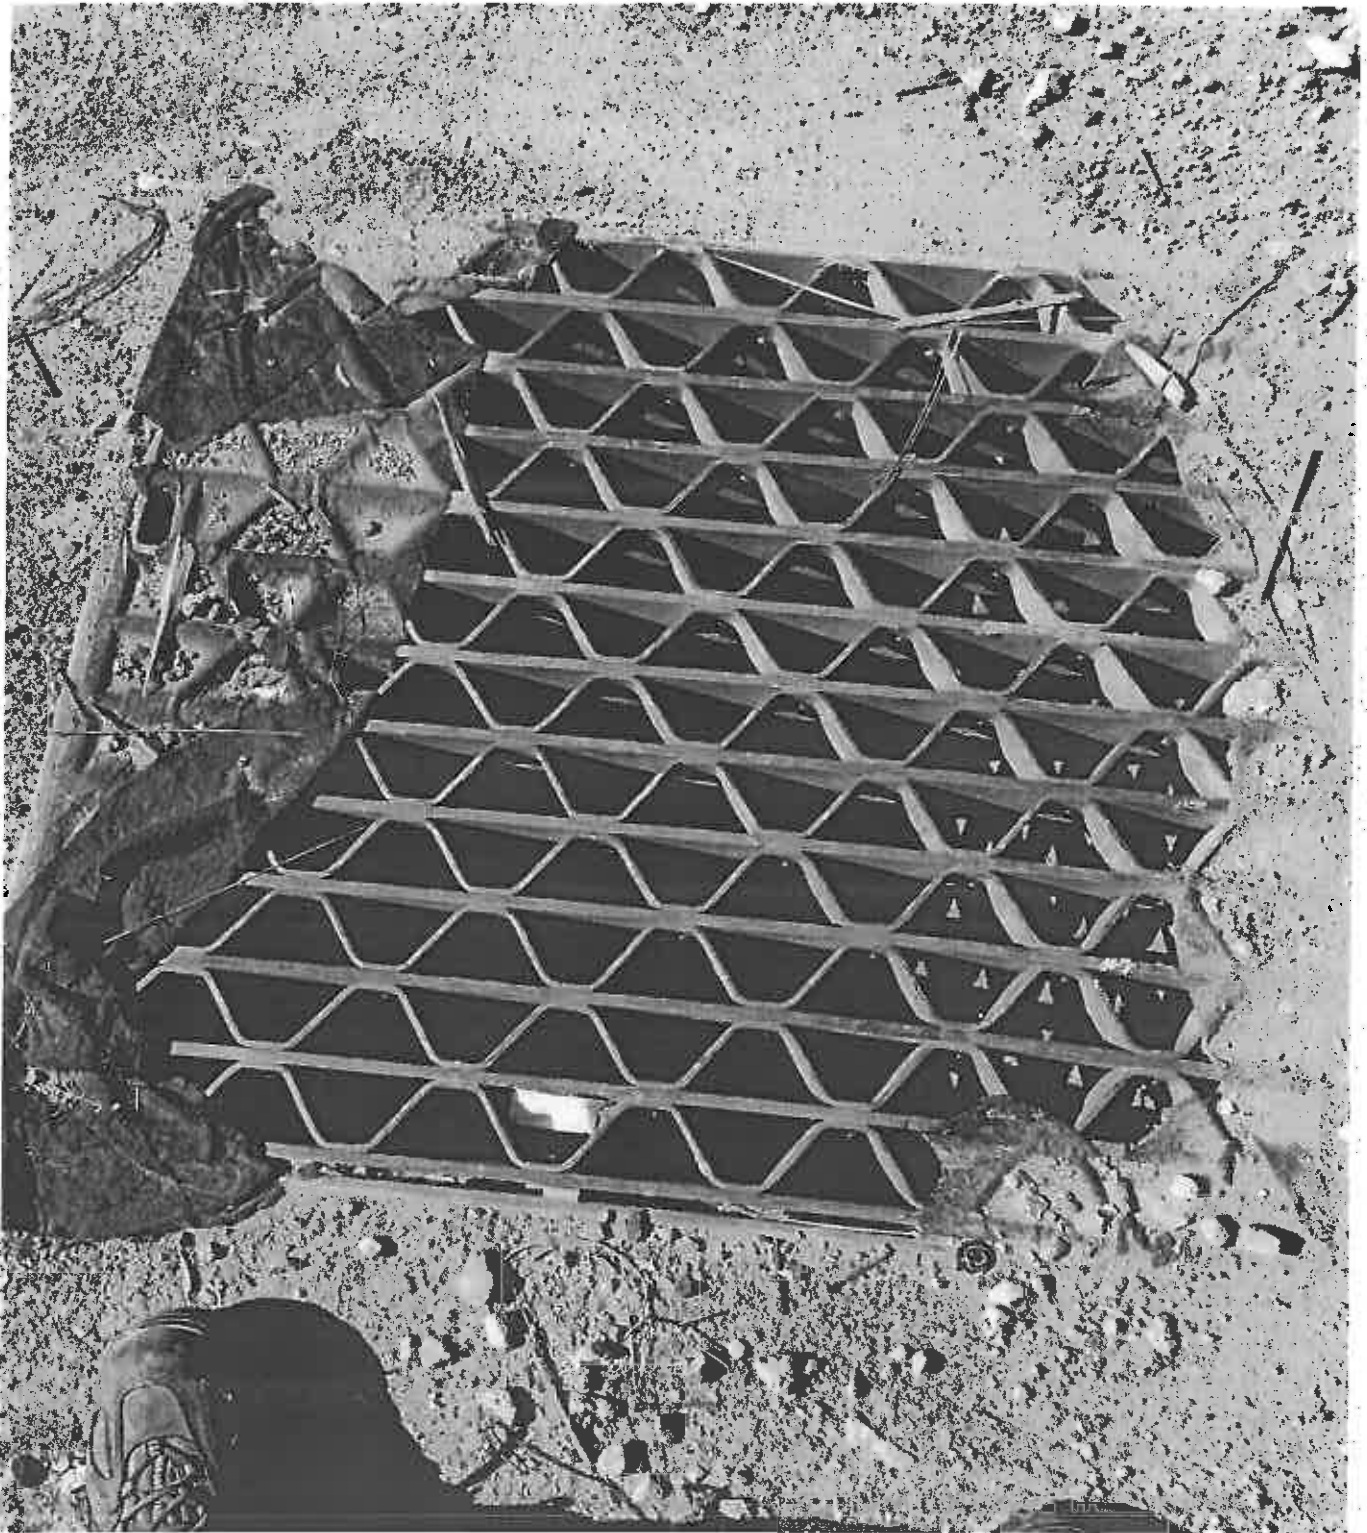
Photo 9. Exposed and unmaintained E and S (Atgrade inlet protection) North of the Site

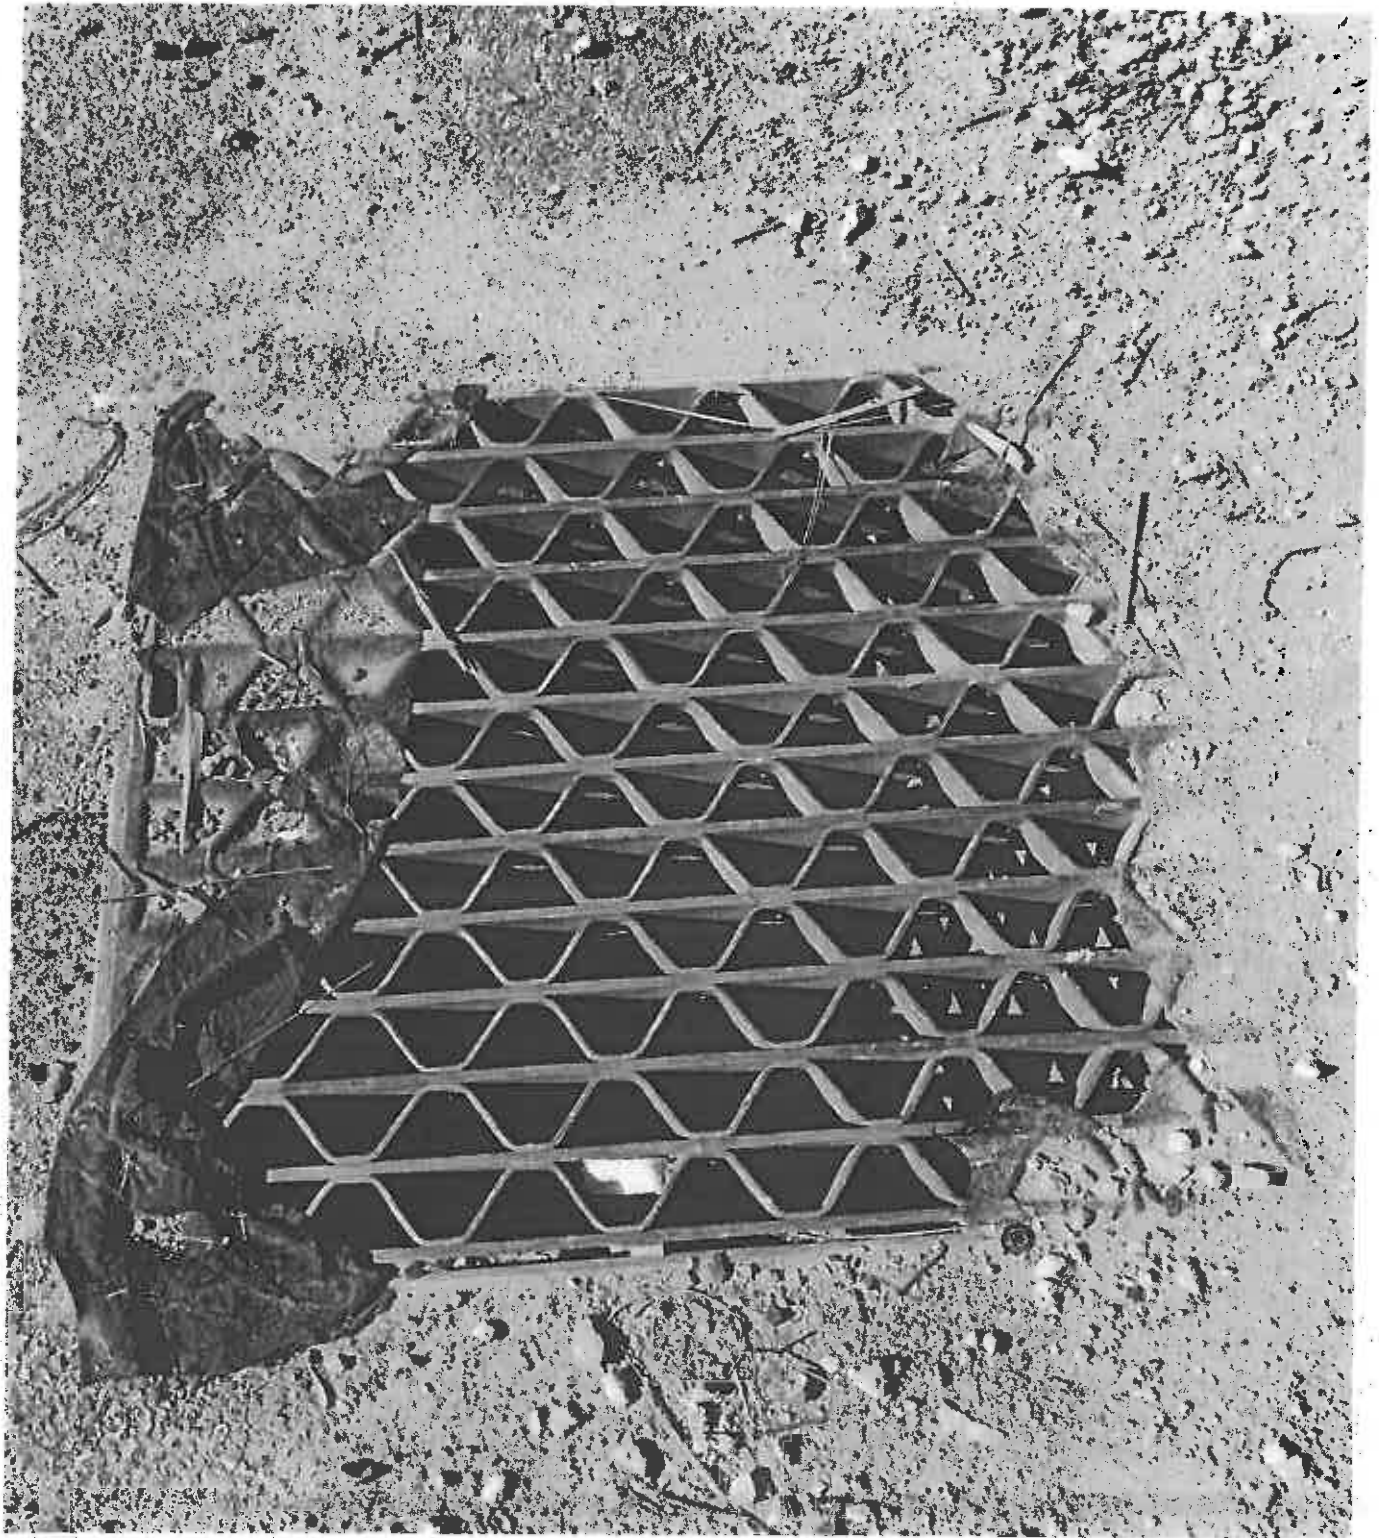
Photo 10. Exposed and unmaintained E and S (Atgrade inlet protection) North of the Site

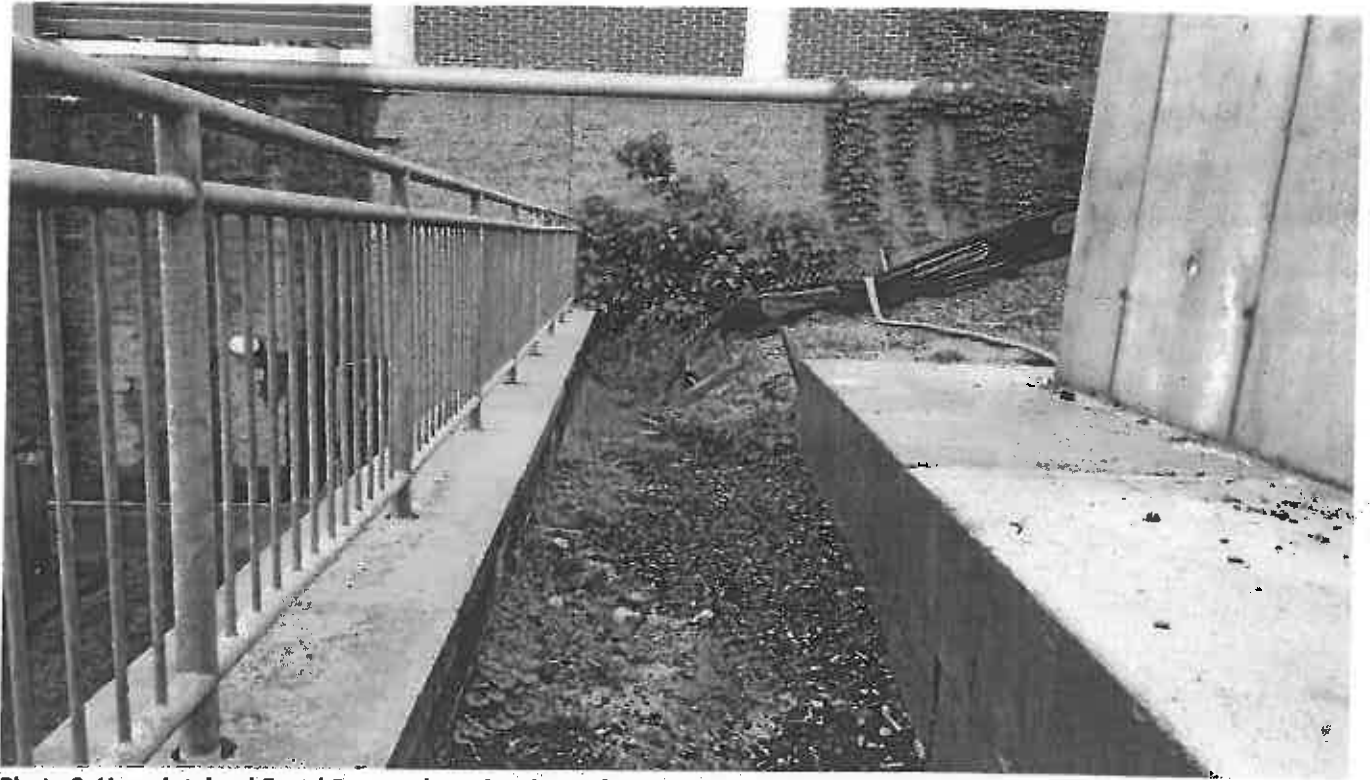
Photo 9. Unmaintained E and S controls at the Slope of the Tunnel Project North of the Site

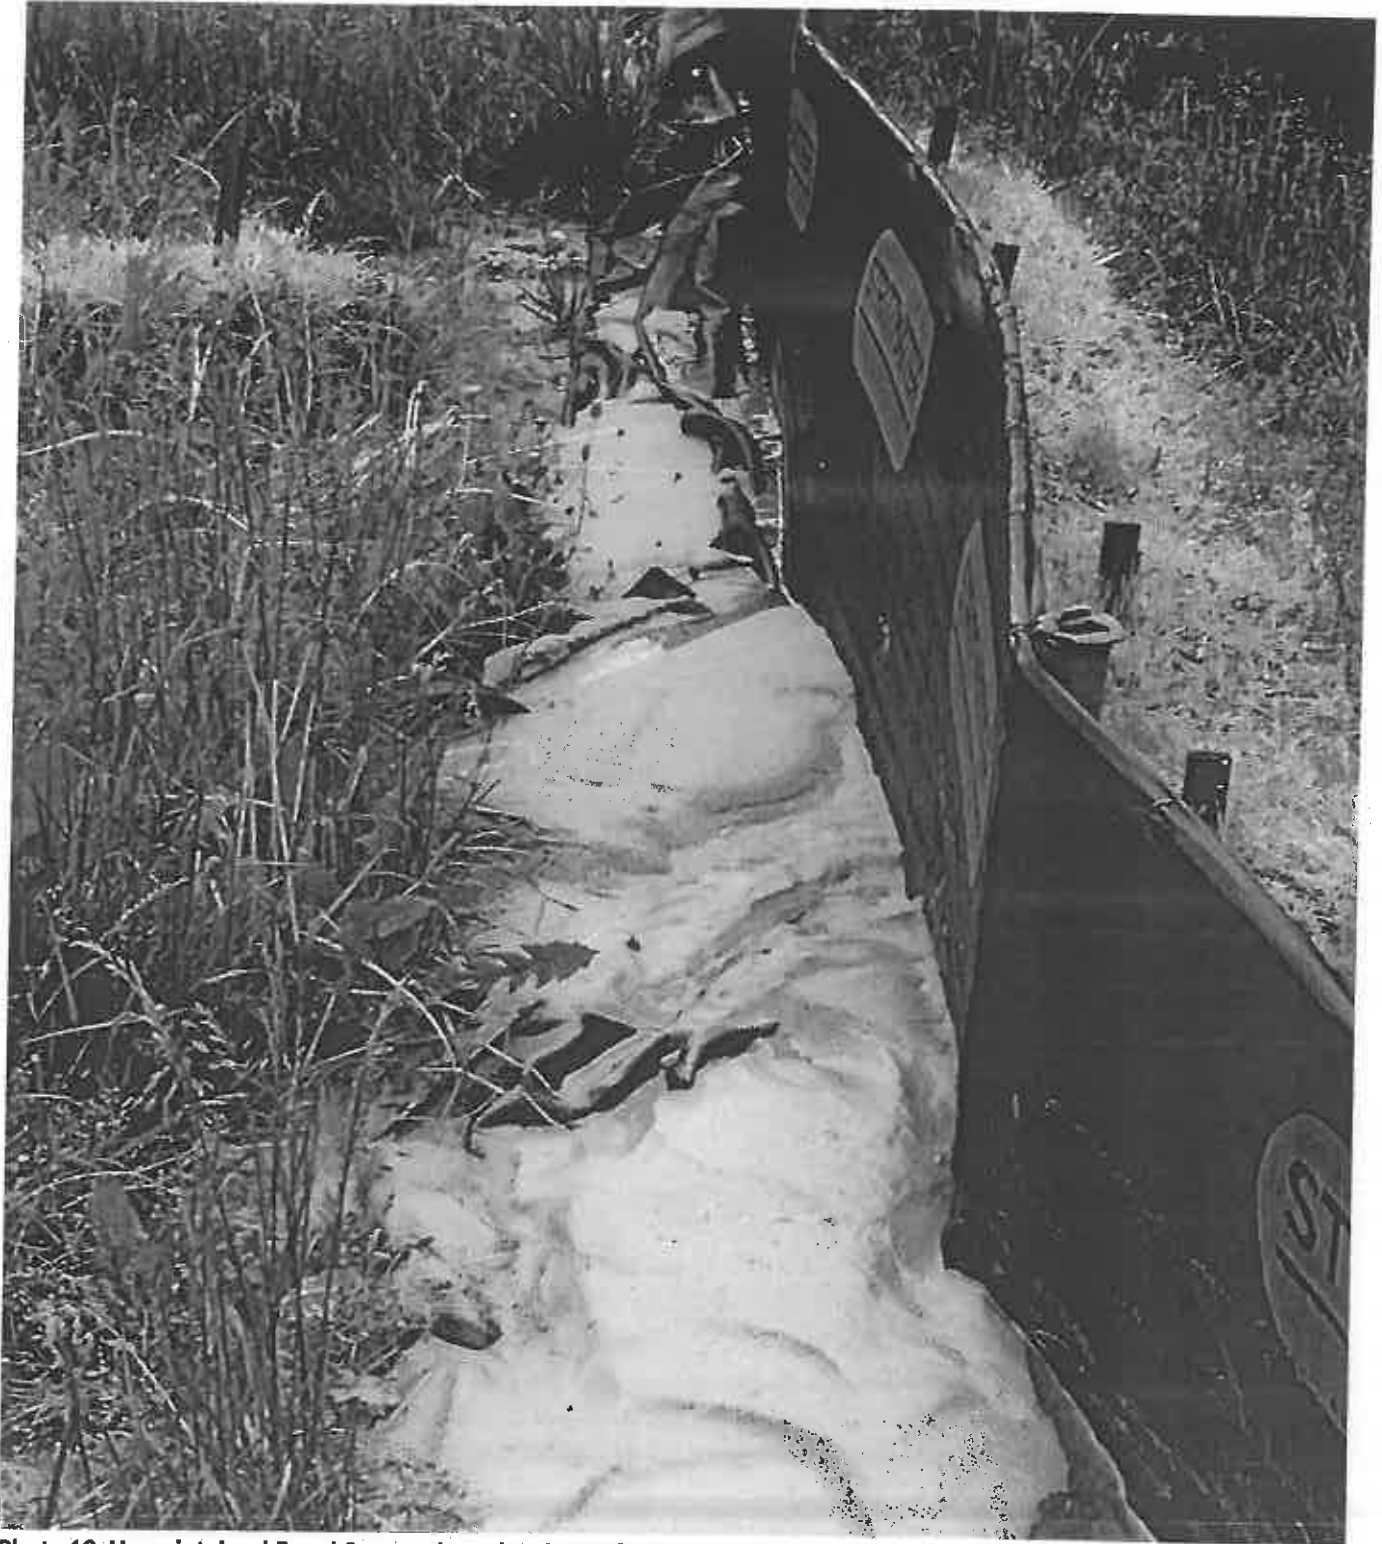
Photo 10. Unmaintained E and S controls at the Slope of the Tunnel Project North of the Site

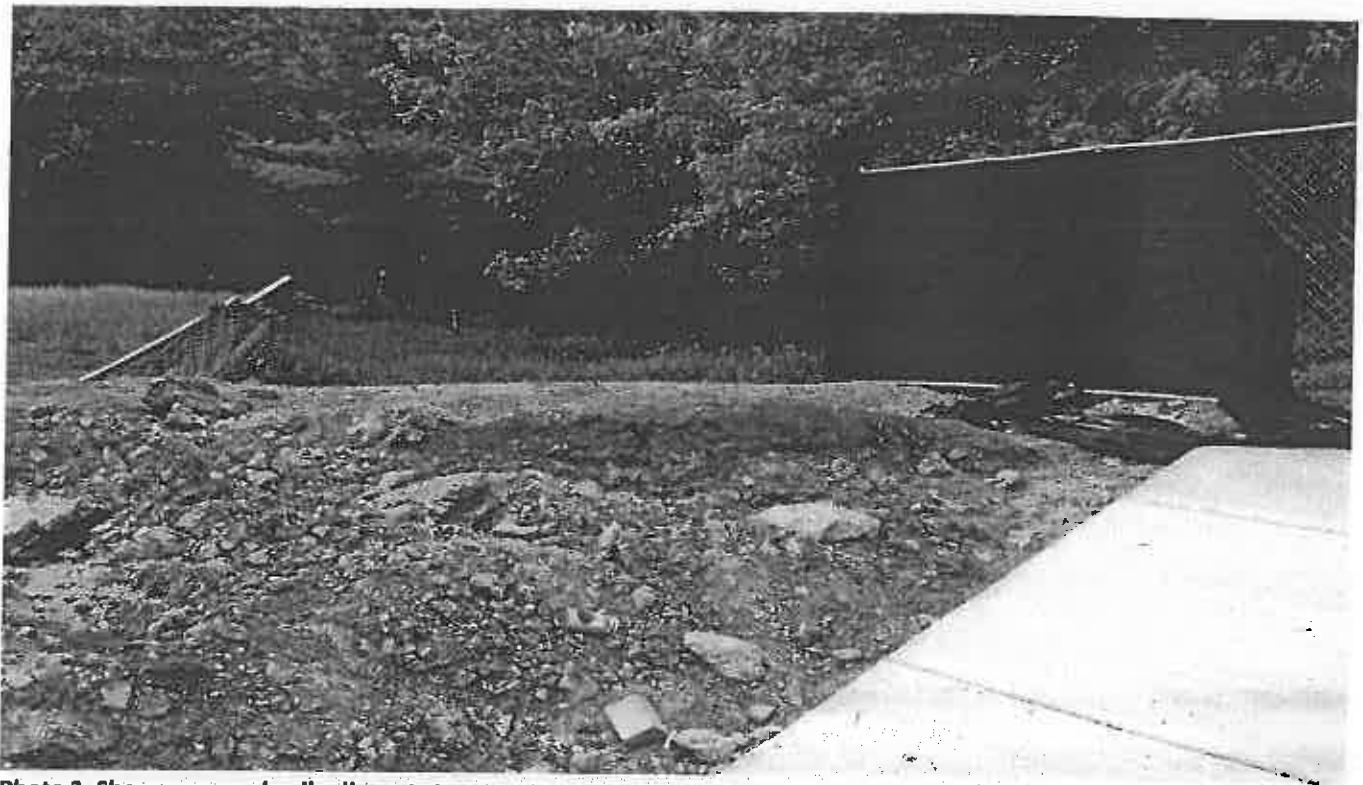
Photo 2. Shows exposed soil adjacent storm water management pond at the new tennis court

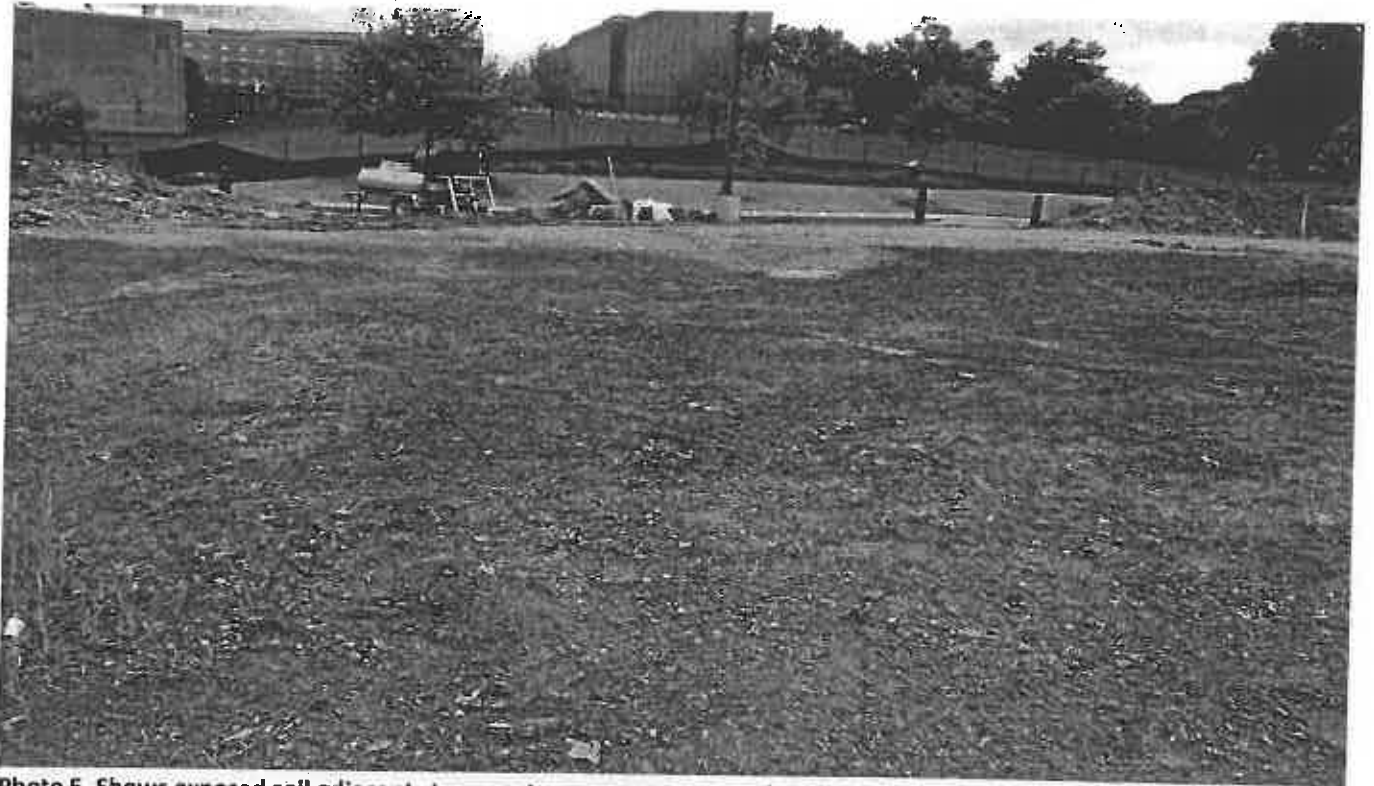
Photo 5. Shows exposed soil adjacent storm water management pond at the new tennis court

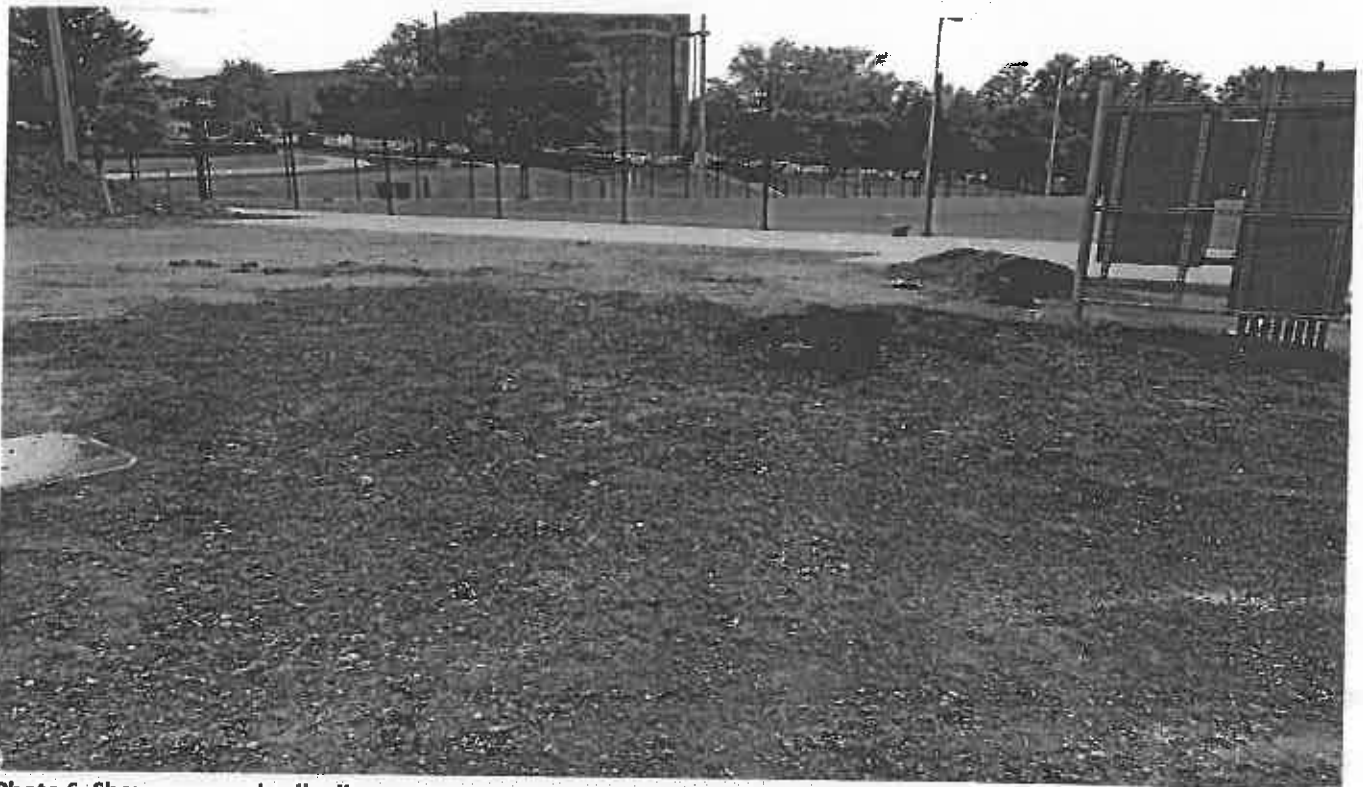
Photo 6. Shows exposed soil adjacent storm water management pond at the new tennis court
