Maryland Department of Environment
Water and Science Administration
Compliance Program - Western Division
91 Eastern Blvd, Hagerstown, MD 21740
301-665-2850

Site Name: New Cole Fieldhouse
Facility Address: 4090 Union Dr, College Park, MD 20742
County: Prince George's County

Inspection Date: November 5, 2018 **Start Date/Time:** November 5, 2018, 09:00 AM
End Date/Time: November 5, 2018, 10:00 AM

Media Type(s): NPDES Construction Activity, State/federal SWM

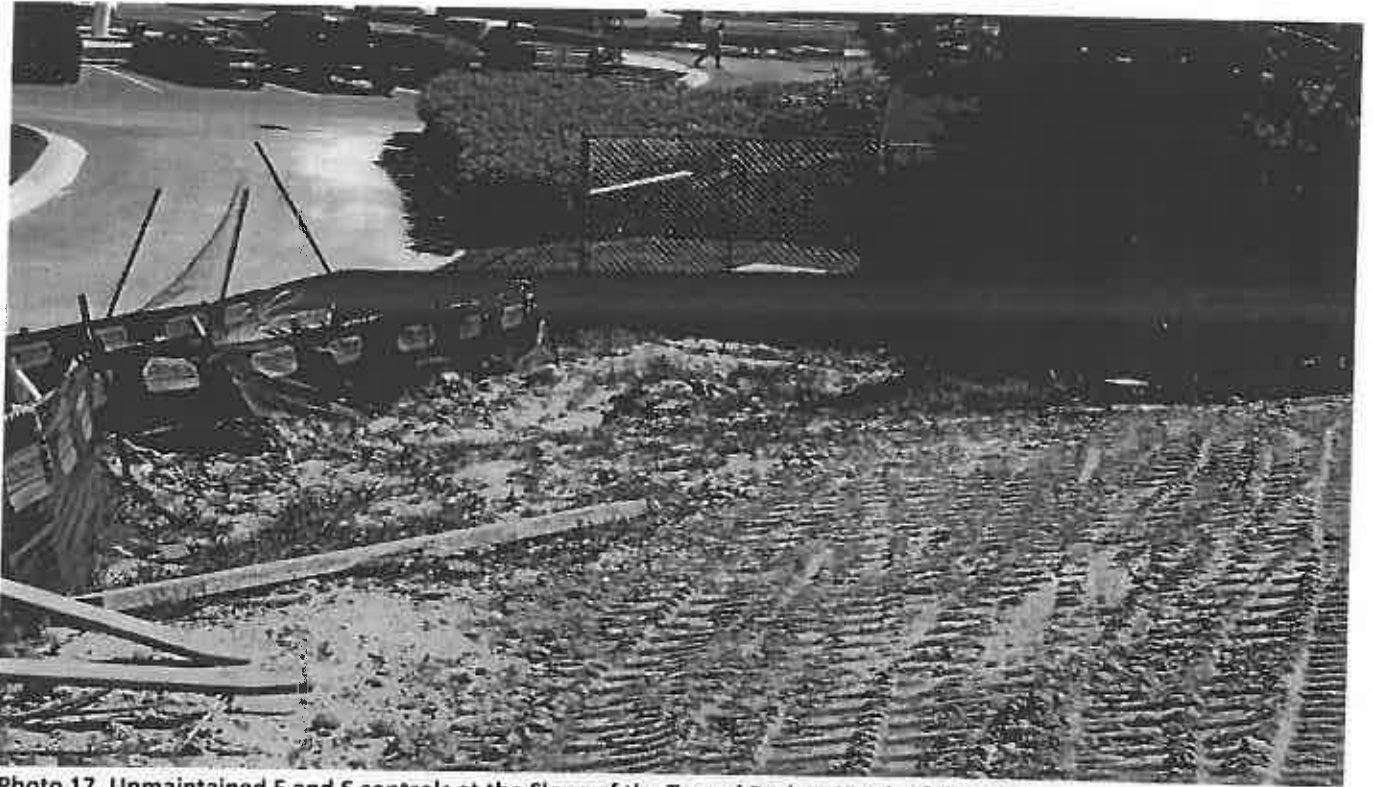
Photo 17. Unmaintained E and S controls at the Slope of the Tunnel Project North of the Site

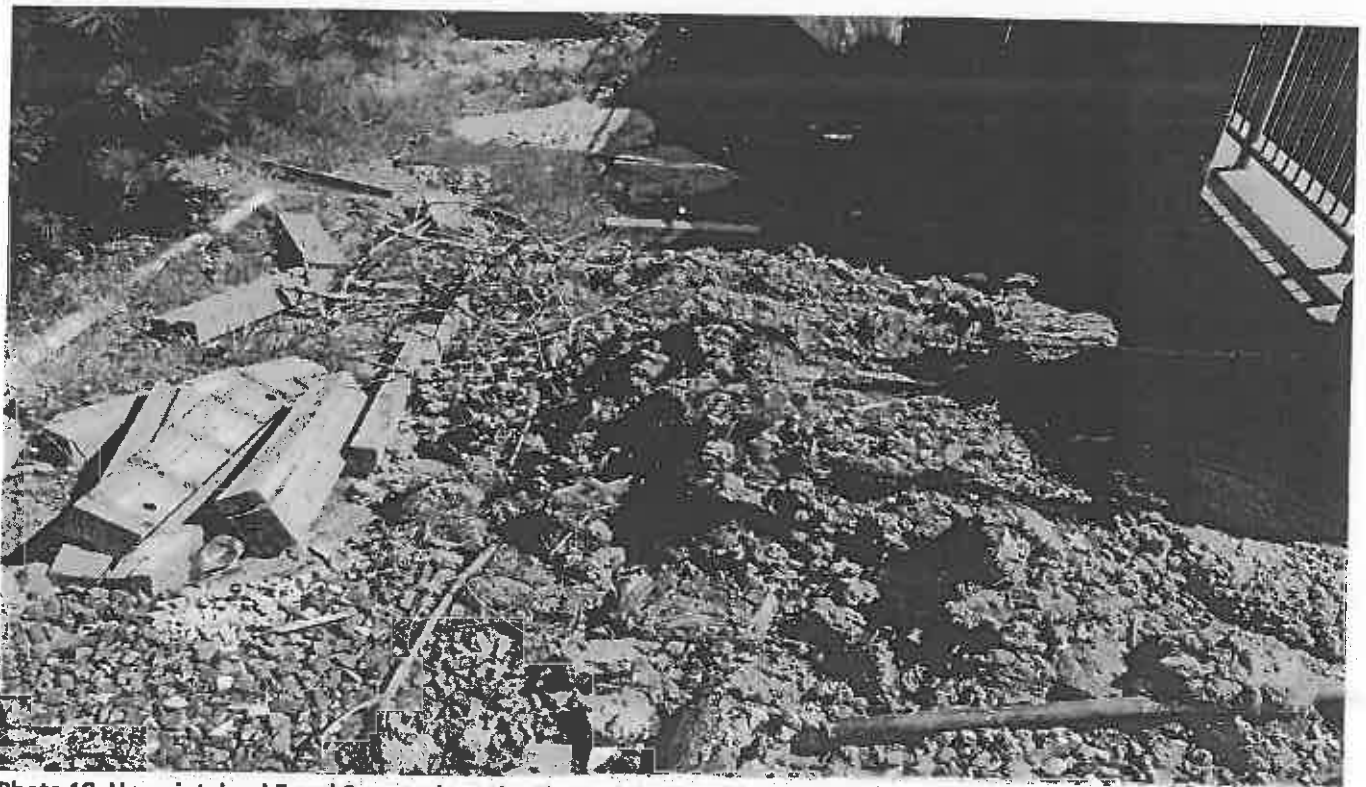
Photo 18. Unmaintained E and S controls at the Slope of the Tunnel Project North of the Site

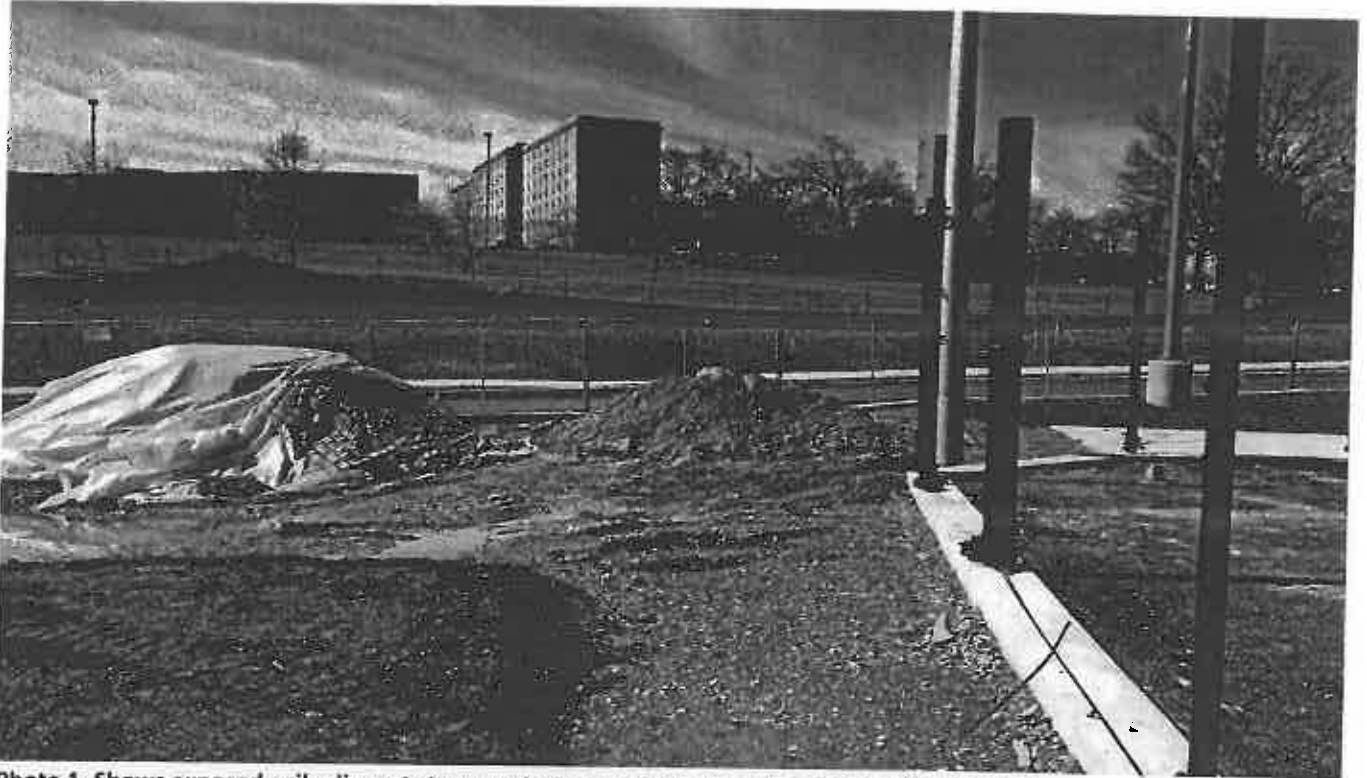
Photo 1. Shows exposed soil adjacent storm water management pond at the new tennis court

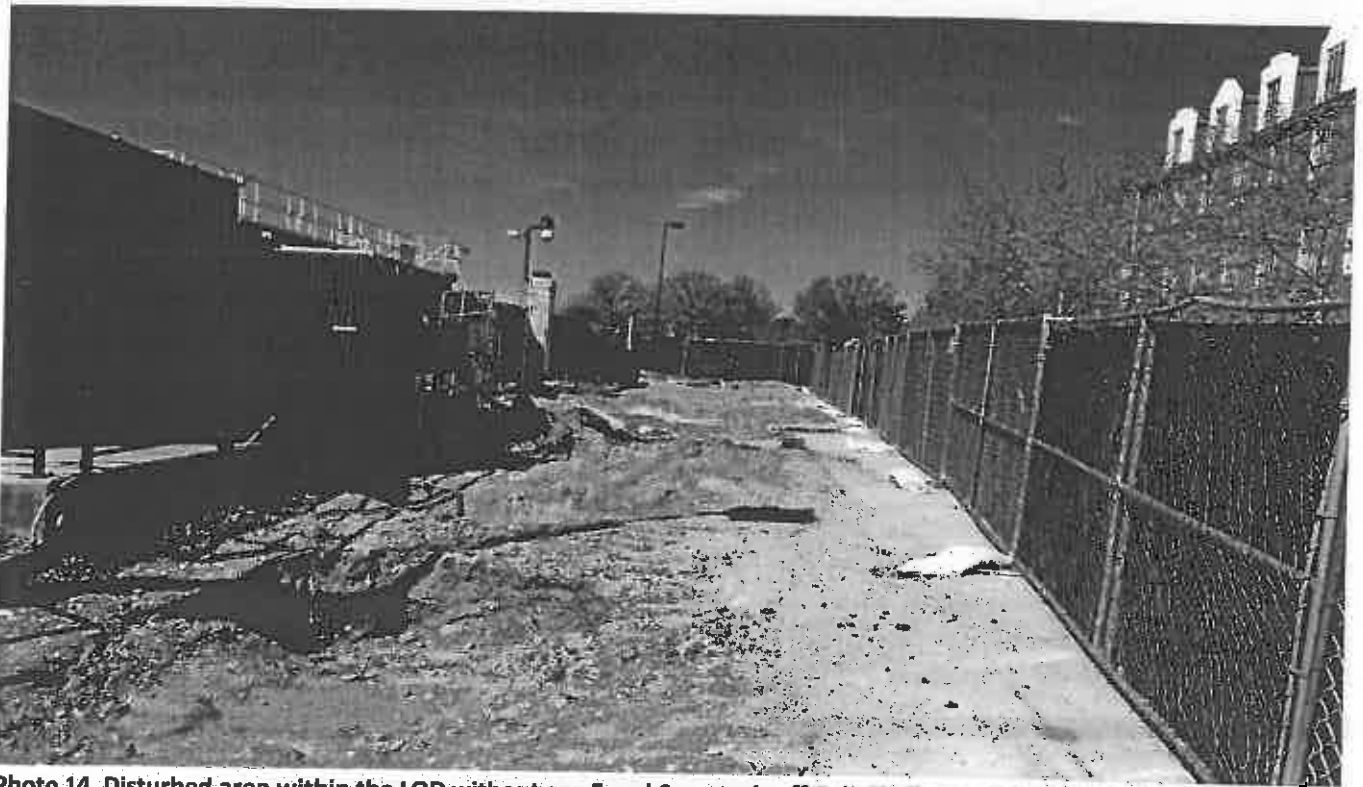
Photo 14. Disturbed area within the LOD without any E and S controls off Cole Fieldhouse Drive NW of the site

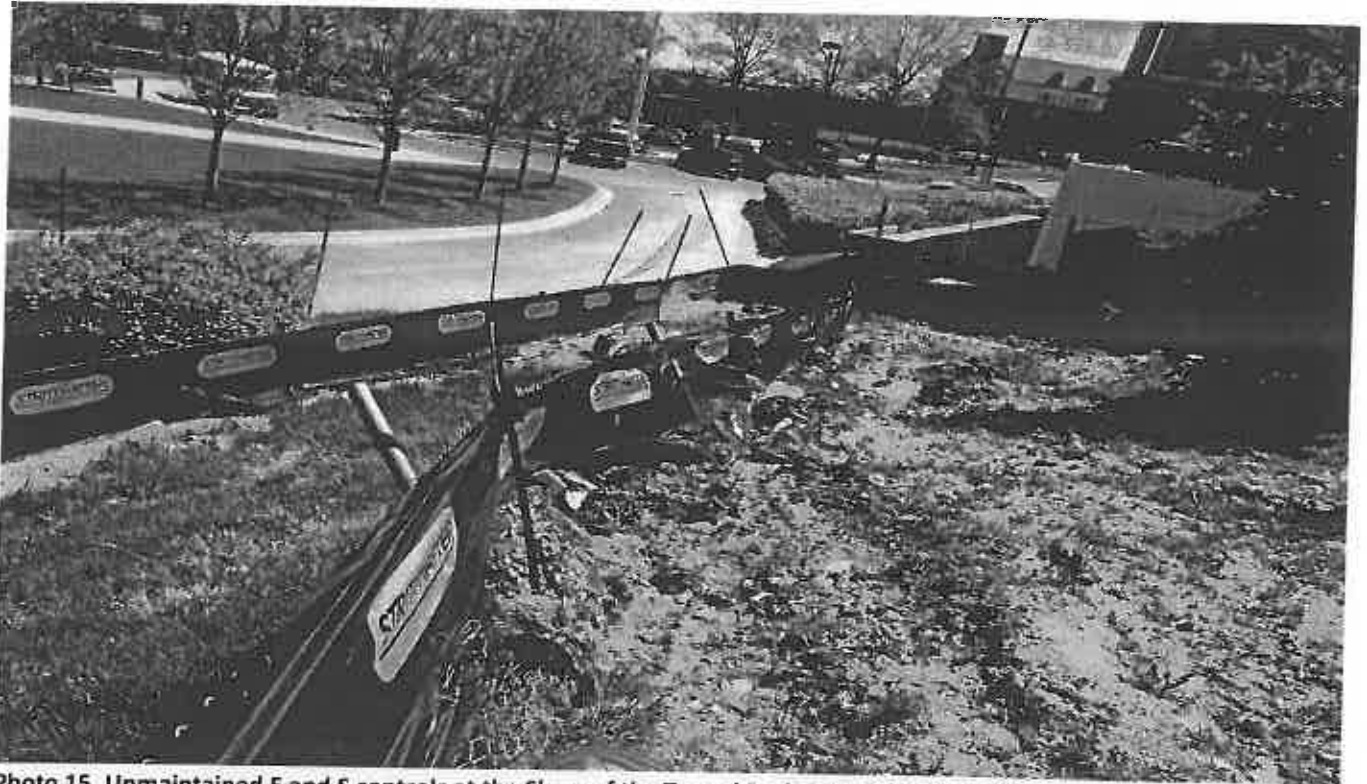
Photo 15. Unmaintained E and S controls at the Slope of the Tunnel Project North of the Site

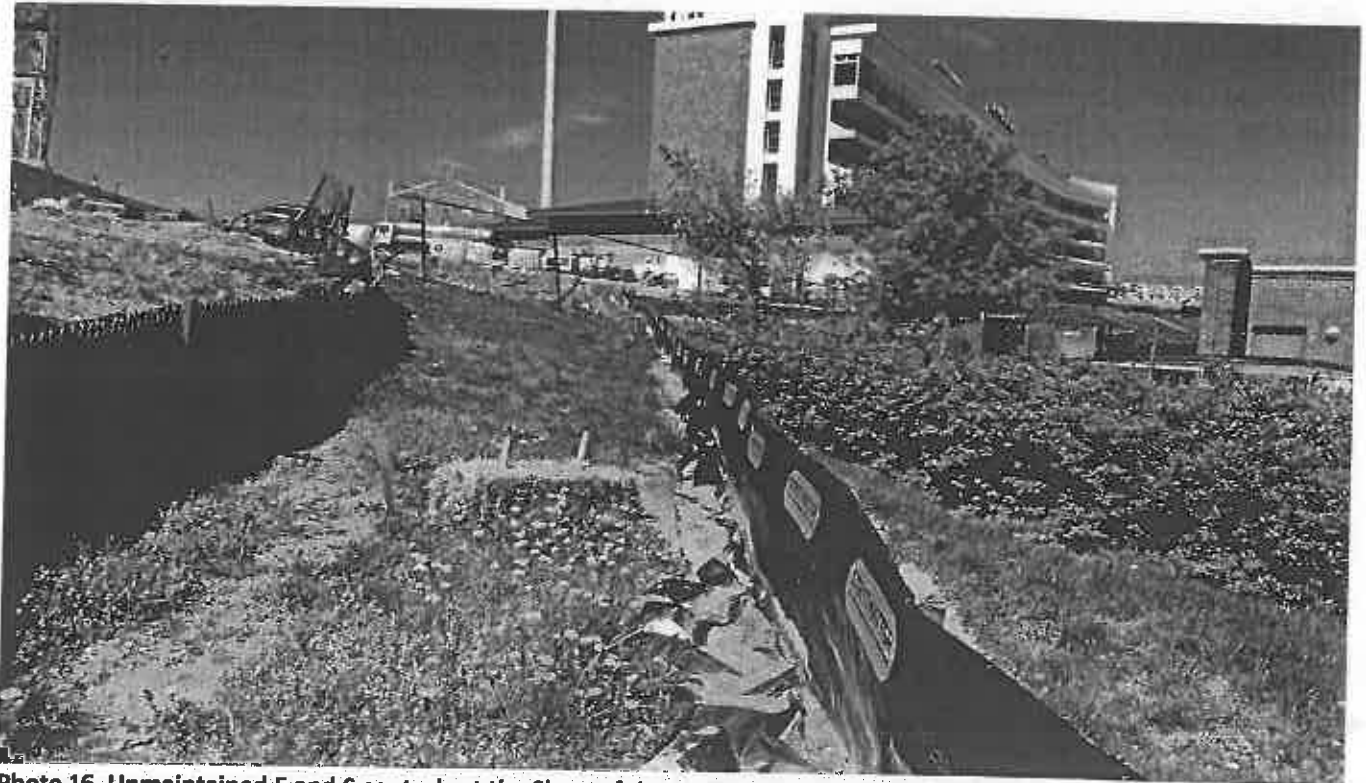
Photo 16. Unmaintained E and S controls at the Slope of the Tunnel Project North of the Site

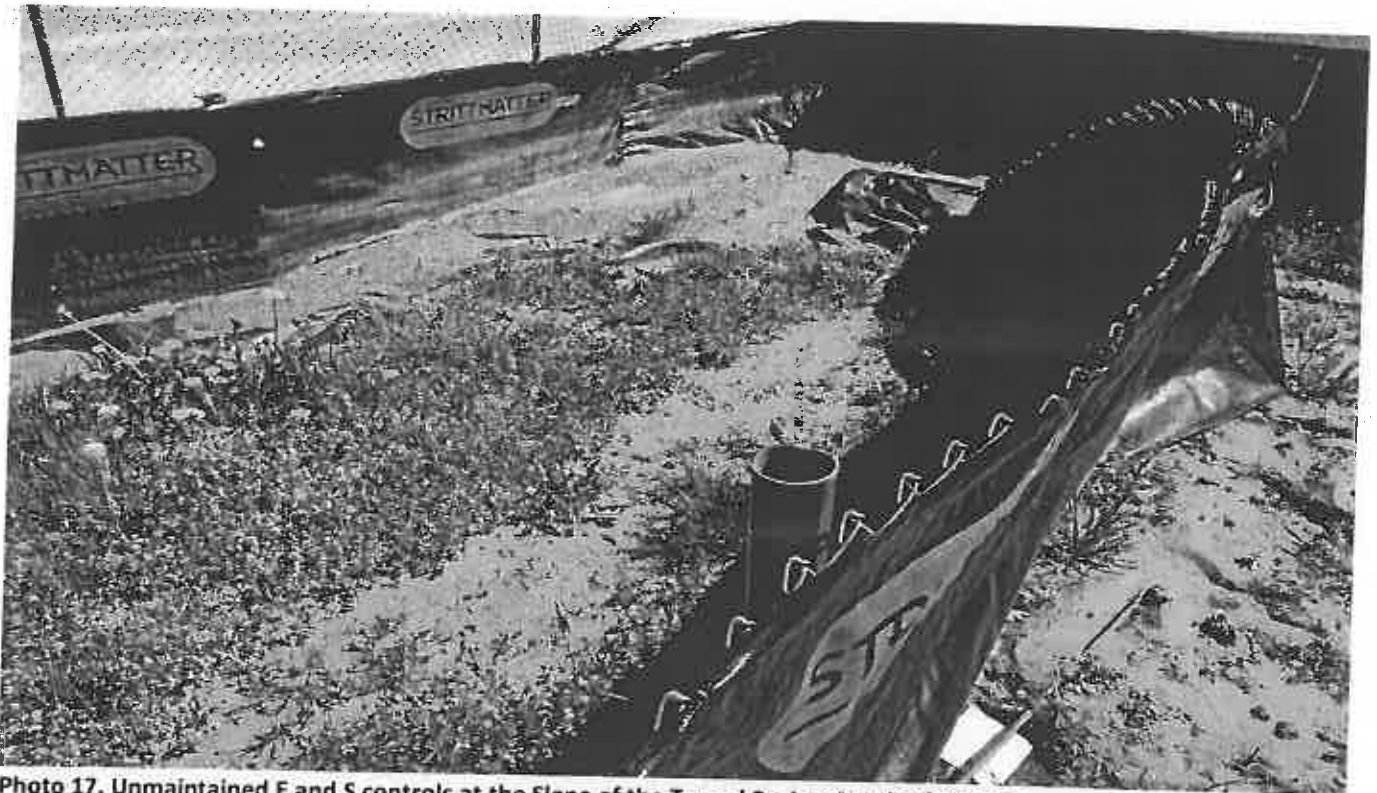
Photo 17. Unmaintained E and S controls at the Slope of the Tunnel Project North of the Site

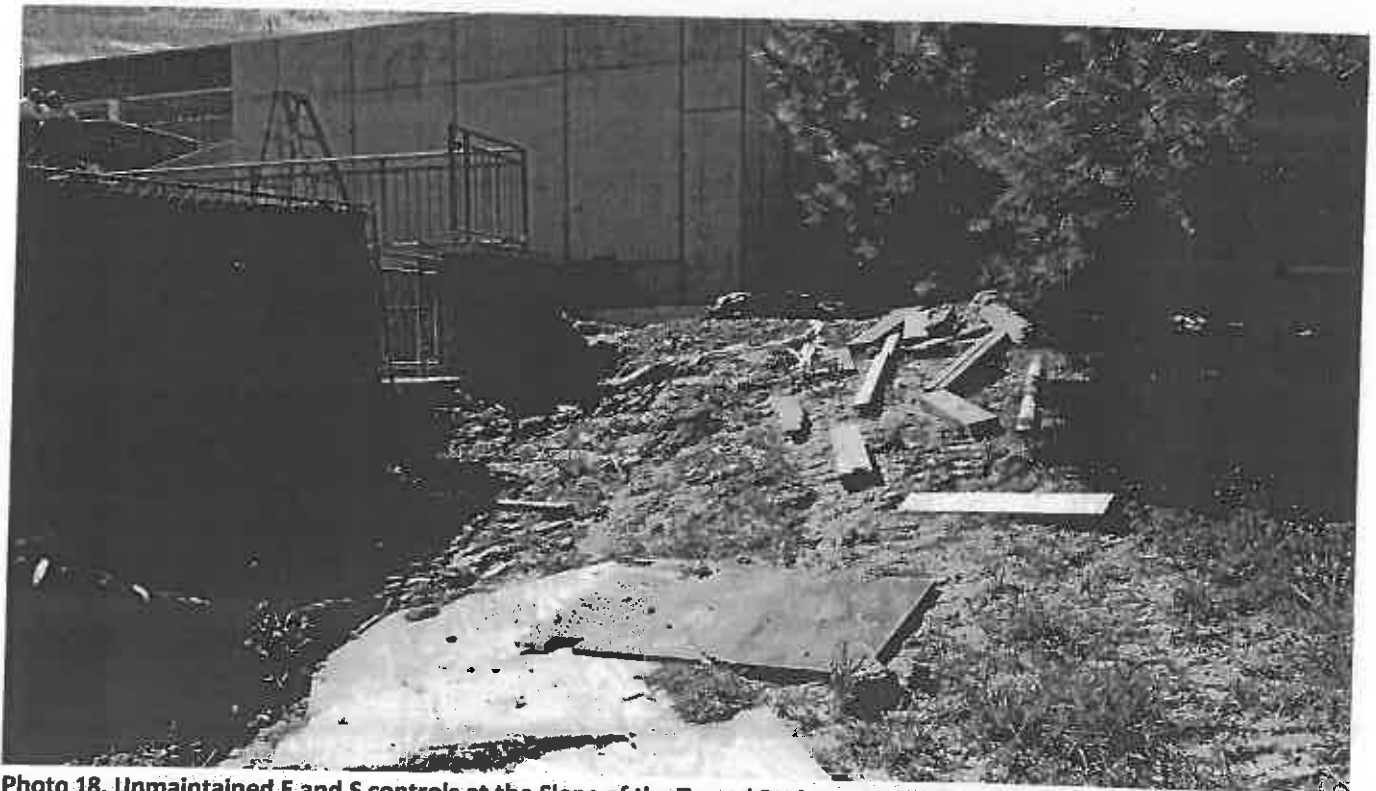
Photo 18. Unmaintained E and S controls at the Slope of the Tunnel Project North of the Site
