Re: Report of Discharge from Sanitary Sewer at the University of Maryland

# PHOTOGRAPHIC LOG

<b>Client Name:</b> University of Maryland	<b>Site Location:</b> Capital One Stadium-Gate J Entrance	<b>Project No.</b> 09/27/19 Sewage Overflow
---	--	--

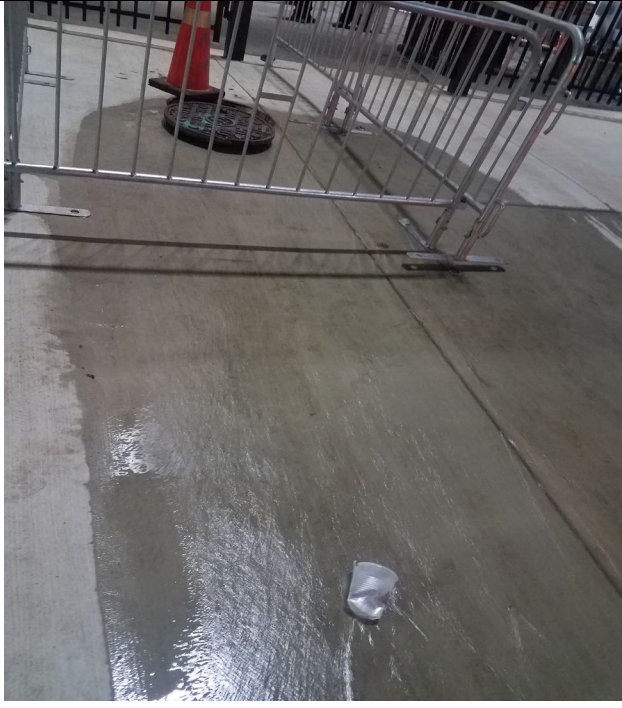
<b>Photo No.</b> 1	<b>Date:</b> 09/27/19
-----------------------	--------------------------

Facing overflowing sanitary sewer manhole

Overflowing sanitary manhole. Discharge began at approximately 10pm on Friday, 9/27/19. Flow rate initially approximated at 50 GPM for the initial 2.5 hours of discharge. Then was greatly reduced to 5 GPH. A total of 7,550 gallons was estimated of being discharged.

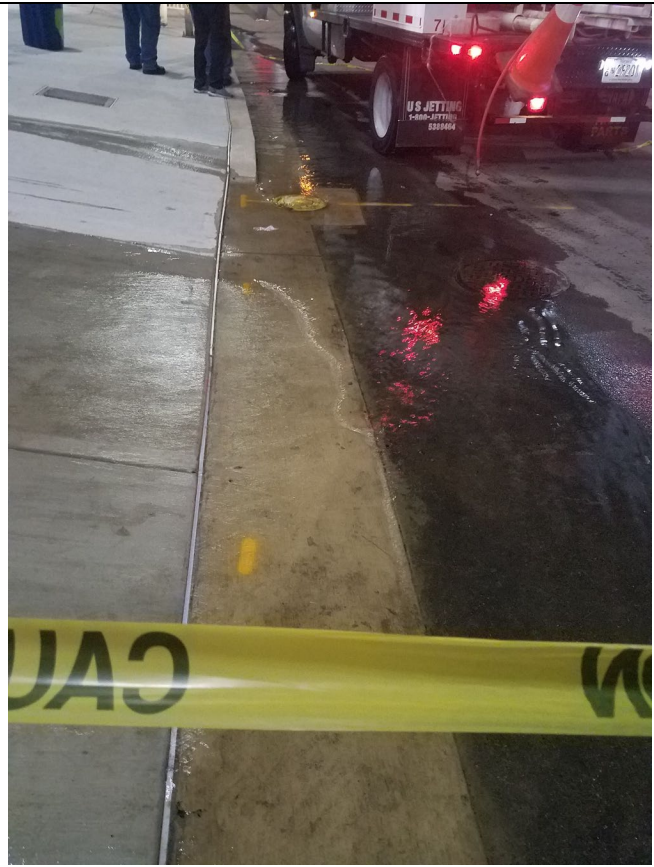
<b>Photo No.</b> 2	<b>Date:</b> 09/27/19
-----------------------	--------------------------

Facing downhill of sanitary sewer manhole towards stormwater inlet.

Picture showing the pathway of the sewer discharge into the downgradient stormwater inlet. Initially, the discharge entered the stormwater system via an inlet, but was eventually redirected to a nearby sanitary sewer manhole. The photo shows UMD's sewer jet truck.

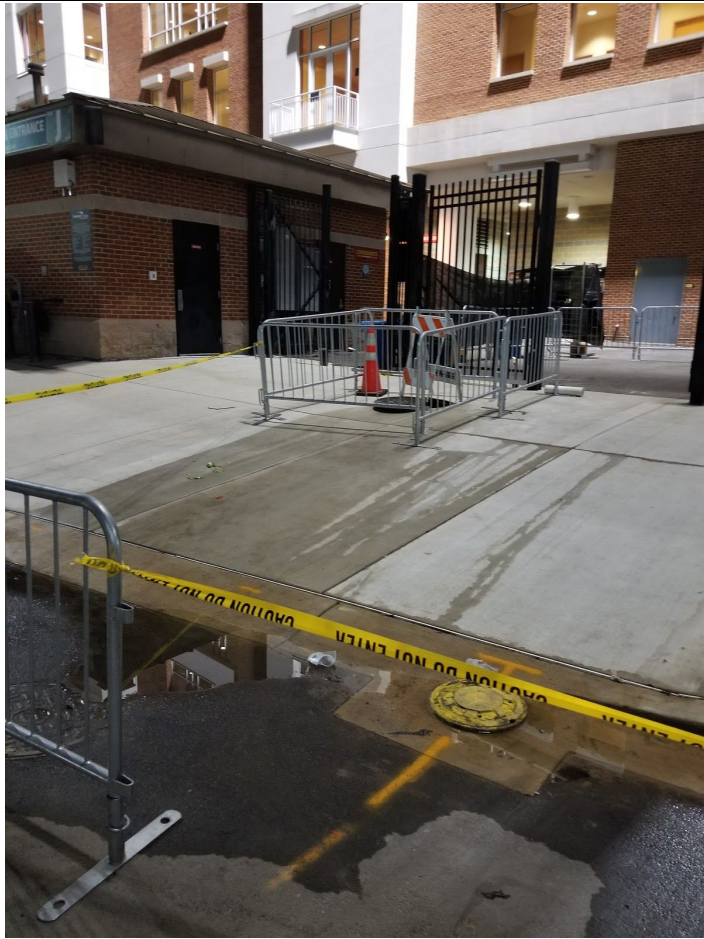
<b>Photo No.</b> 3	<b>Date:</b> 09/28/19
-----------------------	--------------------------

Facing Gate J entrance/  
Overflowing sanitary sewer manhole

Impacted area was cordoned off to the public to mitigate contact

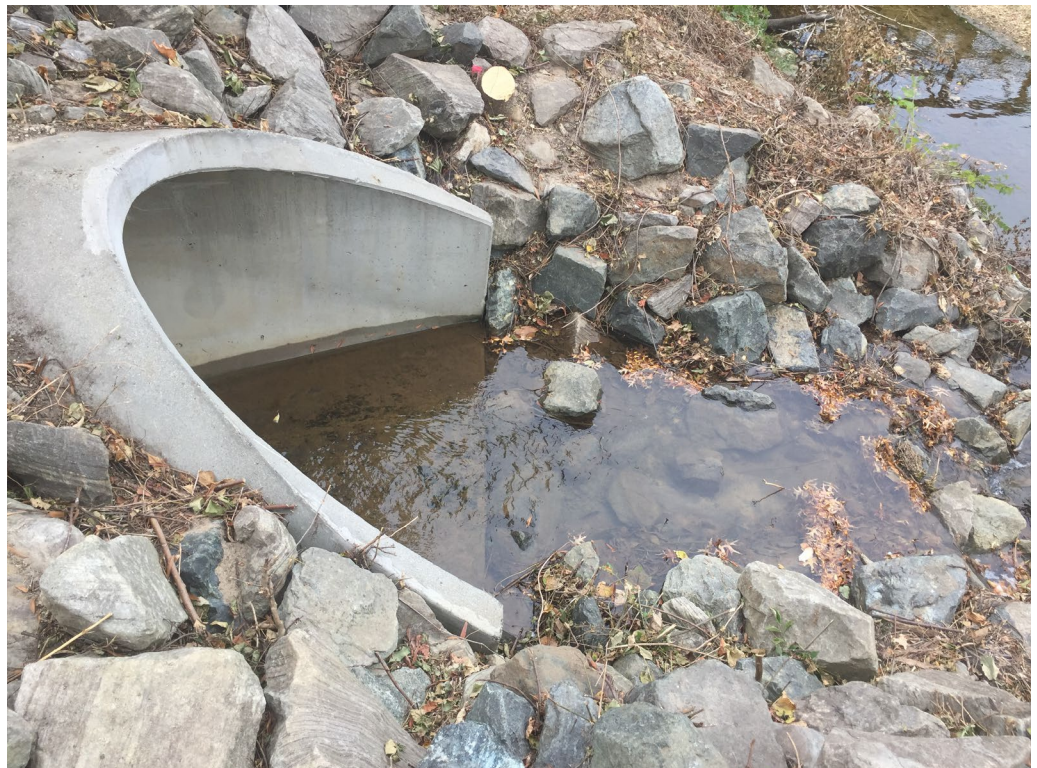
<b>Photo No.</b> 4	<b>Date:</b> 09/28/19
-----------------------	--------------------------

Above Outfall 003

Outfall #003 is the receiving outfall for the drainage area that was impacted by the sewage release. Photo shows that the water discharging from Outfall #003 has no visible suds or solids and is clear

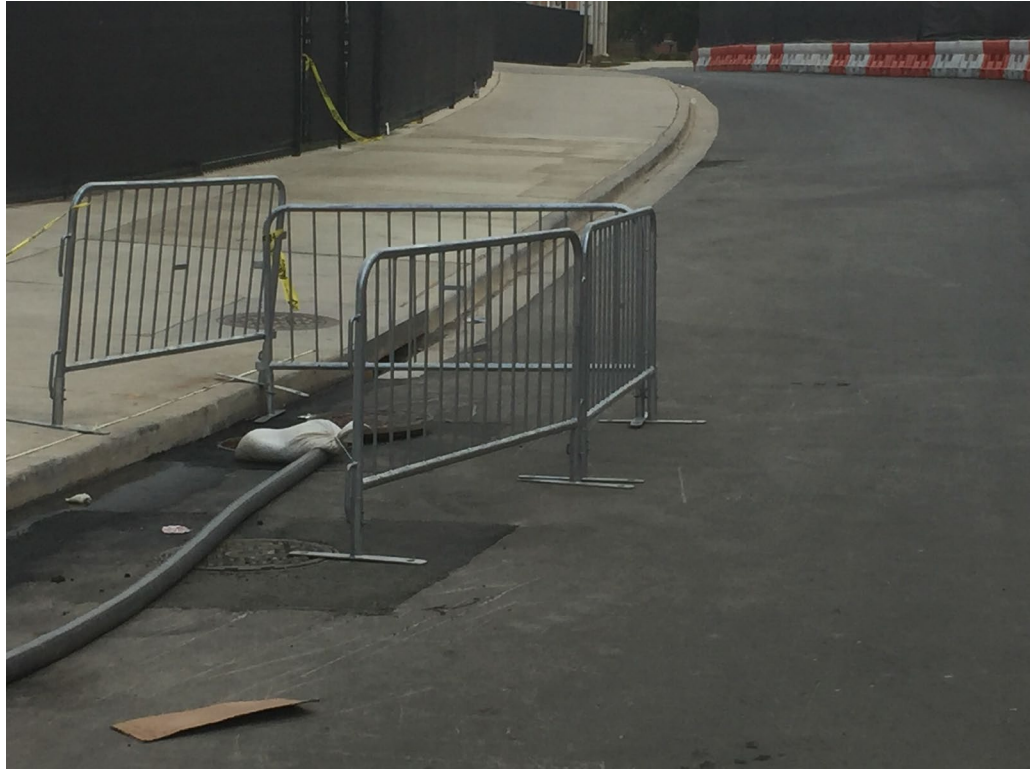
<b>Photo No.</b> 7	<b>Date:</b> 09/28/19
-----------------------	--------------------------

**Direction Photo Taken:**  
From the northeast

**Description:**  
Picture of the downgradient sanitary sewer manhole (where flow was eventually diverted) used during the bypass pumping, as well as the nearby, upgradient stormwater inlet that received the sewage discharge.

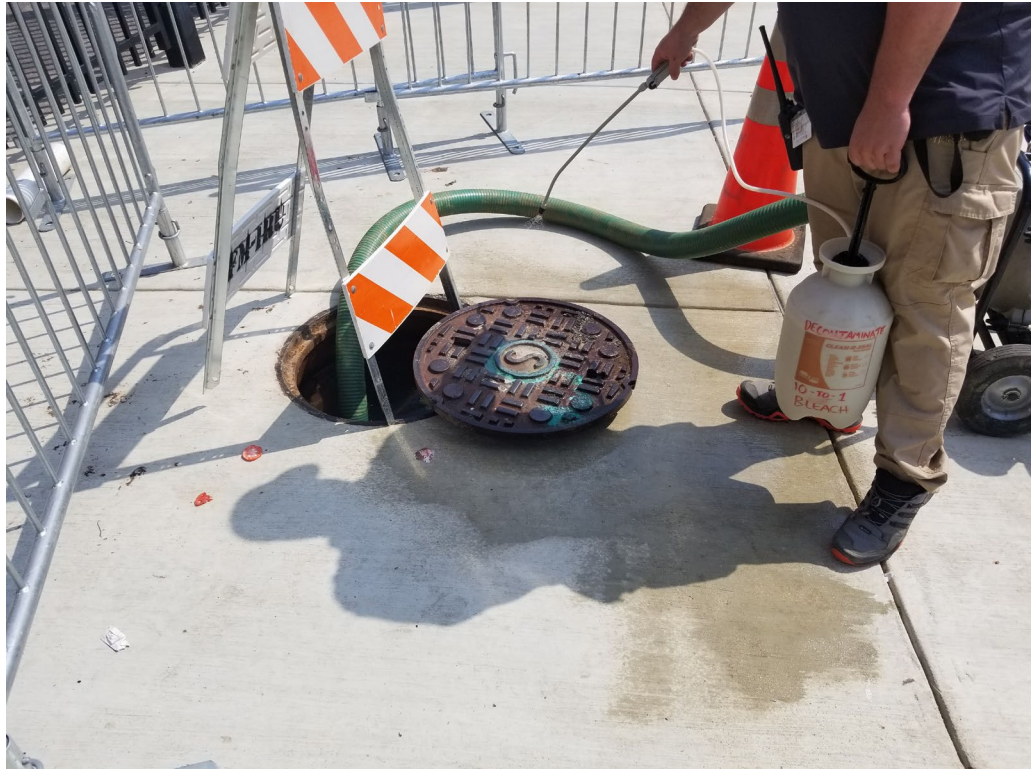
<b>Photo No.</b> 8	<b>Date:</b> 09/28/19
-----------------------	--------------------------

**Description:**  
Picture of a solution of 10% bleach being applied to the impacted area to disinfect the surfaces.

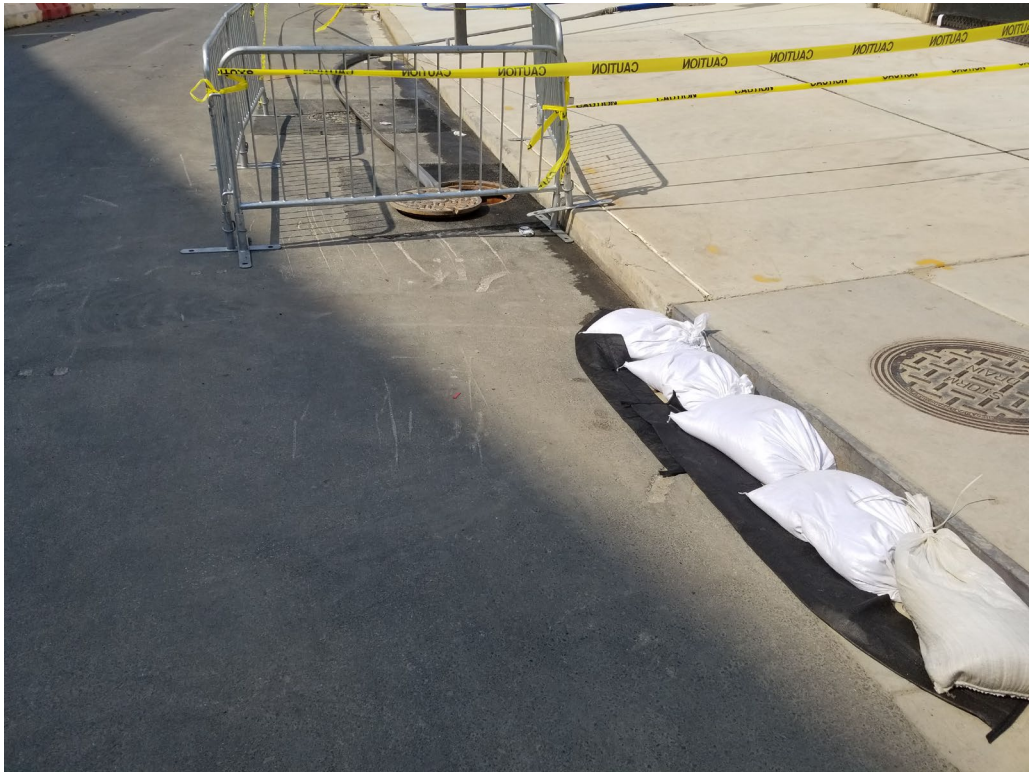
**Photo No.**  
9

Picture of the impacted stormwater inlet sealed with liners and sandbags to prevent the 10% bleach disinfectant solution from entering the stormwater system during the decontamination of the area.

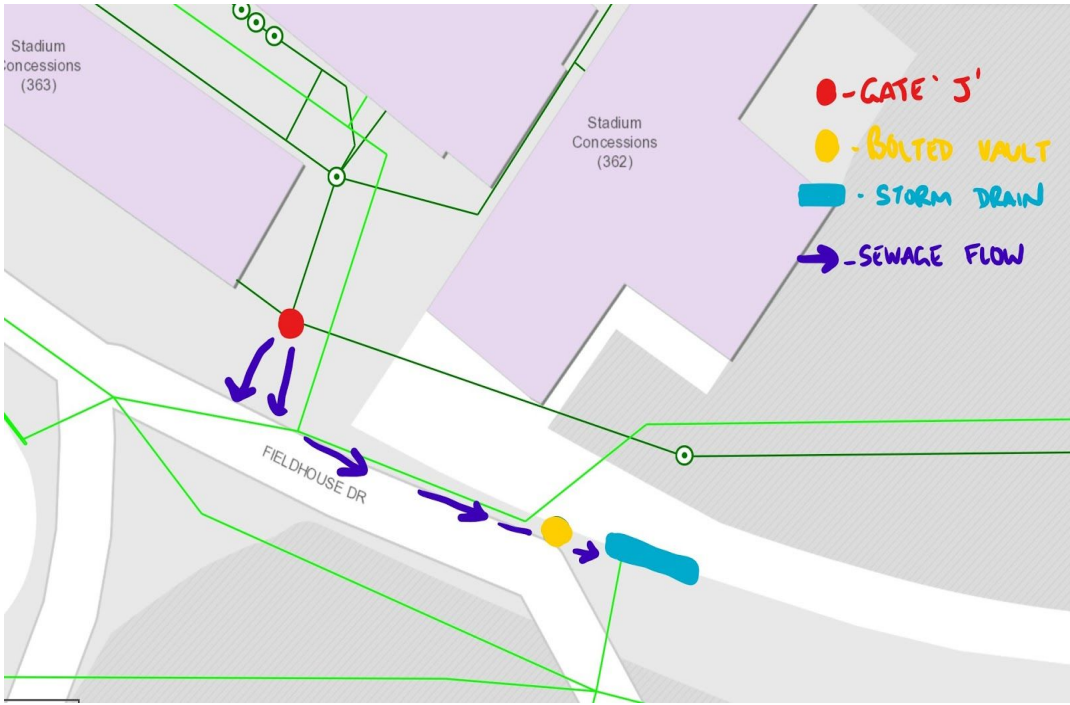
**Photo No.**  
10

A rendering of the flow path taken by the sewage overflow. Indicated on the map are the stormwater inlet and the sanitary system manhole to which the discharge was redirected. The surface flow of the release was approximately 100 feet. Note that the "bolted vault" in the sketch is the downgradient sanitary sewer manhole, which UMD staff had difficulty opening in order to divert the discharge and redirect the sewage during bypass pumping.
