Illicit Discharge Incident Tracking Sheet

Incident ID: 2017-01				
Responder Information				
Call taken by: N/A			Call date: N/A	
Call time: N/A			Precipitation (inches) in past 24-48 hrs: 0.00	
Reporter Information				
Incident time: _____ PM			Incident date: 1/20/2017	
Caller contact information (<i>optional</i>): N/A				
Incident Location (<i>complete one or more below</i>)				
Latitude and longitude: 38.989771, -76.934763				
Stream address or outfall #: Outfall 002				
Closest street address: Baltimore Ave. & Lakeland Rd., College Park, MD 20742				
Nearby landmark: Brendan Iribe Center				
Primary Location Description		Secondary Location Description:		
<input checked="" type="checkbox"/> Stream corridor (<i>In or adjacent to stream</i>)		<input checked="" type="checkbox"/> Outfall	<input type="checkbox"/> In-stream flow	<input type="checkbox"/> Along banks
<input type="checkbox"/> Upland area (<i>Land not adjacent to stream</i>)		<input type="checkbox"/> Near storm drain	<input type="checkbox"/> Near other water source (storm water pond, wetland, etc.):

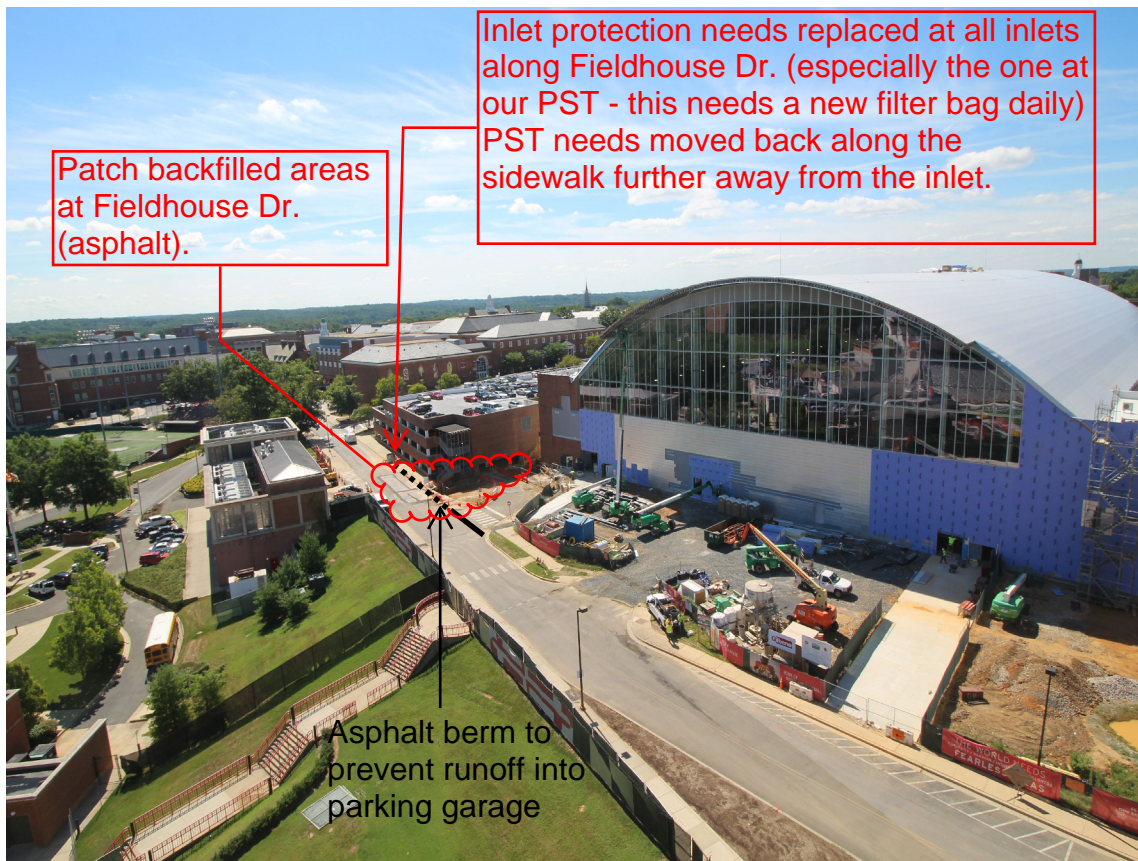
The New Cole Fieldhouse PTZ - View 1, College Park, MD

Environmental Affairs (EA) observed highly turbid, sediment laden water was being discharged from Outfall 003 due to the dewatering at the Cole Field House construction site. EA notified UMD Facilities Management, who then notified the contractor, Gilbane Building Co., to perform corrective action. Gilbane is going to install approximately 150 linear feet of super silt fence and hydro-seed 21,000 sq. feet (see attachment for details).

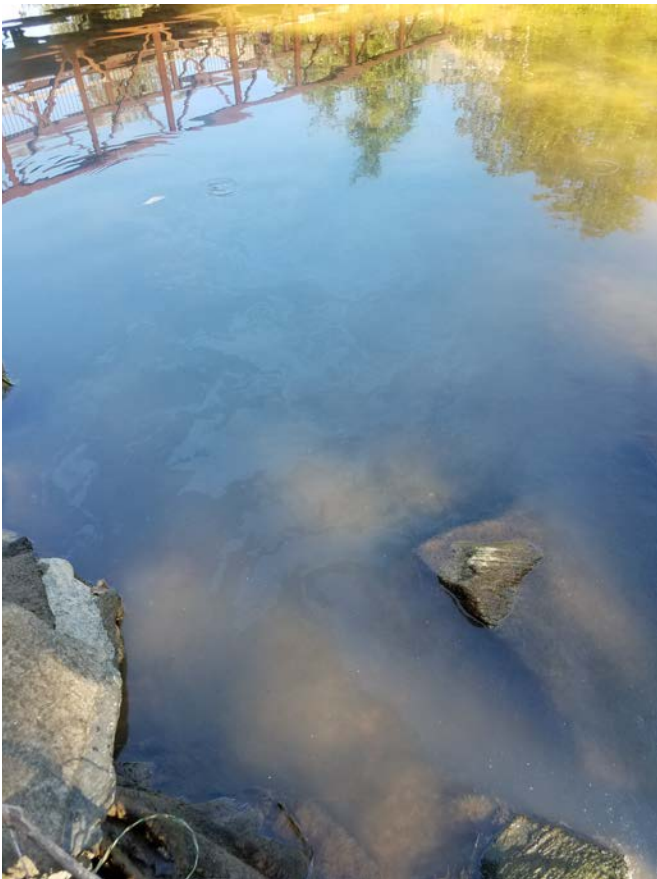
UMD Illicit Discharge Photo Log
10/18/2017 – Stamp Student Union Cooking Oil/Grease Spill

Environmental Affairs (EA) staff observed a spill from a compost compactor at the Stamp Student Union loading dock that had discharged to the storm drain on Fieldhouse Drive. The liquid appeared to contain cooking oil and food grease. EA then investigated the Outfall that the spill location drains to, Outfall 003, and found cloudy water with an oil sheen discharging to Paint Branch Creek. The sheen was very minor and did not appear to significantly affect the creek.

Top left: Scum layer on the water surface at Outfall 003

Top right: Persistent foam at Outfall 003

EA staff made the required phone notification to Maryland Department of the Environment and deployed oil sorbent booms and pads at Outfall 003 in an attempt to capture the oil/grease that was released. Oil continued to discharge from the stormwater conveyance system so a contractor was brought in on 10/19 to jet and vacuum the stormwater lines between the Stamp Student Union and Outfall 003 in order to remove residual oil/grease that could be discharged during the next rain event.

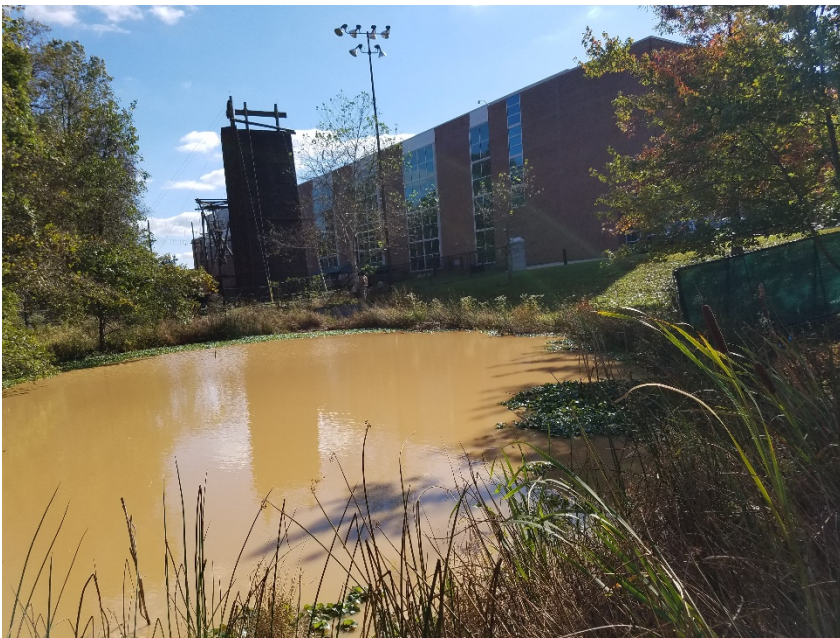
UMD Illicit Discharge Photo Log
10/30/2017 – Parking Lot #2g Construction

During monthly NPDES sampling, Environmental Affairs (EA) observed highly turbid, sediment laden water discharging from Outfall 019. EA investigated the Outfall 019 watershed and determined that the source of the sediment was the construction site at the parking lots (lot # 2g) just west of Eppley Recreation Center. The site had a large area of disturbed, uncovered soil that eroded during the heavy rains on 10/29, and the existing stormwater BMPs (silt fence and stormwater retention pond) were not adequately containing the sediment. See attached photo log. EA notified UMD Facilities Management, who then notified the contractor to improve the existing BMPs and/or implement new BMPs that prevent sediment from contaminating stormwater runoff.

Top left: Looking west from Eppley Recreation Center, disturbed, uncovered soil at former parking lot #2g.

Top right: Outfall 019 discharging highly turbid, sediment laden water.
