Illicit Discharge Incident Tracking Sheet

University of Maryland Photo Log
9/03/2019 – Sewage Overflow at South Campus Dining Hall

PHOTOGRAPHIC LOG

Client Name: University of Maryland	Site Location: Capital One Stadium-Gate J Entrance	Project No. 09/27/19 Sewage Overflow
---	--	--

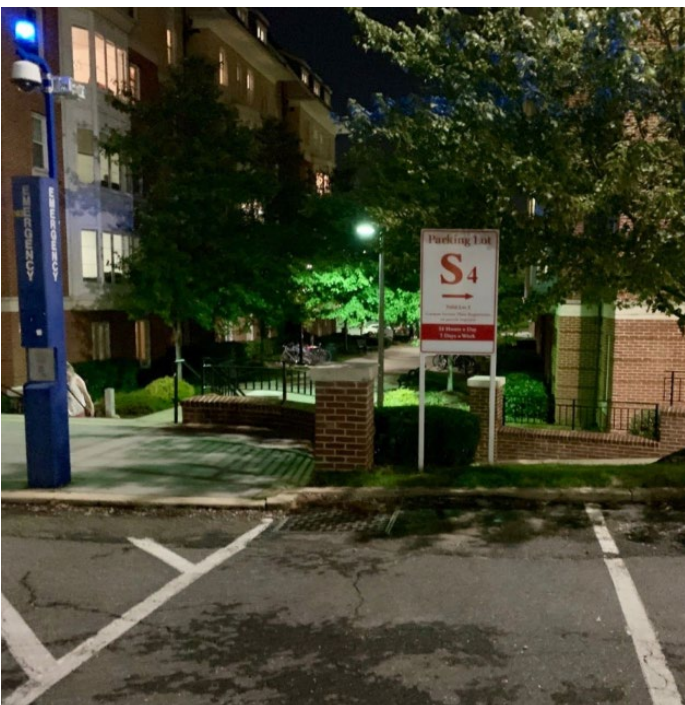
Bottom Left: One (1) of the two (2) stormwater inlets affected. Most of the standing water in the parking lot evaporated before entering the storm system.

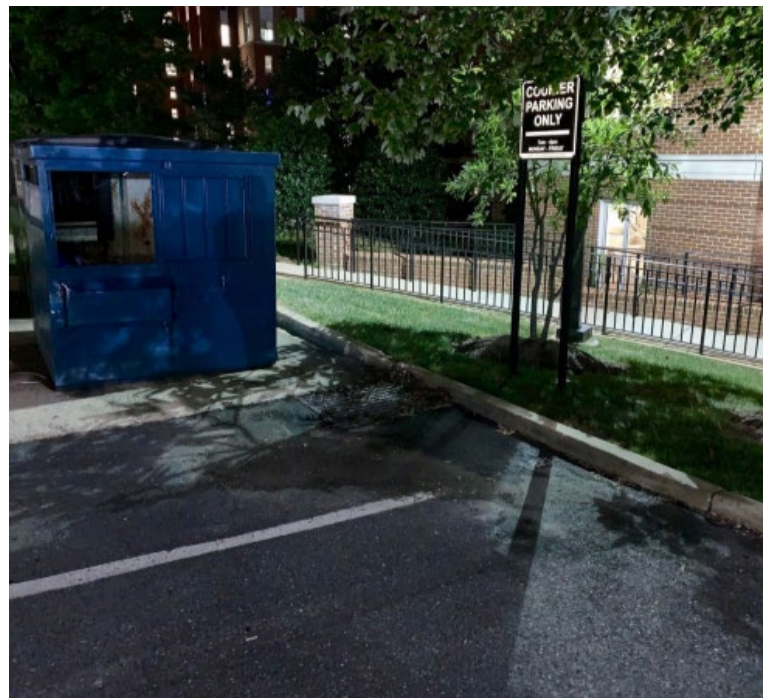
Bottom Right: Two (2) of the two (2) stormwater inlets affected. Most of the standing water in the parking lot evaporated before entering the storm system.

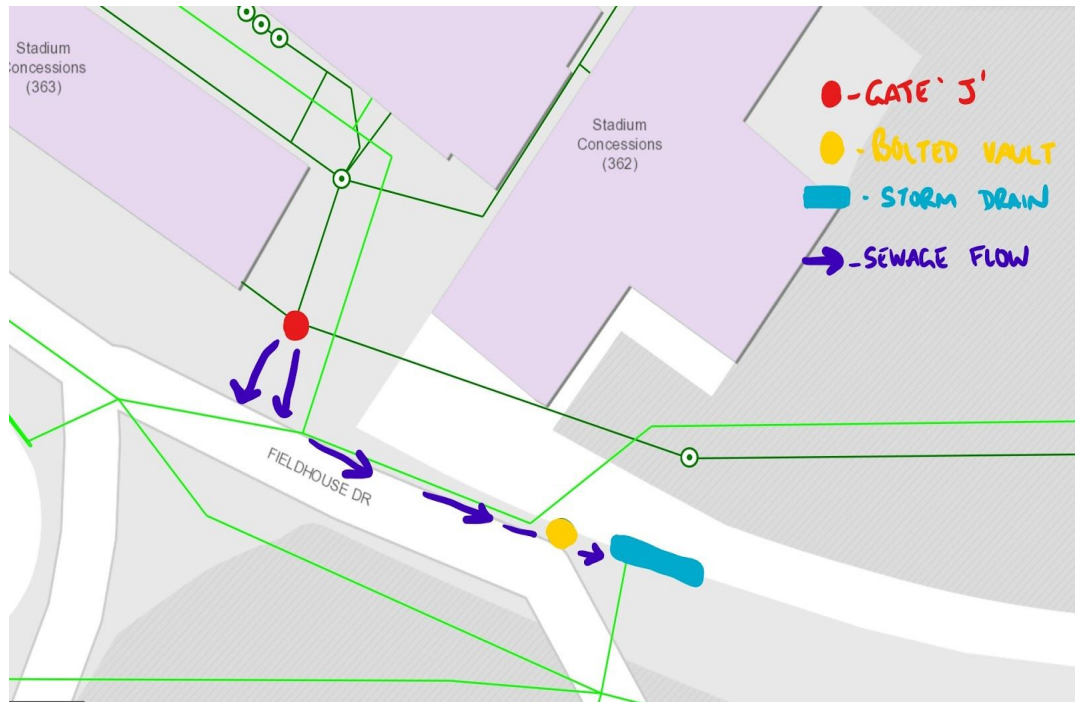
A rendering of the flow path taken by the sewage overflow. Indicated on the map are the stormwater inlet and the sanitary system manhole to which the discharge was redirected. The surface flow of the release was approximately 100 feet.
