Maryland Department of Environment
Water and Science Administration
Compliance Program - Western Division
91 Eastern Blvd, Hagerstown, MD 21740
301-665-2850

Site Name: New Cole Fieldhouse
Facility Address: 4090 Union Dr, College Park, MD 20742
County: Prince George's County

Inspection Date: November 5, 2018 **Start Date/Time:** November 5, 2018, 09:00 AM
End Date/Time: November 5, 2018, 10:00 AM

Media Type(s): NPDES Construction Activity, State/federal SWM

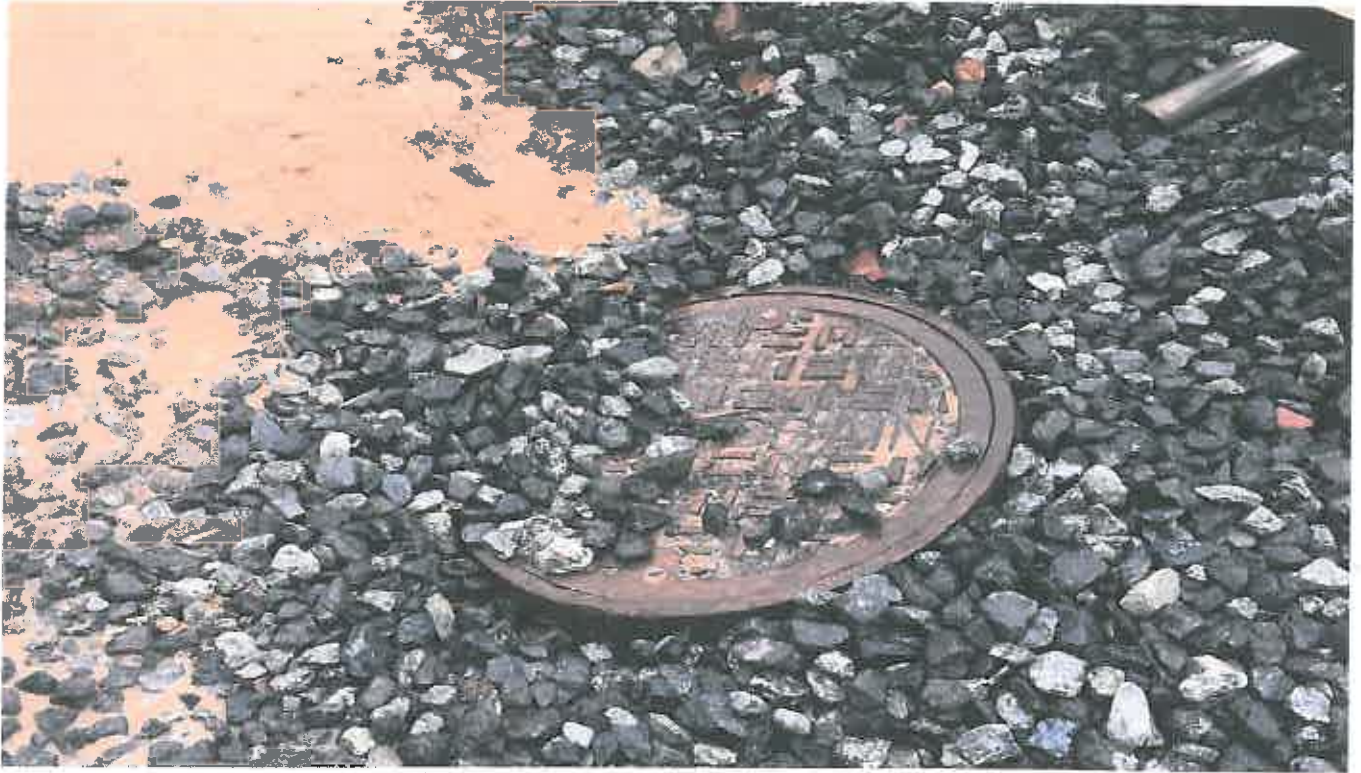
Photo 13. Ongoing pumping of Sediment laden Stormwater into active stormdrain onsite (State Waters)

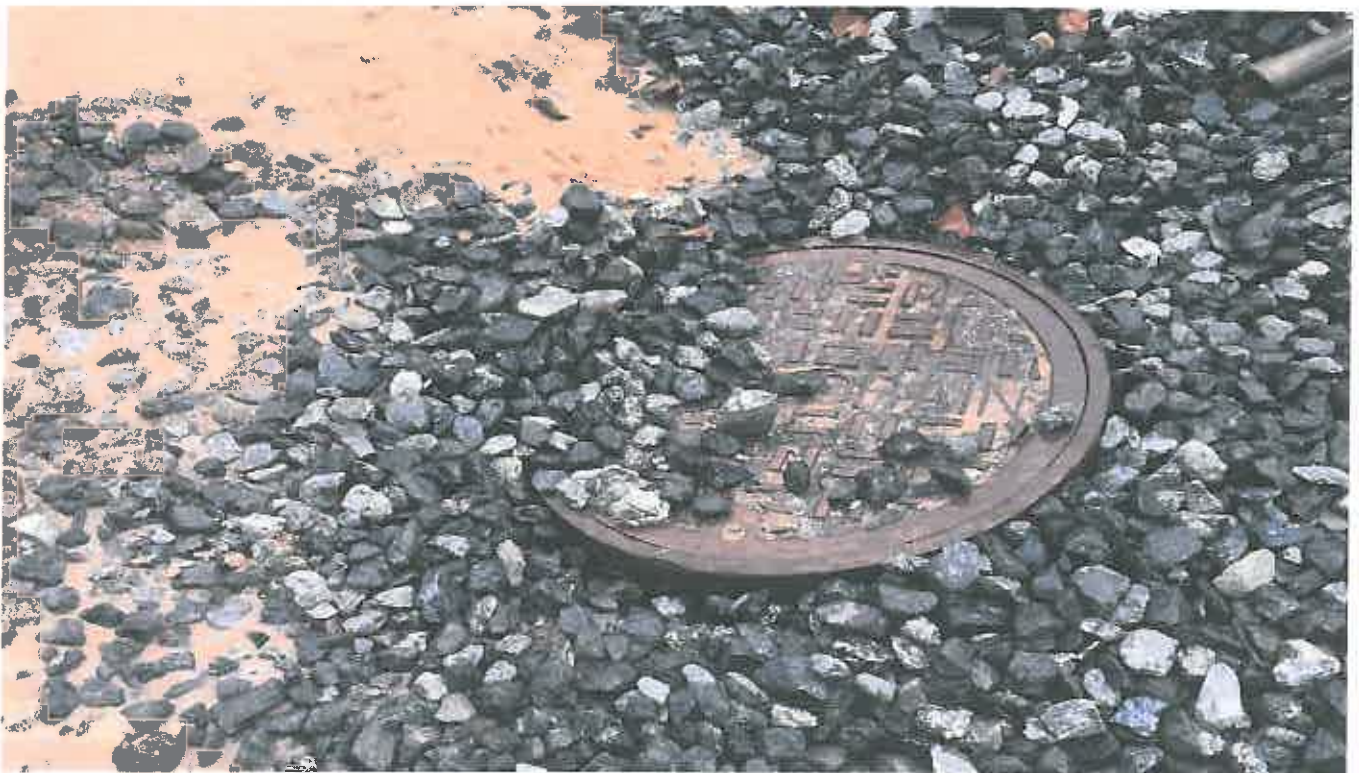
Photo 14. Ongoing pumping of Sediment laden Stormwater into active stormdrain onsite (State Waters)

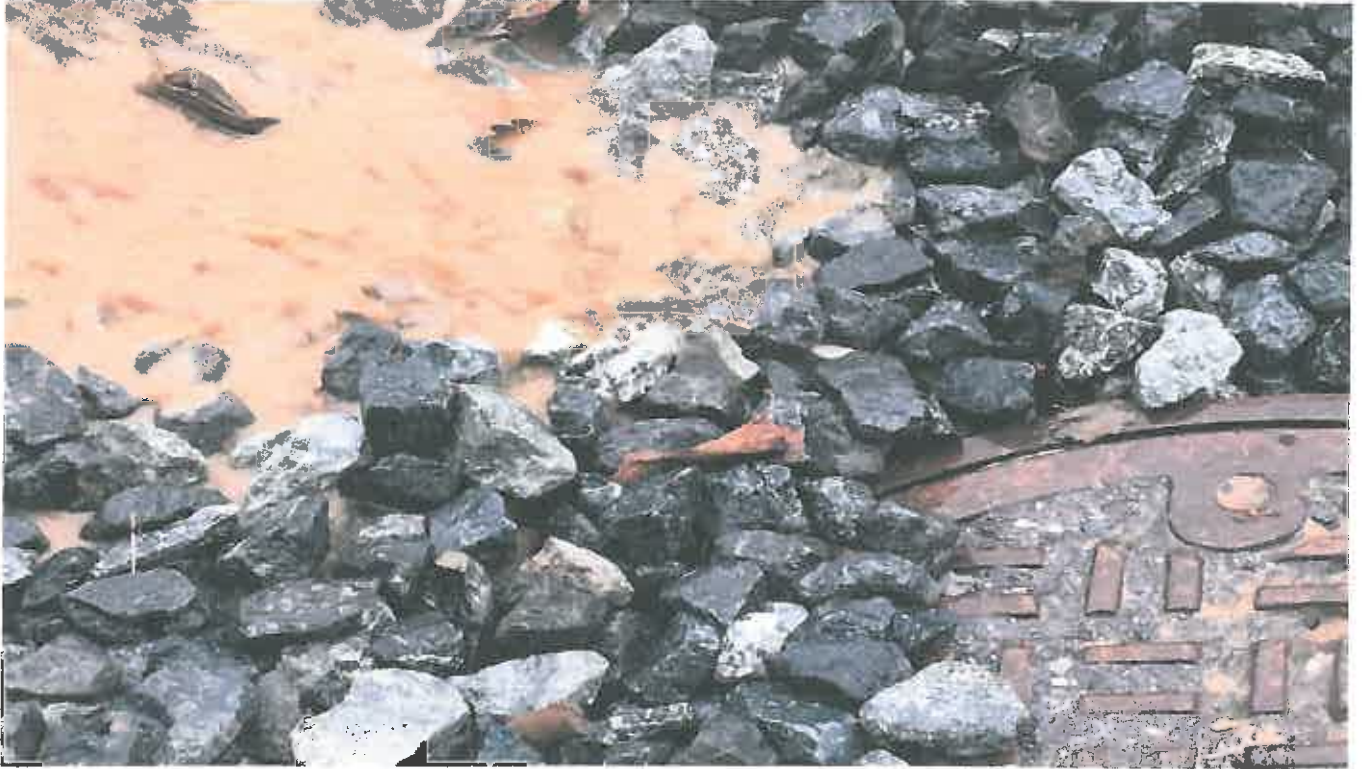
Photo 11. Ongoing pumping of Sediment laden Stormwater into active stormdrain onsite (State Waters)

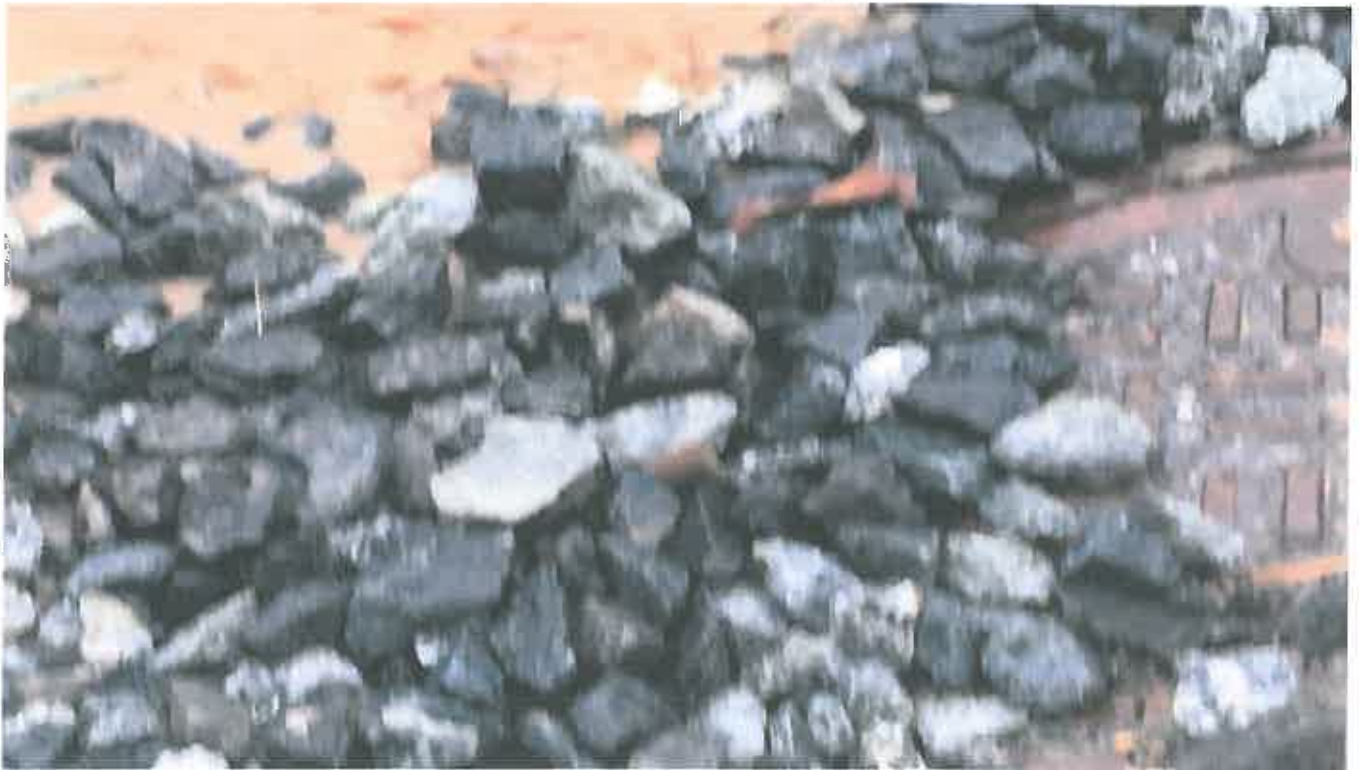
Photo 12. Ongoing pumping of Sediment laden Stormwater into active stormdrain onsite (State Waters)

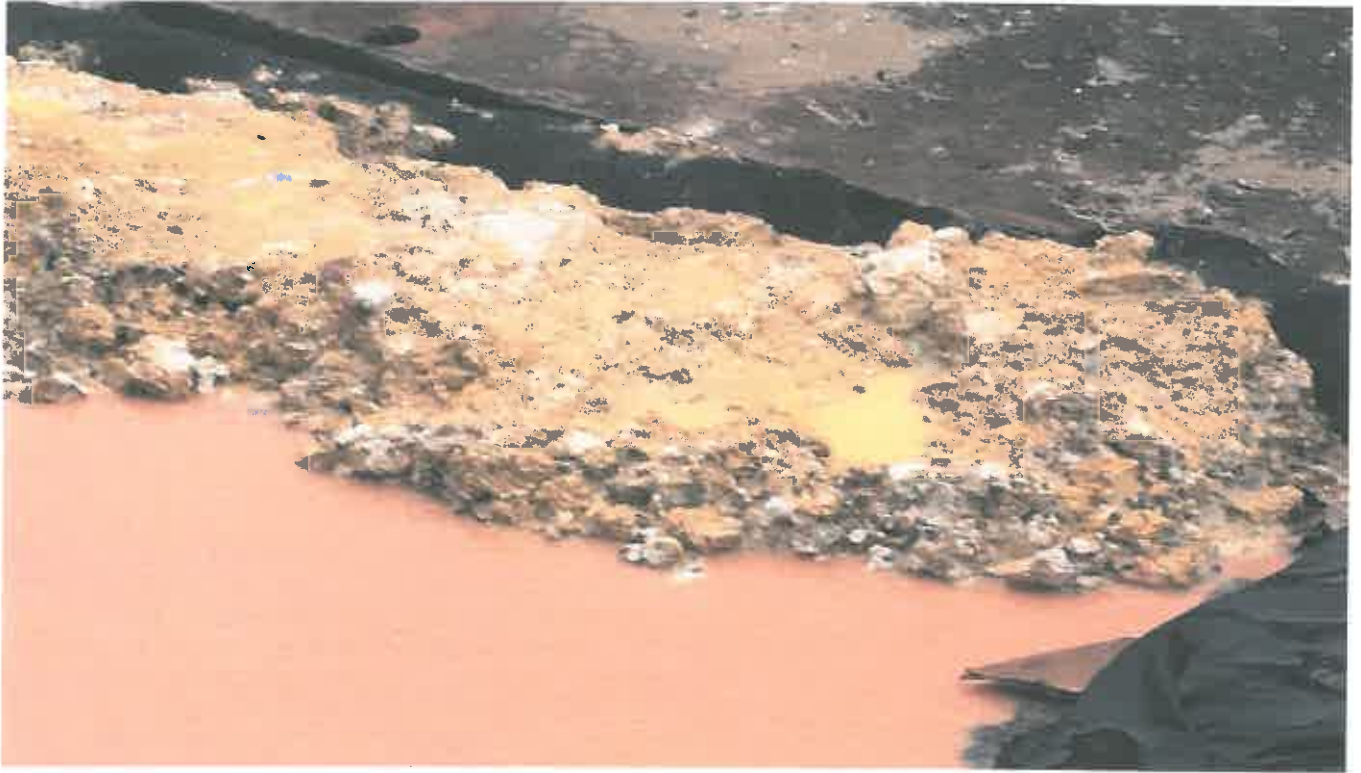
Photo 9. Ongoing pumping of Sediment laden Stormwater into active stormdrain onsite (State Waters)

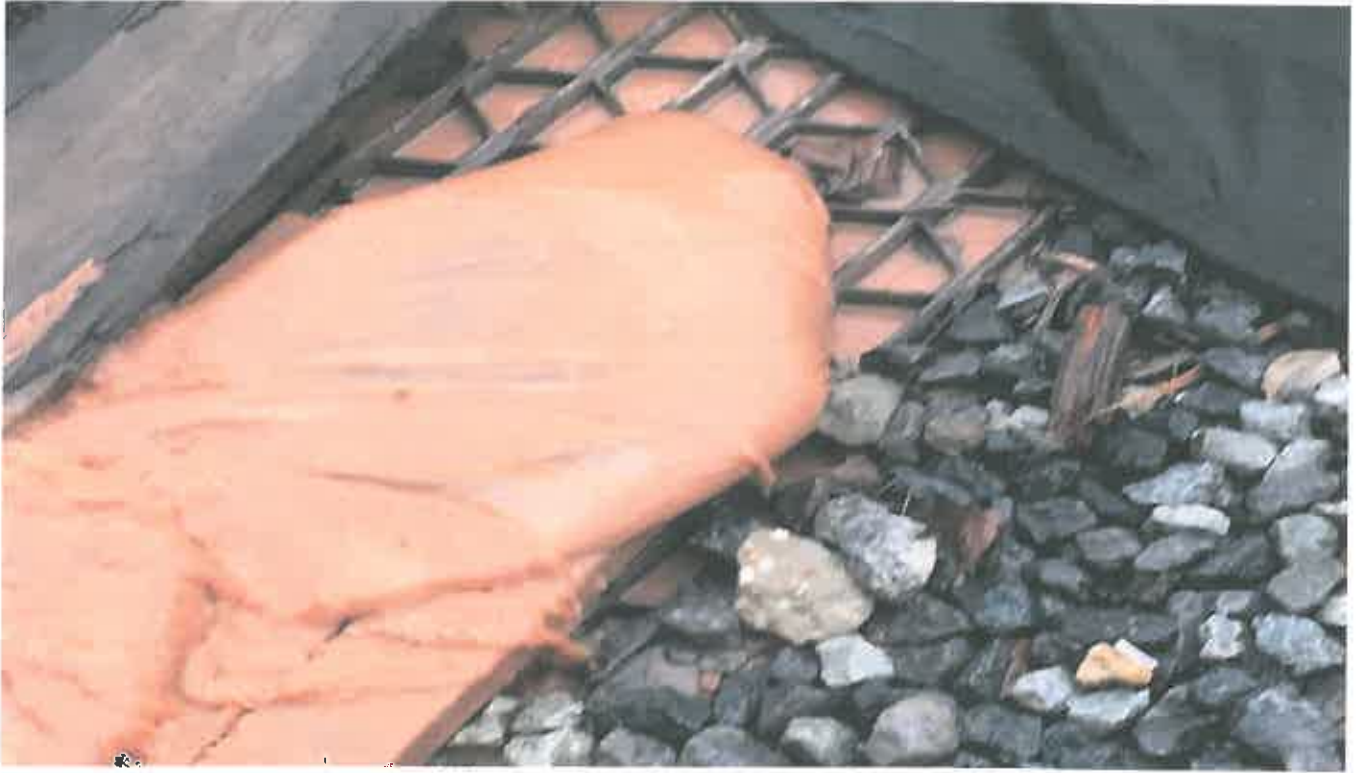
Photo 7. Ongoing pumping of Sediment laden Stormwater into active stormdrain onsite (State Waters)

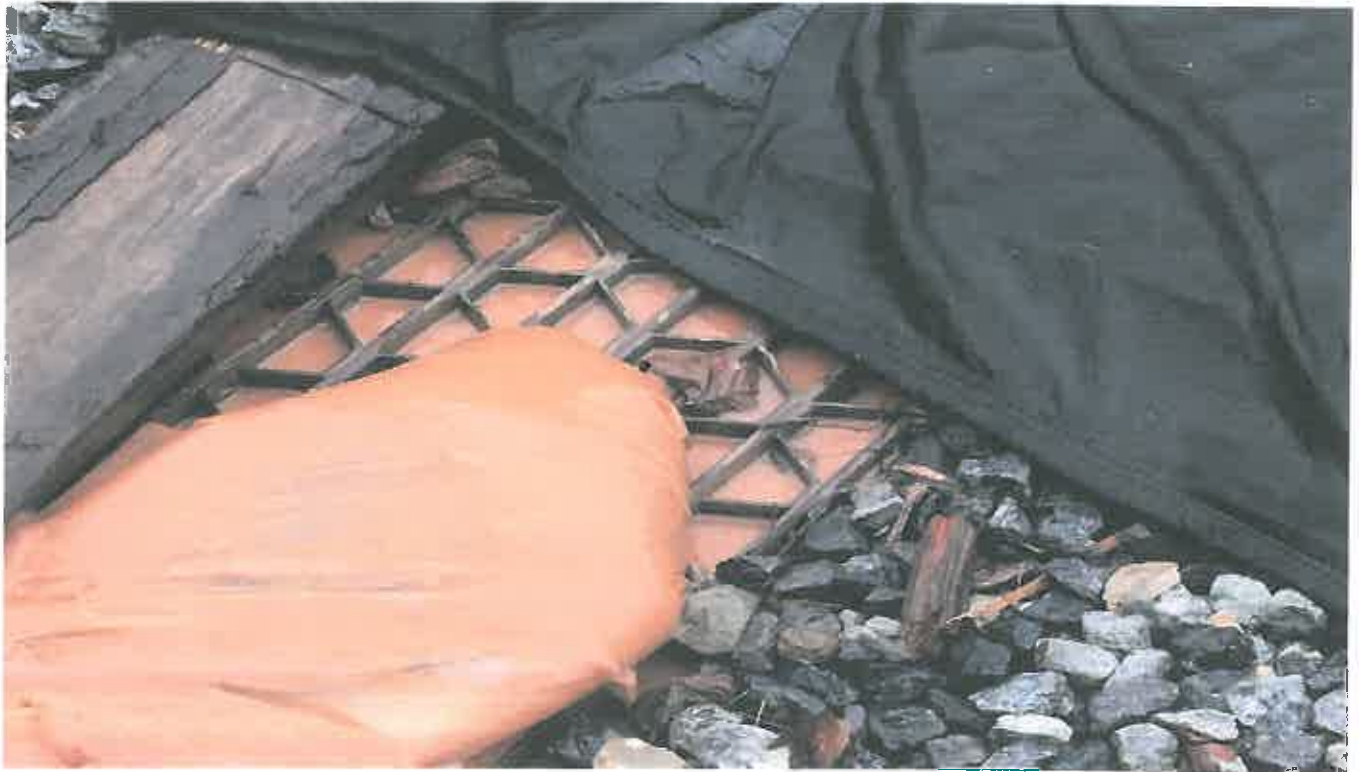
Photo 8. Ongoing pumping of Sediment laden Stormwater into active stormdrain onsite (State Waters)

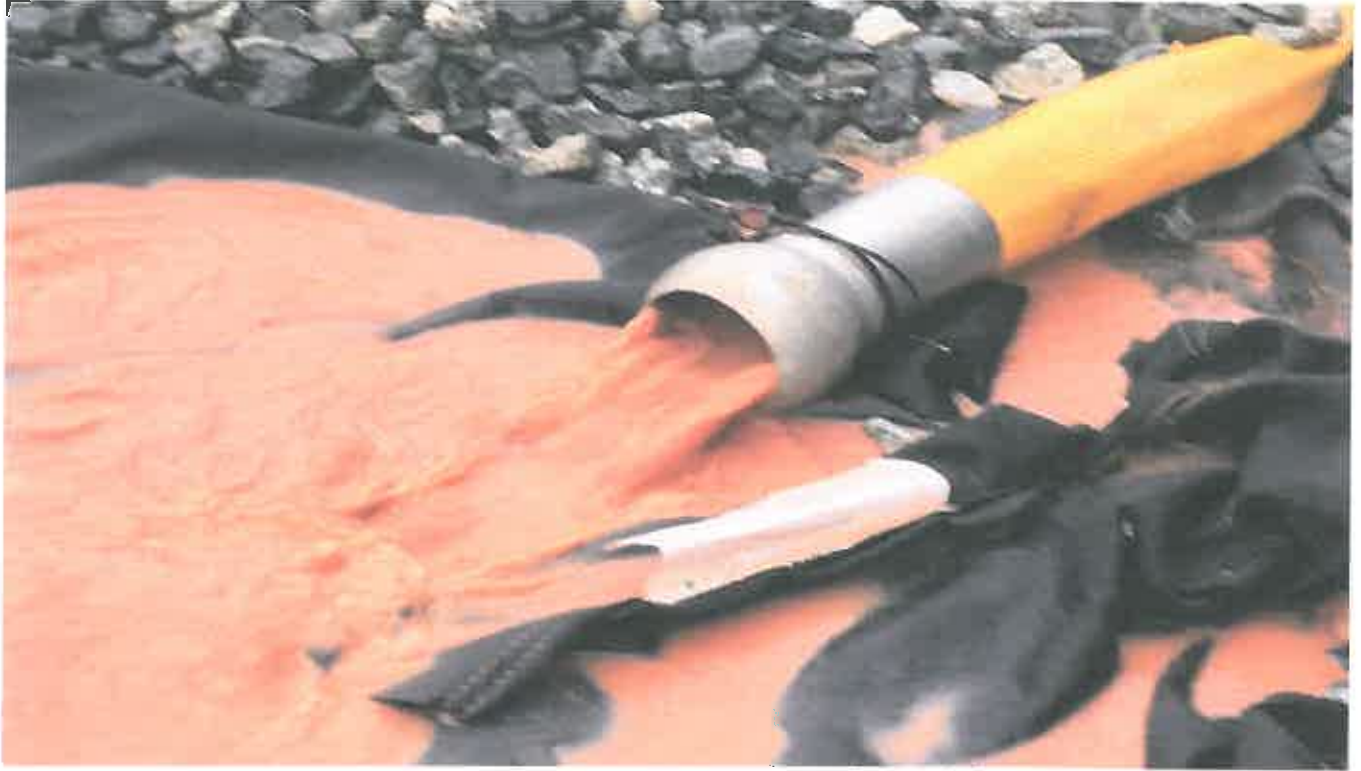
Photo 5. Ongoing pumping of Sediment laden Stormwater into active stormdrain onsite (State Waters)

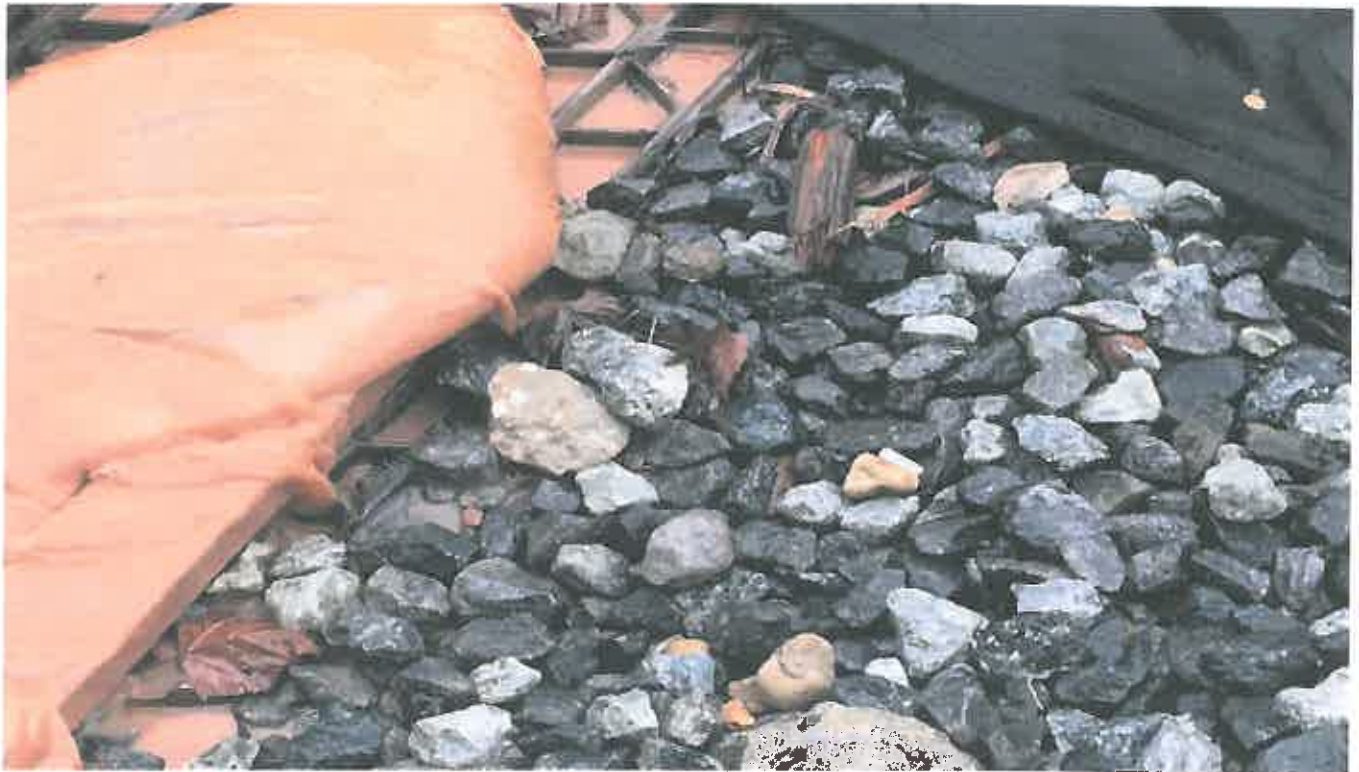
Photo 6. Ongoing pumping of Sediment laden Stormwater into active stormdrain onsite (State Waters)

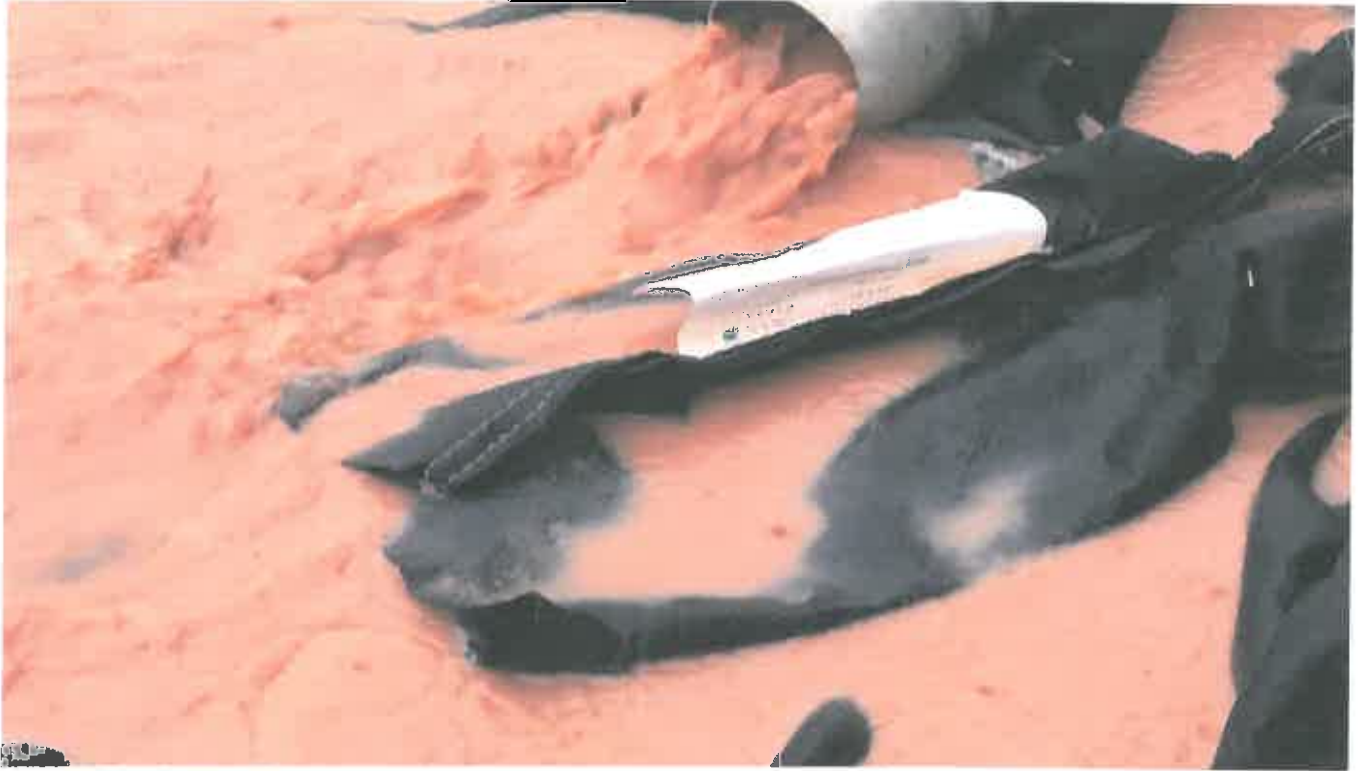
Photo 3. Ongoing pumping of Sediment laden Stormwater into active stormdrain onsite (State Waters)

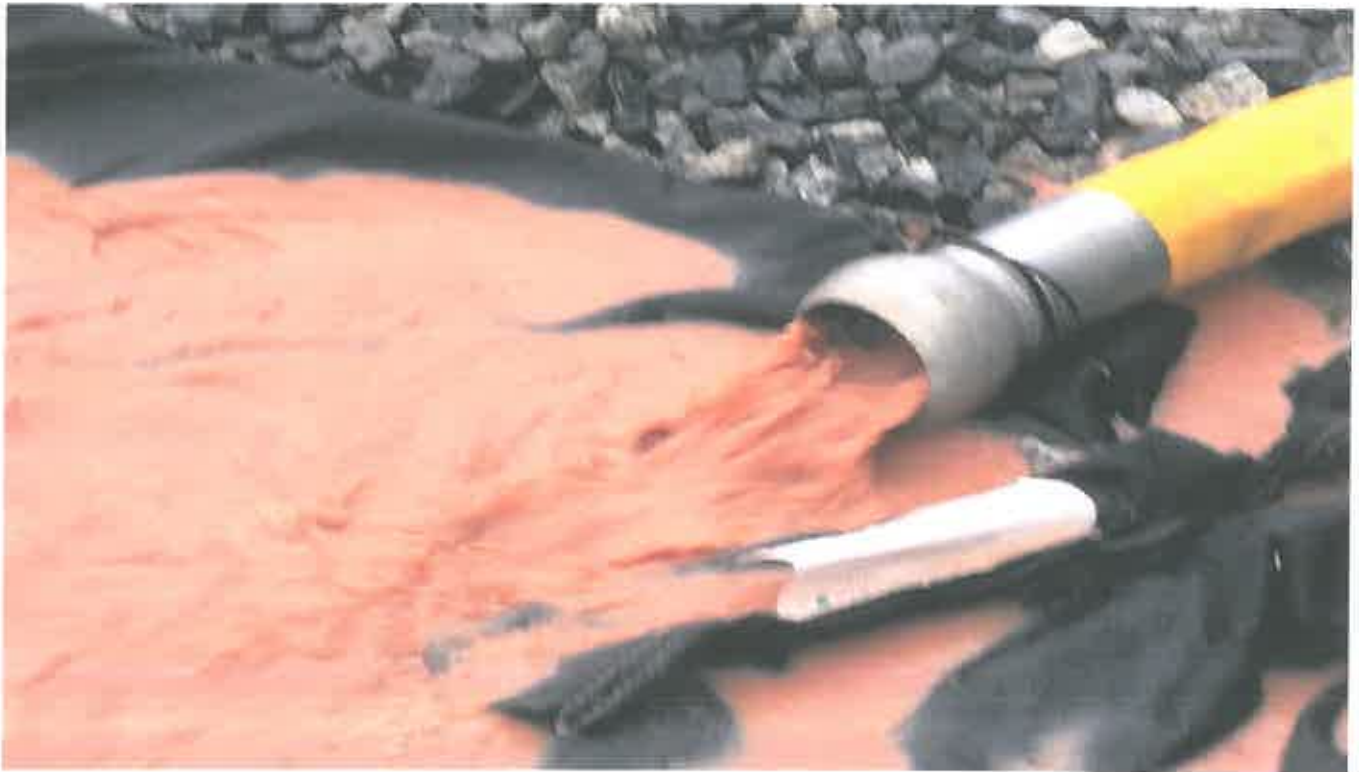
Photo 4. Ongoing pumping of Sediment laden Stormwater into active stormdrain onsite (State Waters)

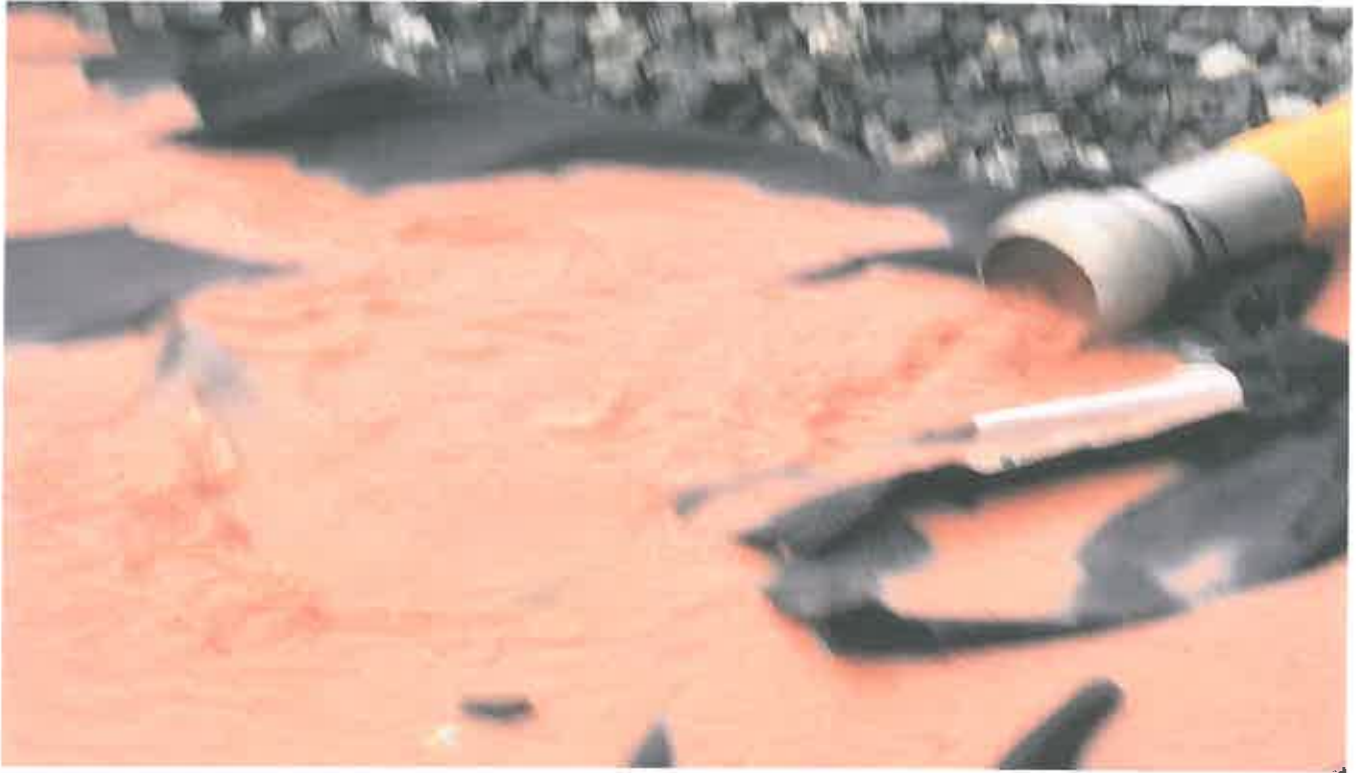
Photo 1. Ongoing pumping of Sediment laden Stormwater into active stormdrain onsite (State Waters)

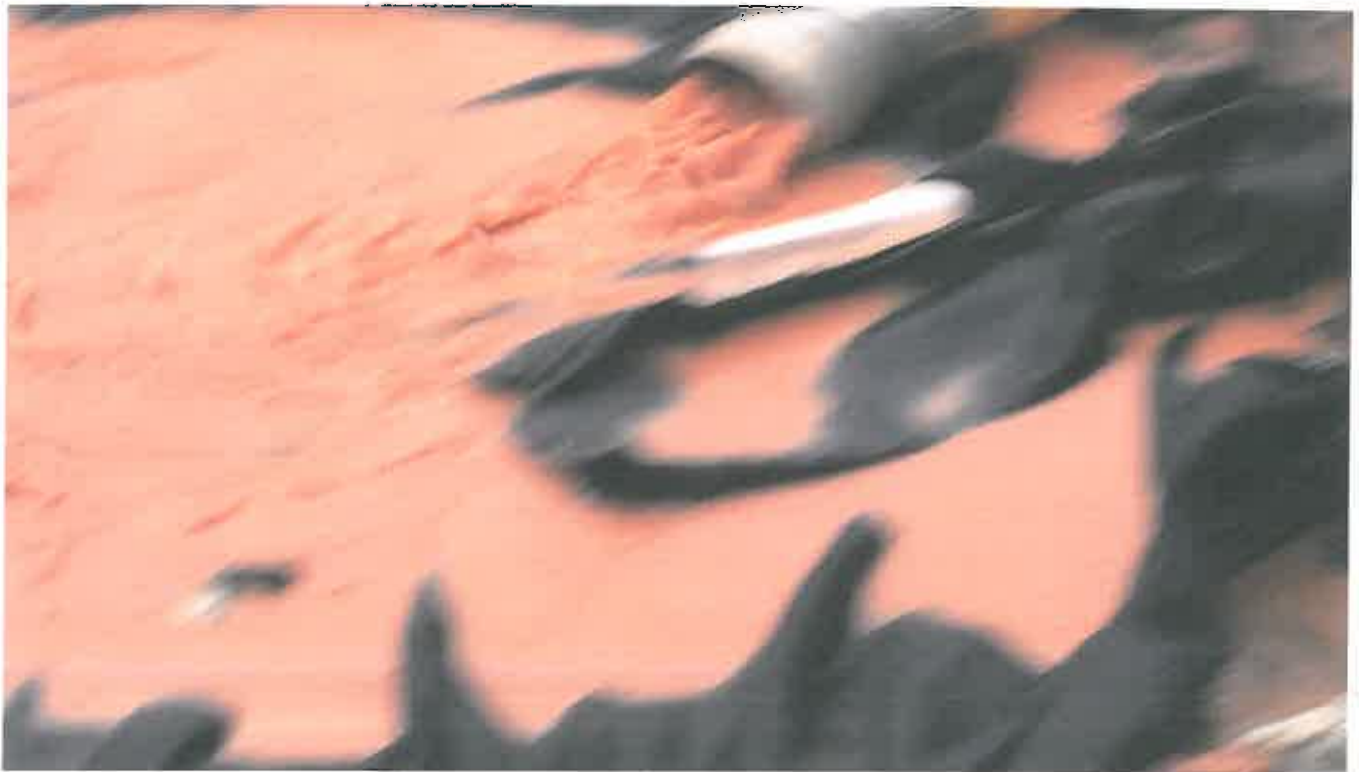
Photo 2. Ongoing pumping of Sediment laden Stormwater into active stormdrain onsite (State Waters)

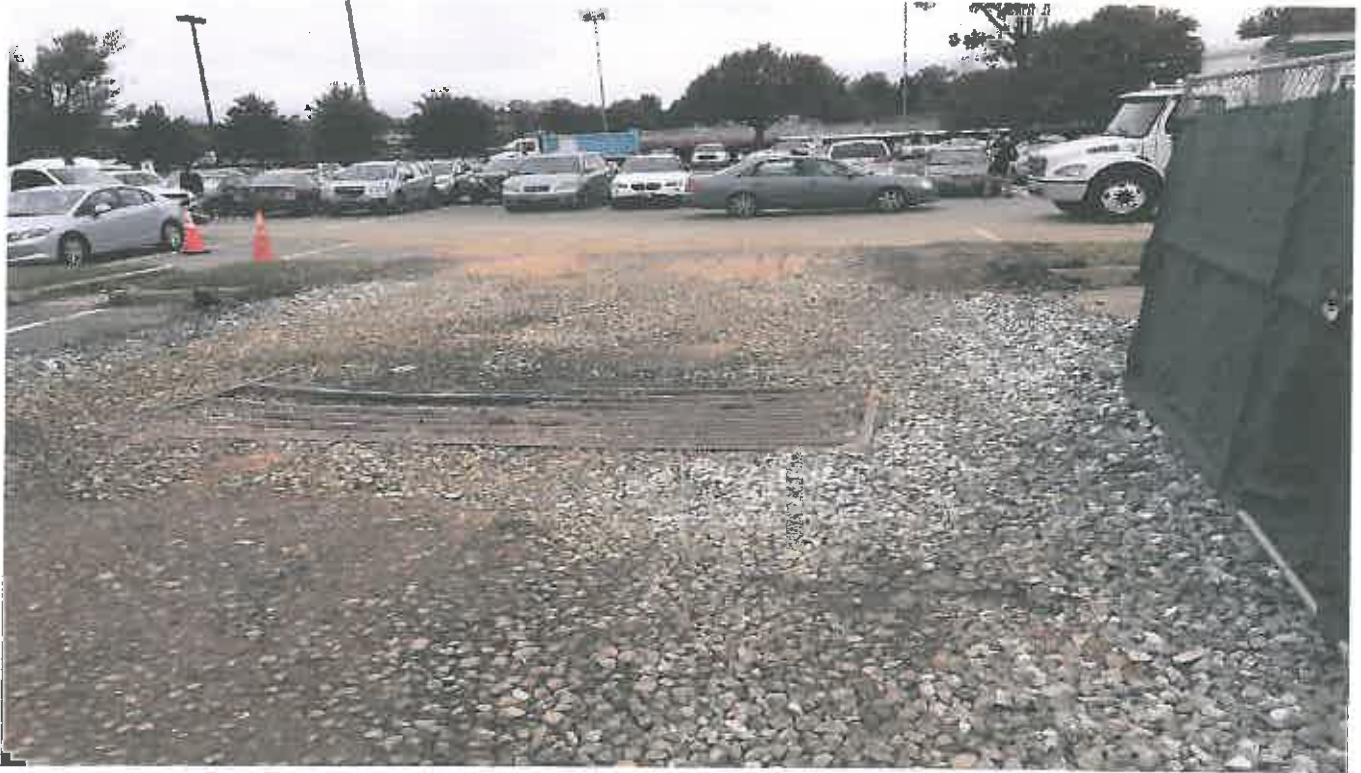
Photo 7. Sediment laden Stabilized Construction Entrance 2 Exit to the Car Park

Visual observation and photos shows sediment laden stabilize construction entrances uphill at the site. I recommend contractor rough grade the entrances and add more aggregate stones as need be.

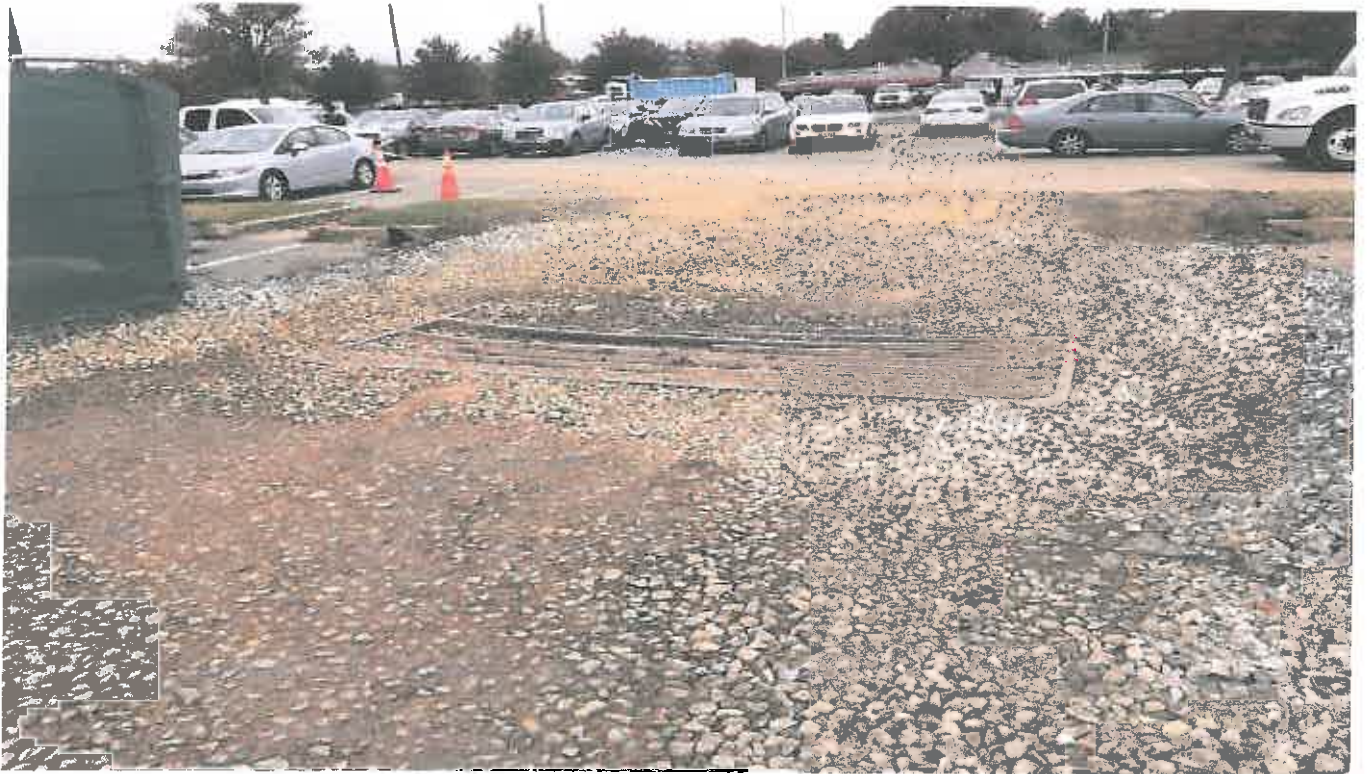
Photo 8. Sediment laden Stabilized Construction Entrance 2 Exit to the Car Park

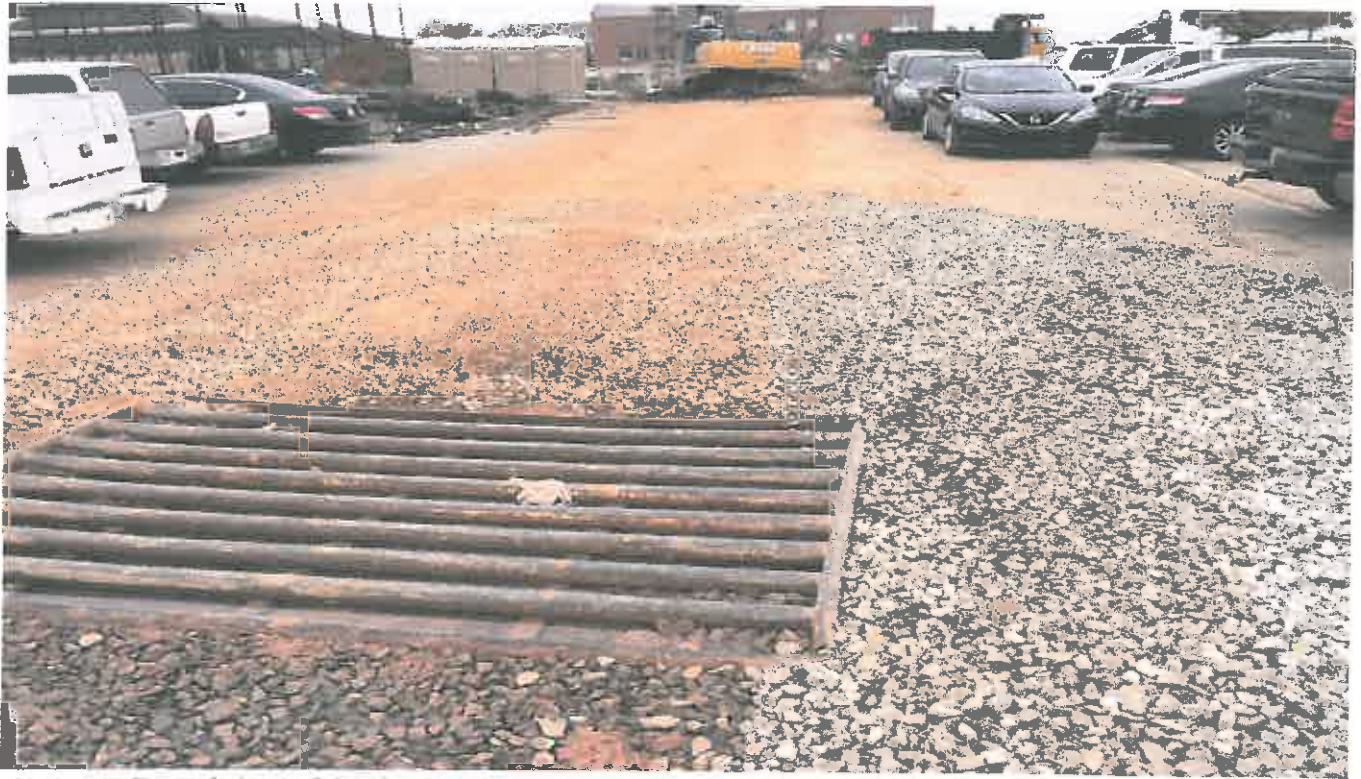
Photo 5. Sediment laden Stabilized Construction Entrance 1 Uphill towards Cole Fieldhouse Drive

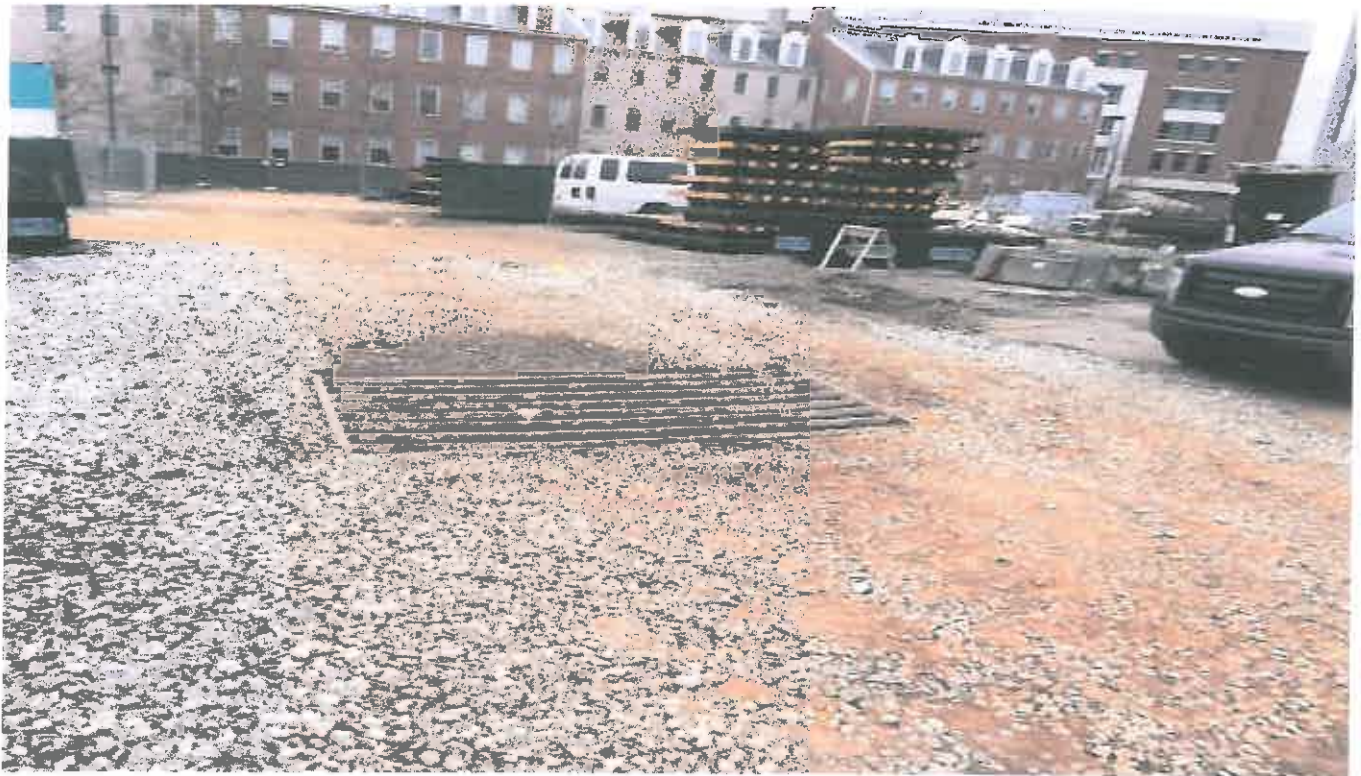
Photo 6. Sediment laden Stabilized Construction Entrance 1 Uphill towards Cole Fieldhouse Drive

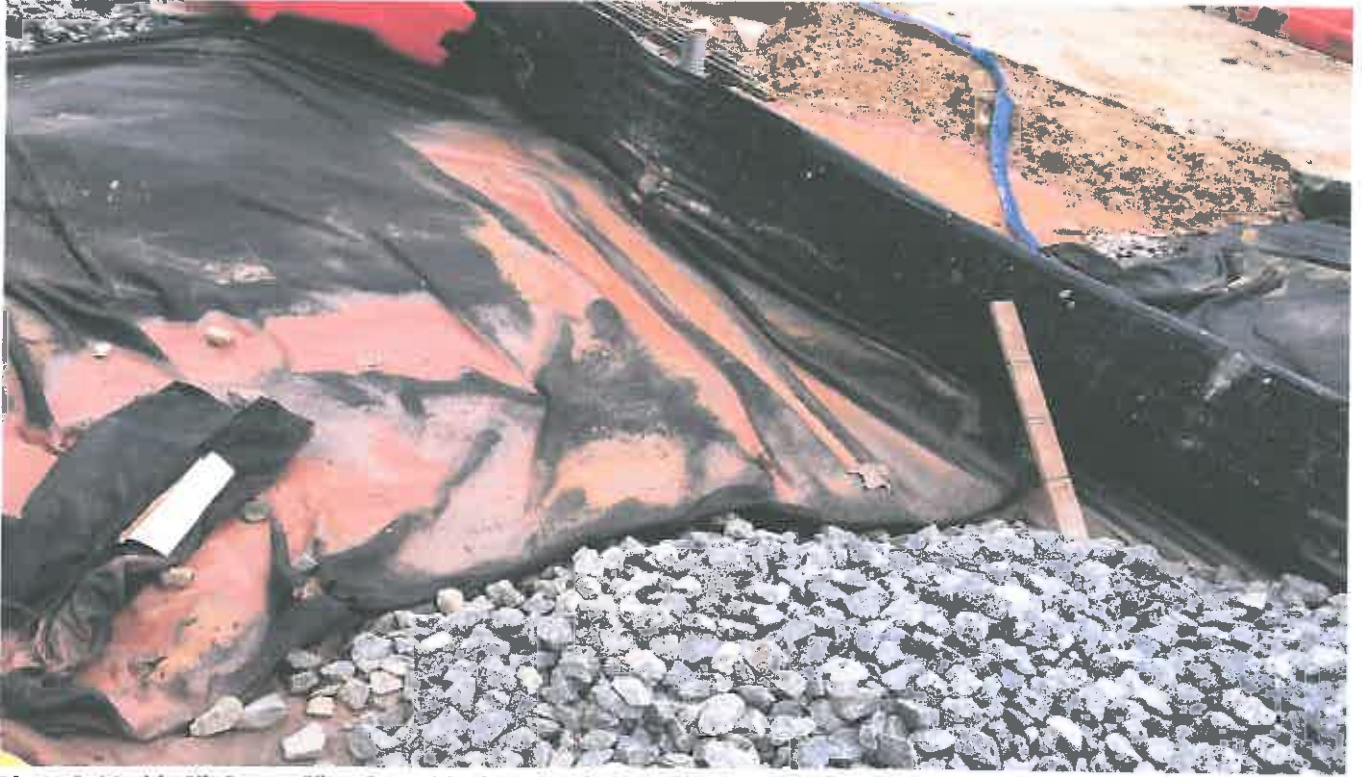
Although no discharge during this inspection, visual observation and photos shows sediment laden filter bag with close proximity to active stormdrain and in position to discharge sediment in the State waters in the event of rainfall. I recommend replacing the filter bag per our conversation today.

Photo 3. Muddy Silt Bag or Filter Bag with Close Proximity to the Stormdrain

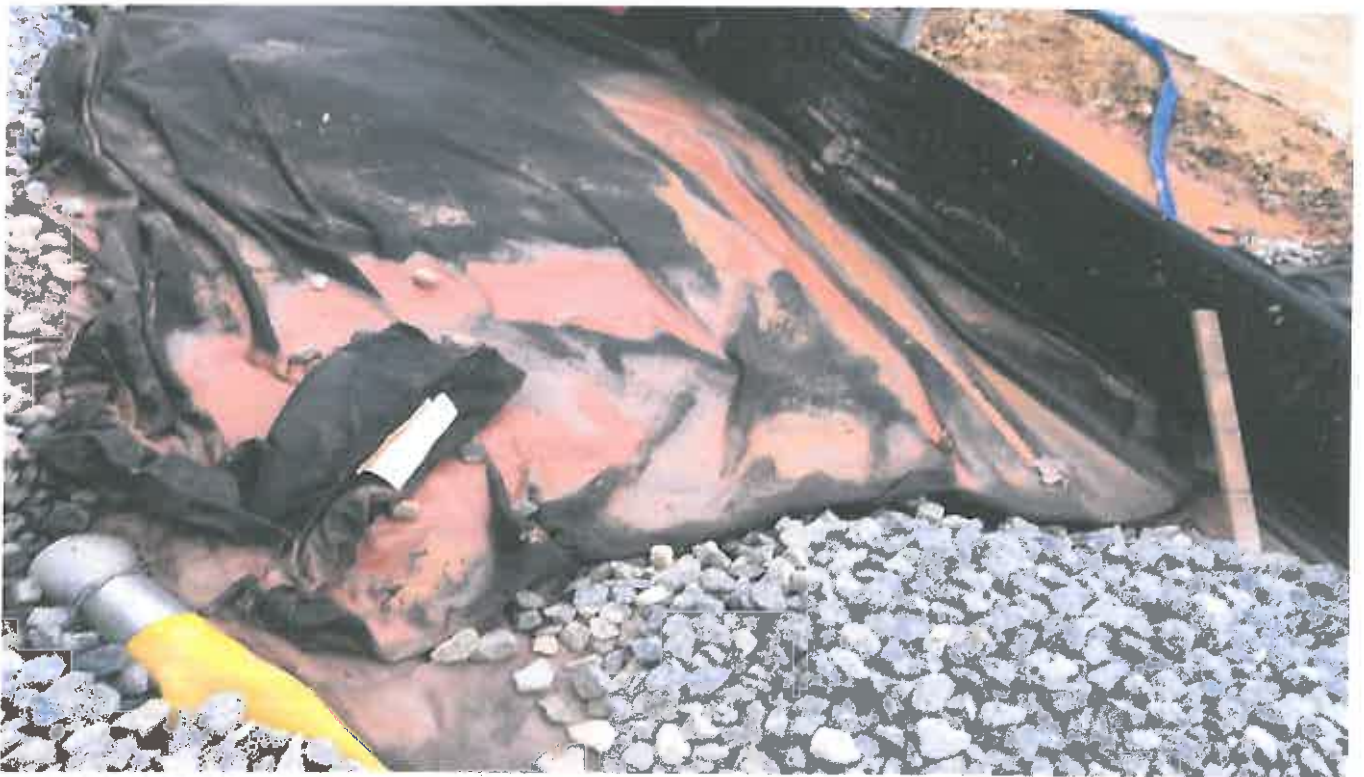
Photo 4. Muddy Silt Bag or Filter Bag with Close Proximity to the Stormdrain

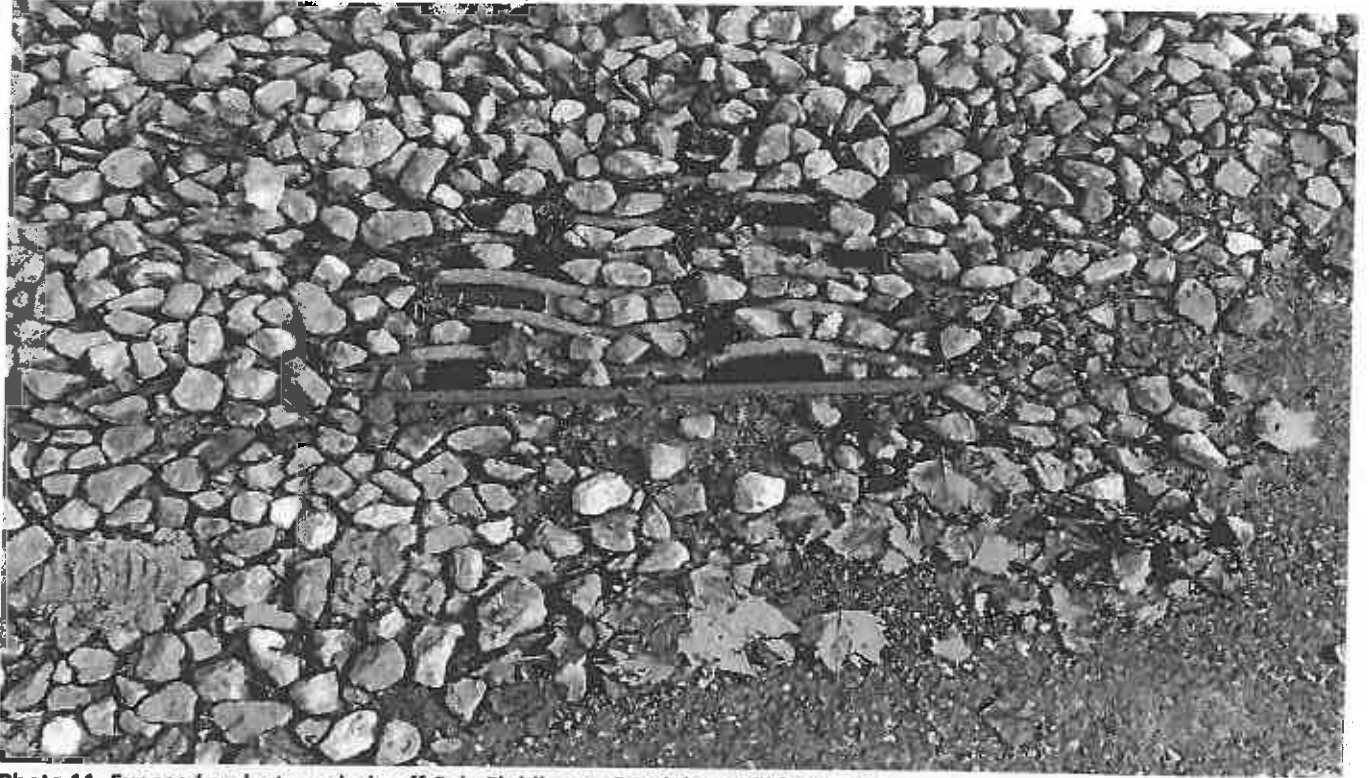
Photo 11. Exposed curb stormdrain off Cole Fieldhouse Road downhill from site

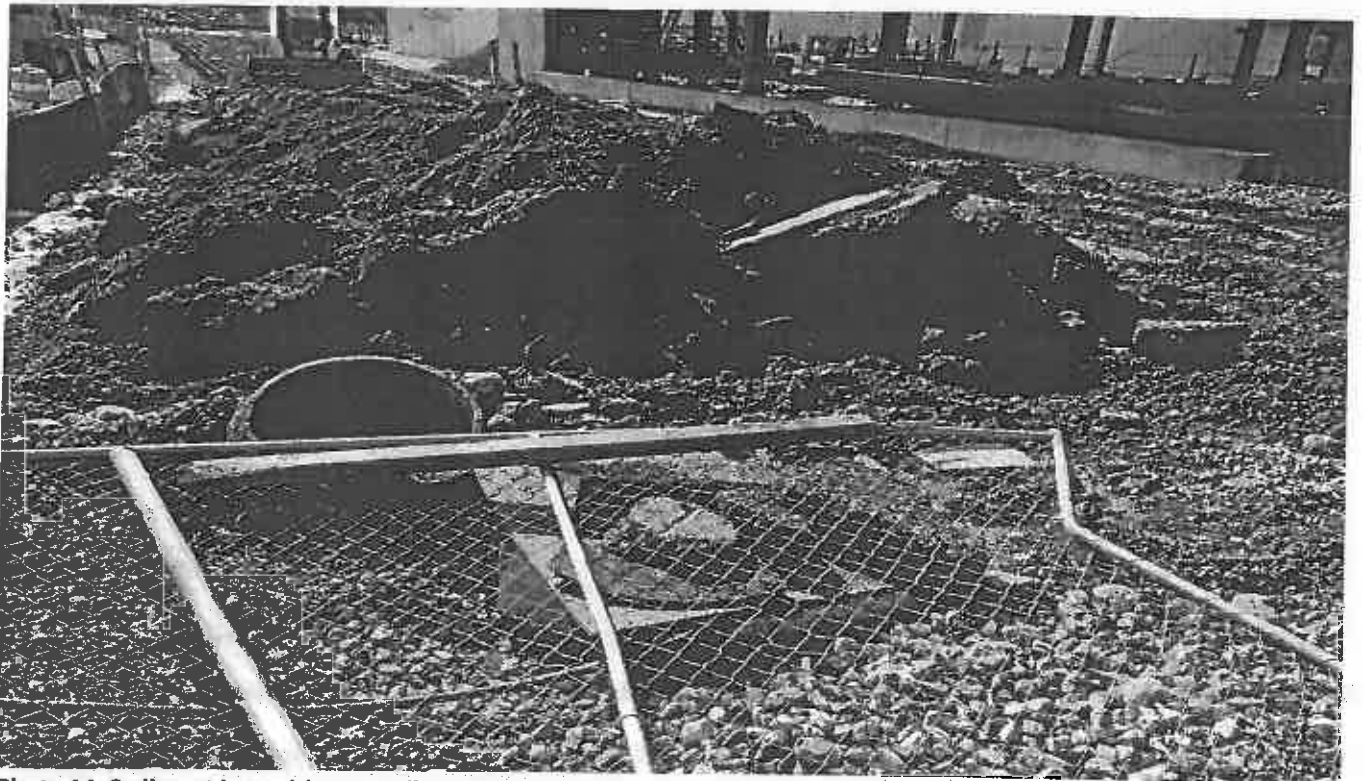
Photo 14. Sediment in position to pollute stormdrain.
