Maryland Department of Environment
Water and Science Administration
Compliance Program - Western Division
91 Eastern Blvd, Hagerstown, MD 21740
301-665-2850

Site Name: New Cole Fieldhouse
Facility Address: 4090 Union Dr, College Park, MD 20742
County: Prince George's County

Inspection Date: November 5, 2018 **Start Date/Time:** November 5, 2018, 09:00 AM
End Date/Time: November 5, 2018, 10:00 AM

Media Type(s): NPDES Construction Activity, State/federal SWM

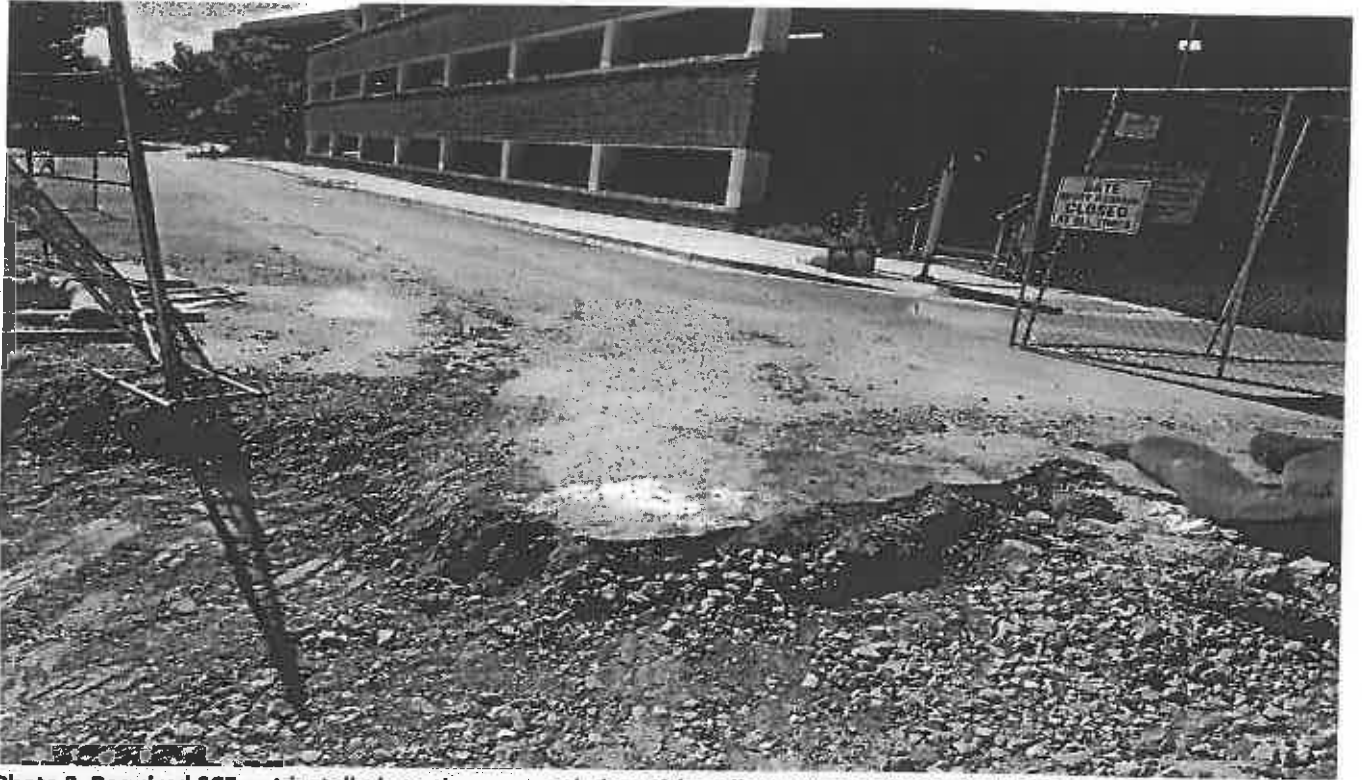
Photo 3. Required SCE not installed per the approved plan with sediment track off the site NE of the side.

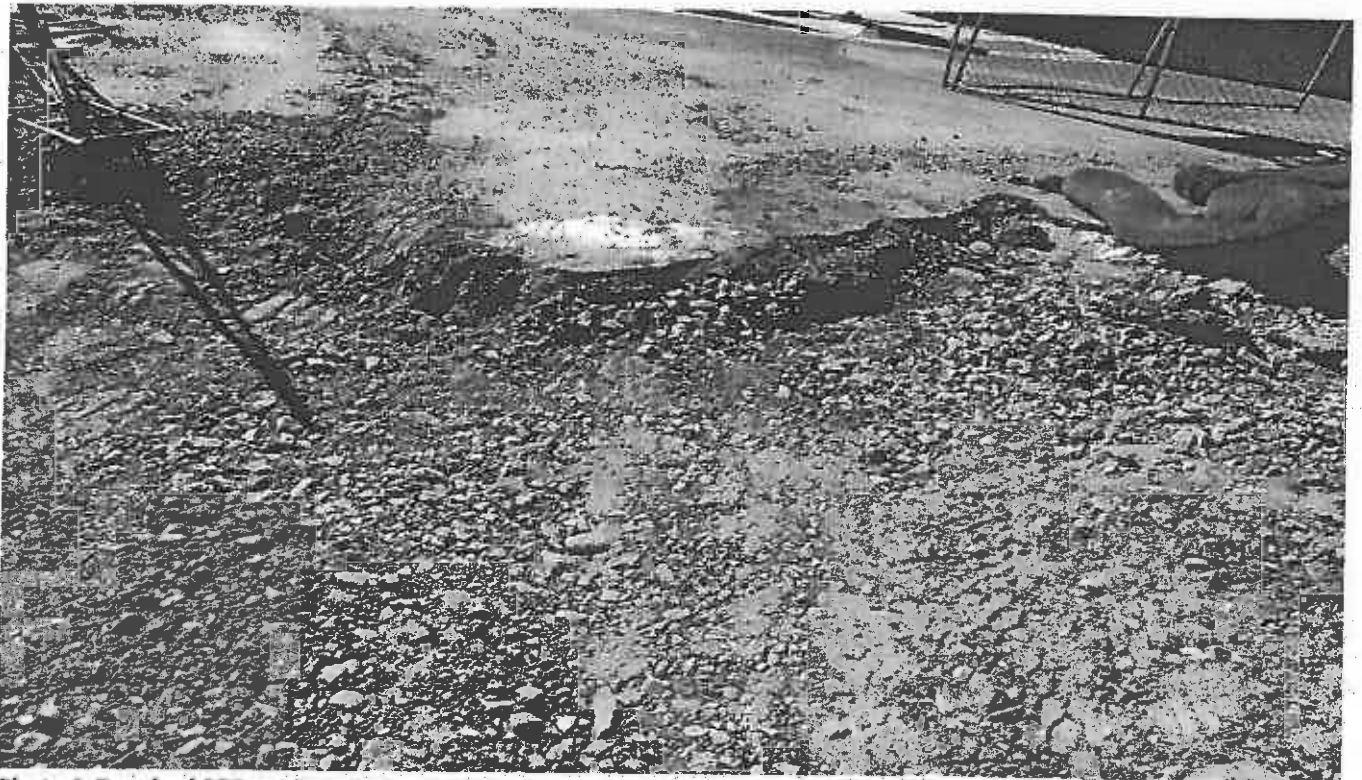
Photo 4. Required SCE not installed per the approved plan with sediment track off the site NE of the side.

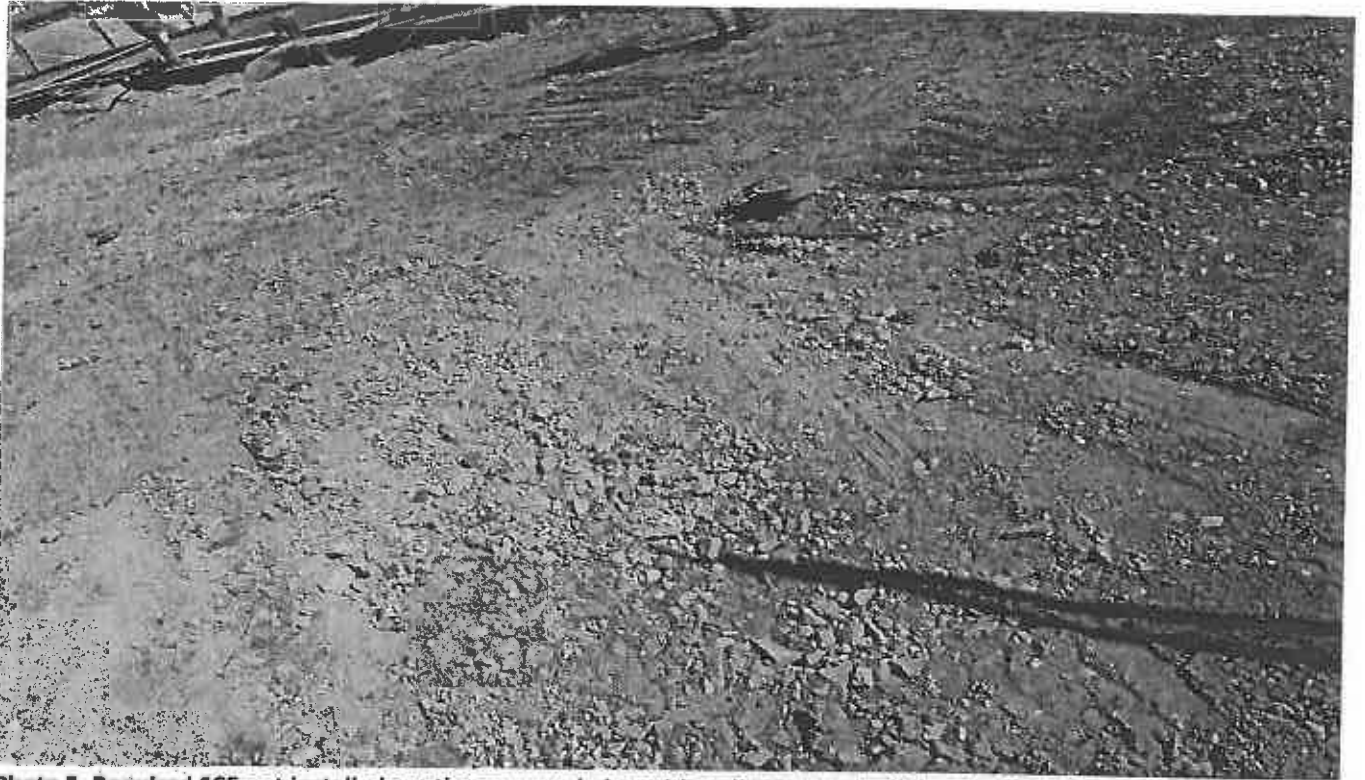
Photo 5. Required SCE not installed per the approved plan with sediment track off the site NE of the side.

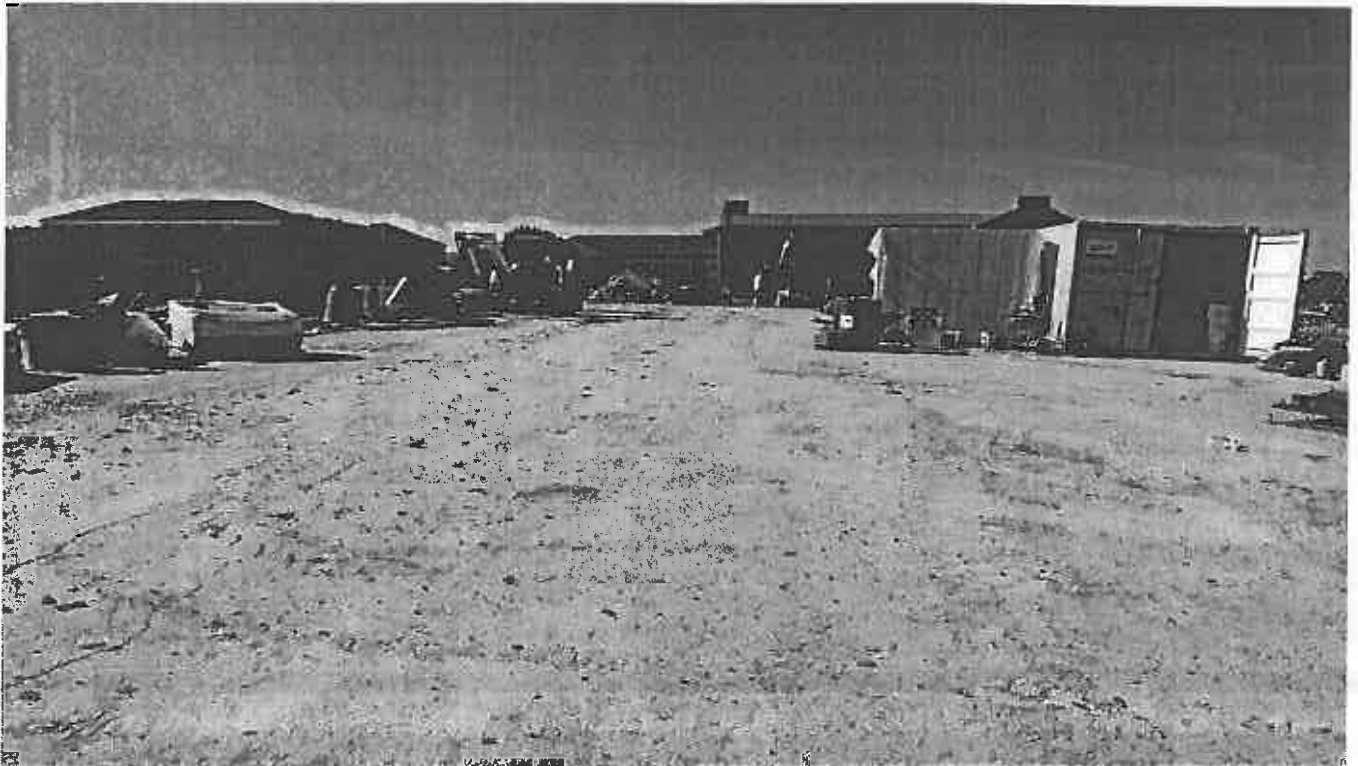
Photo 12. Sediment Track on Paved Road

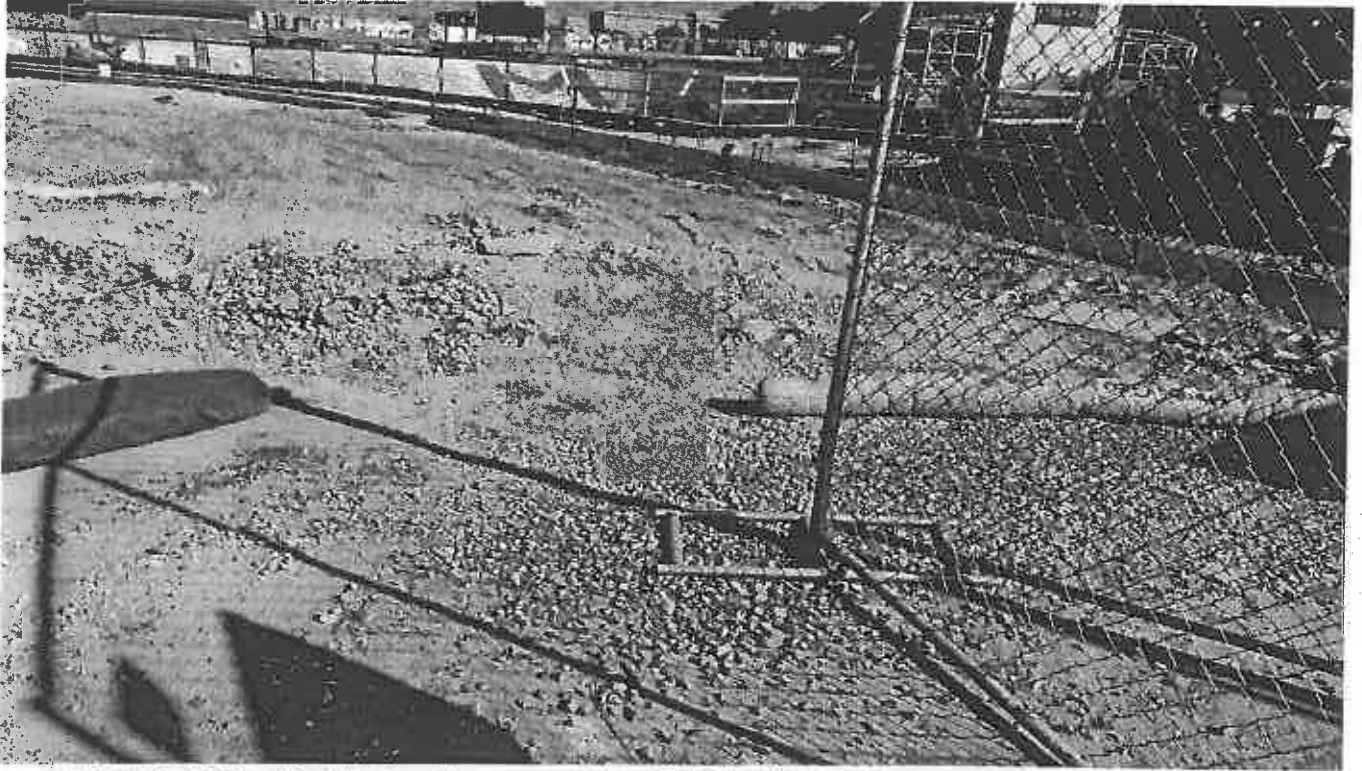
Photo 1. Required SCE not installed per the approved plan NE of the site.

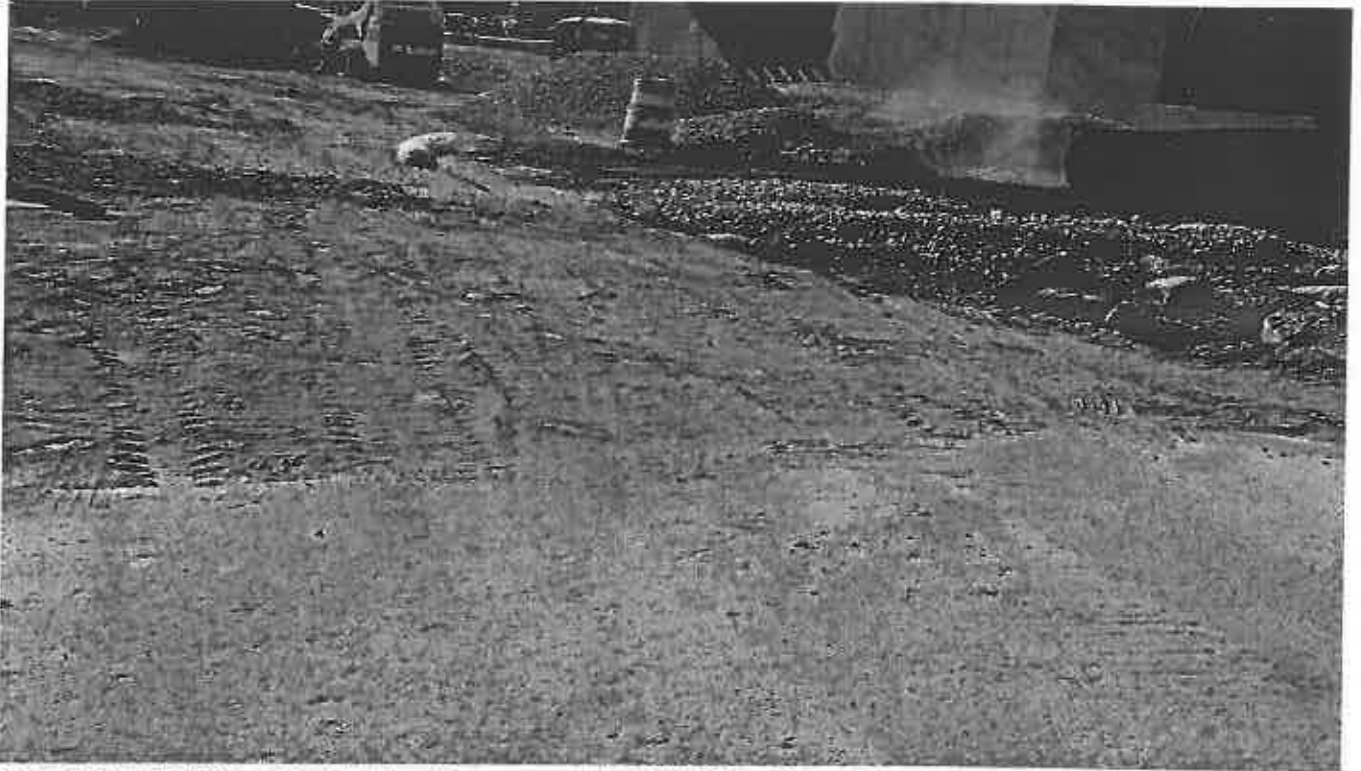
Photo 5. Required SCE not installed per the approved plan NW of the site.

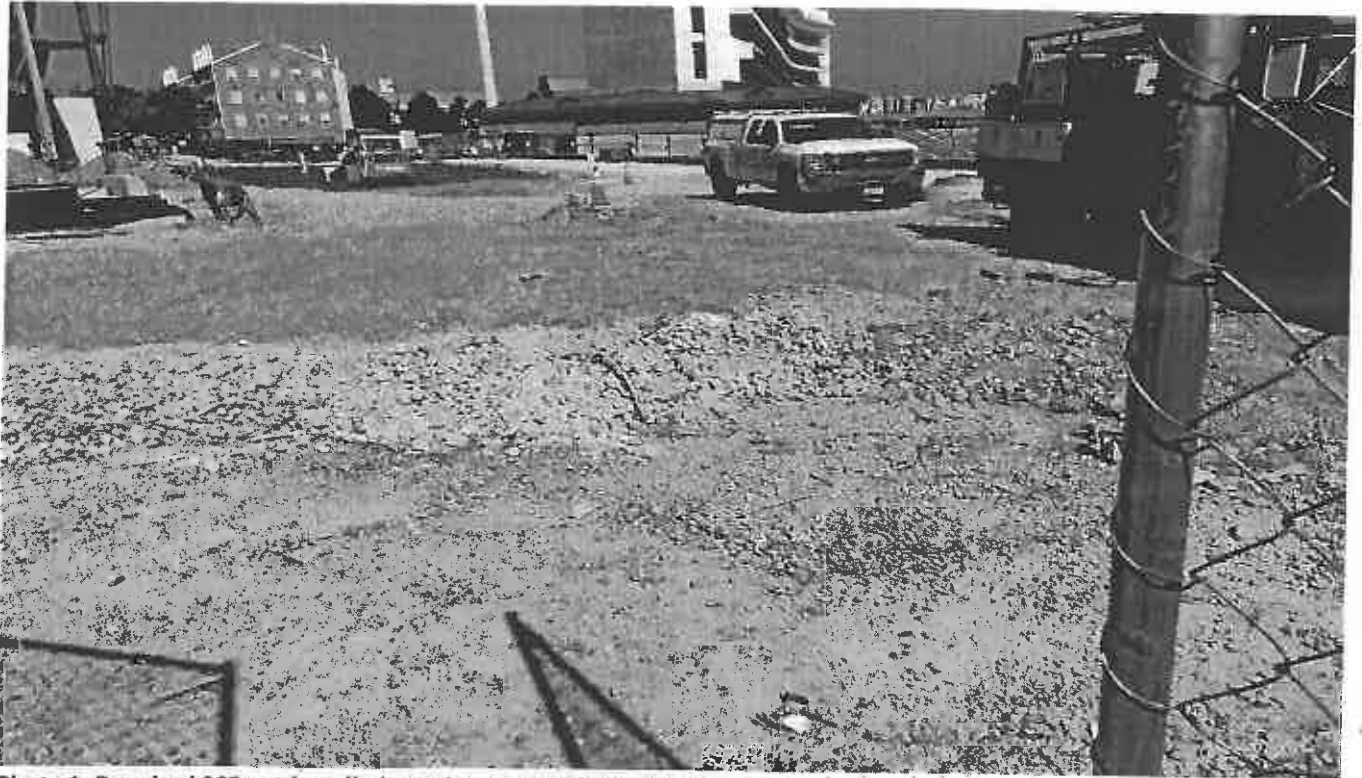
Photo 1. Required SCE not installed per the approved plan NE of the site.

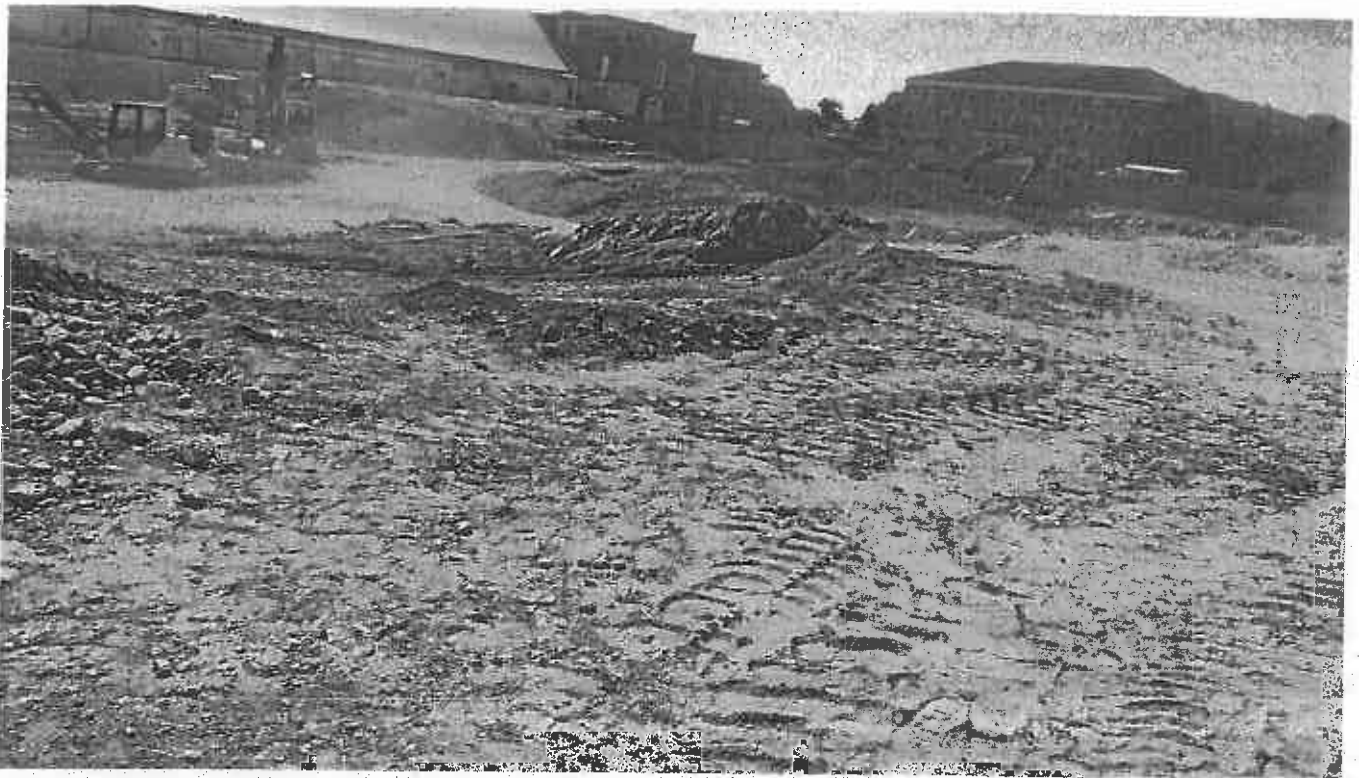
Photo 2. Stabilize Construction Entrance without aggregate stones tracking mud on paved road SW site of site

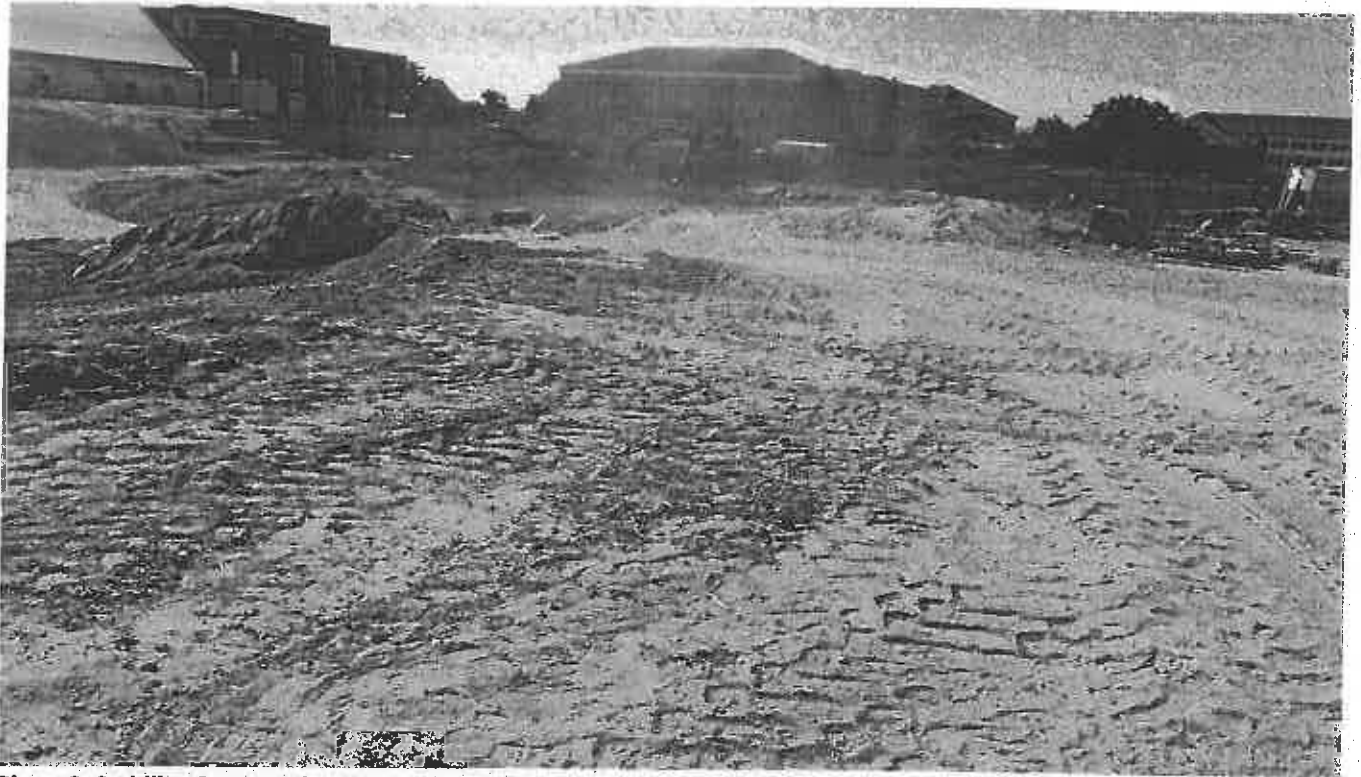
Photo 3. Stabilize Construction Entrance without aggregate stones tracking mud on paved road SW site of site

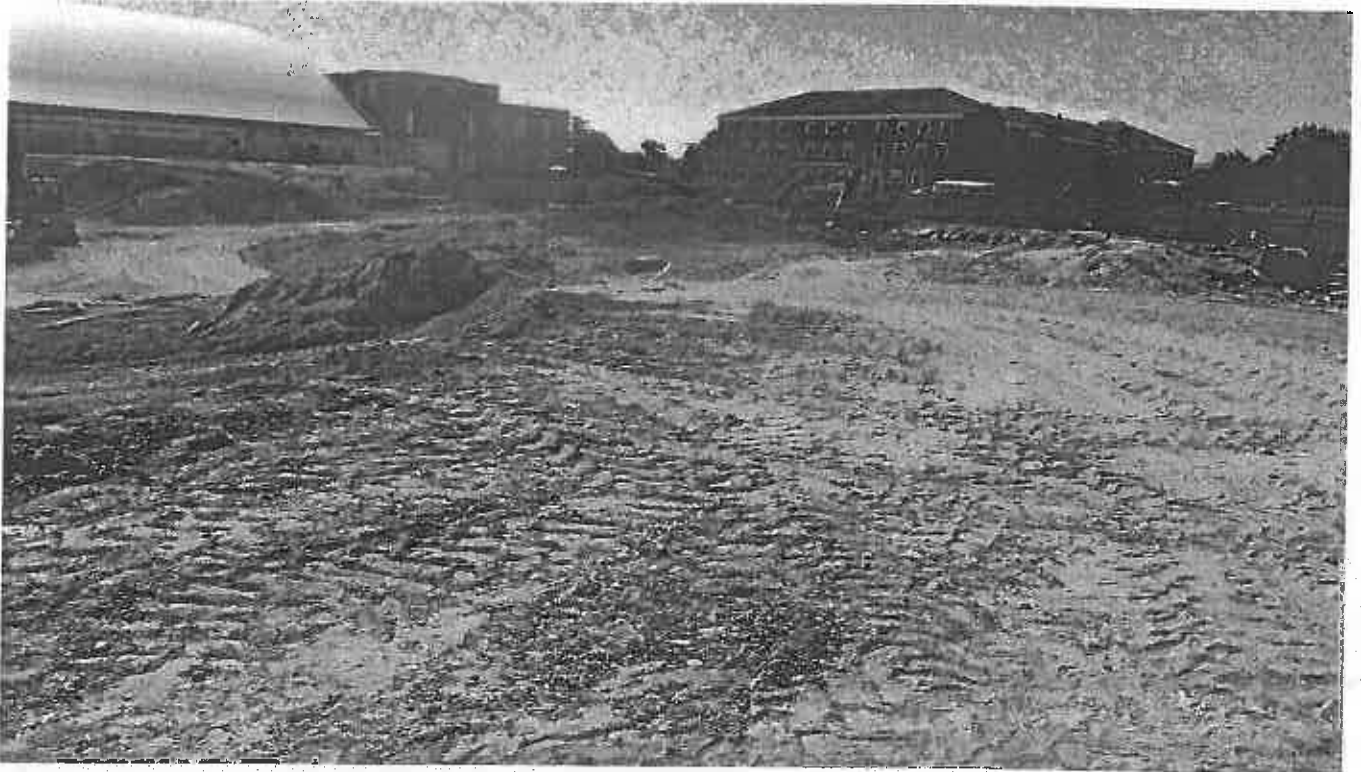
Photo 4. Stabilize Construction Entrance without aggregate stones tracking mud on paved road SW site of site

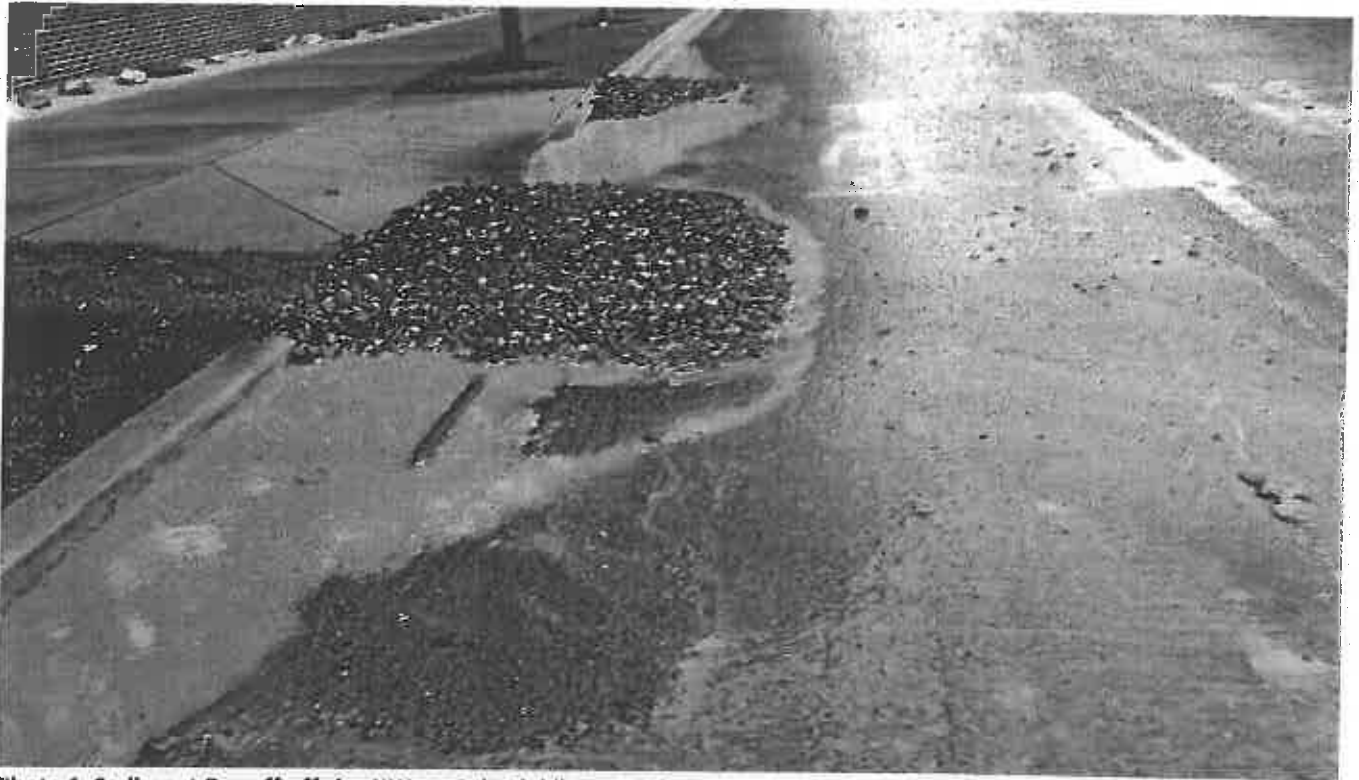
Photo 1. Sediment Runoff off site NW on Cole Fieldhouse Drive.

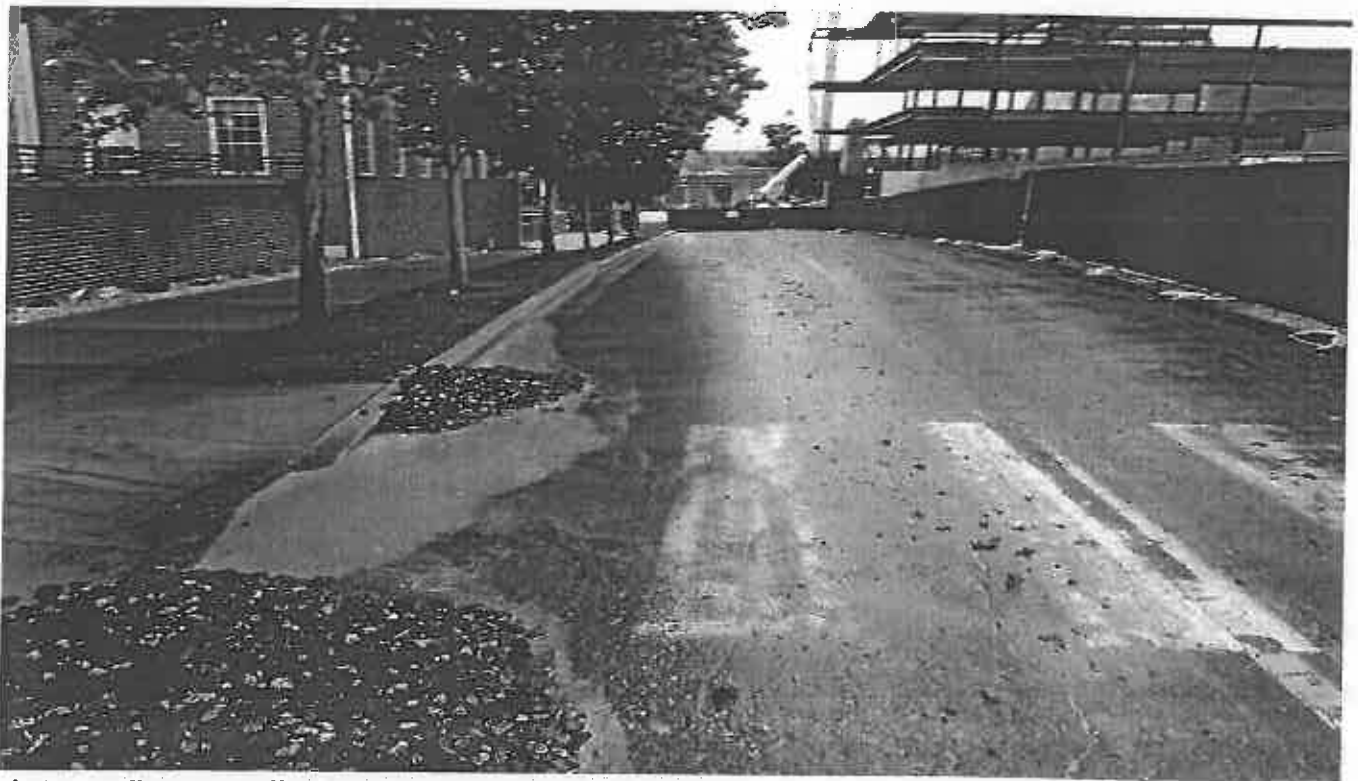
Photo 2. Sediment Runoff off site NW on Cole Fieldhouse Drive.

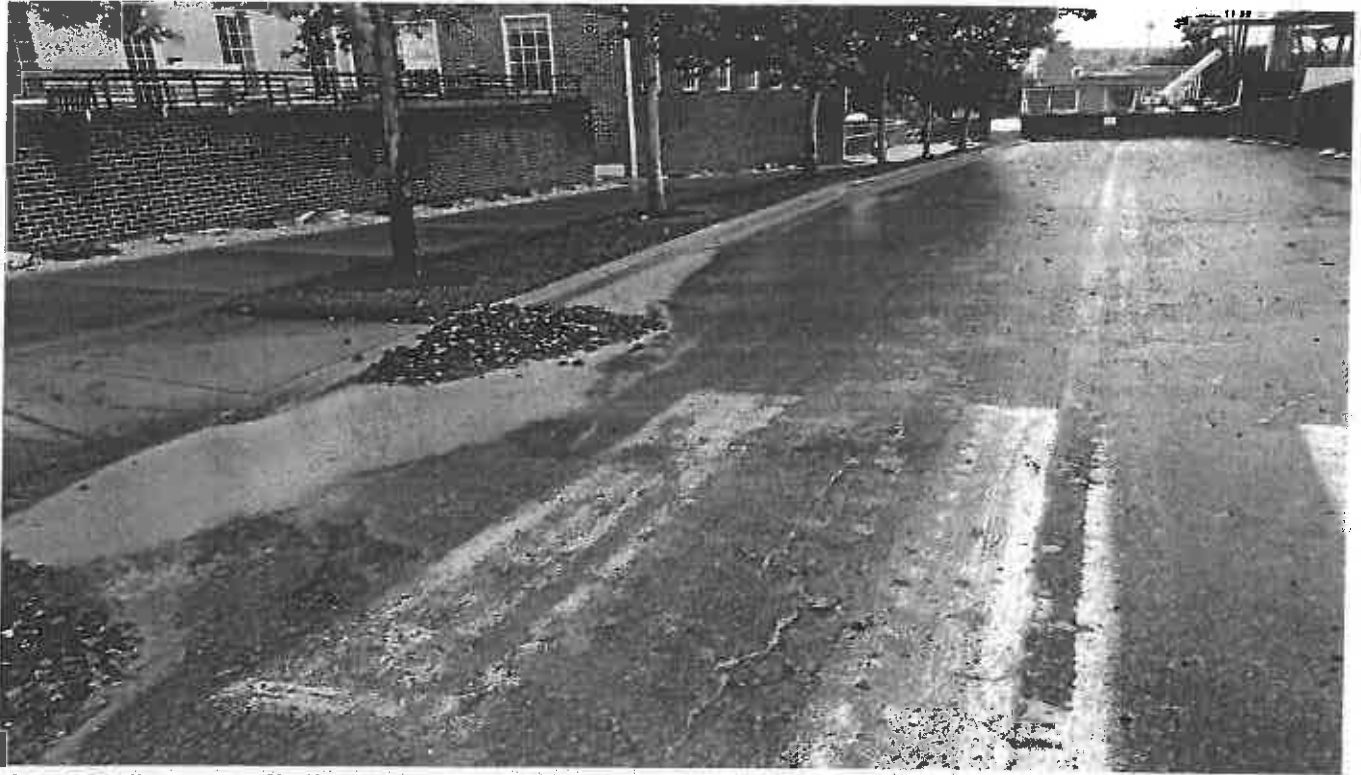
Photo 3. Sediment Runoff off site NW on Cole Fieldhouse Drive.

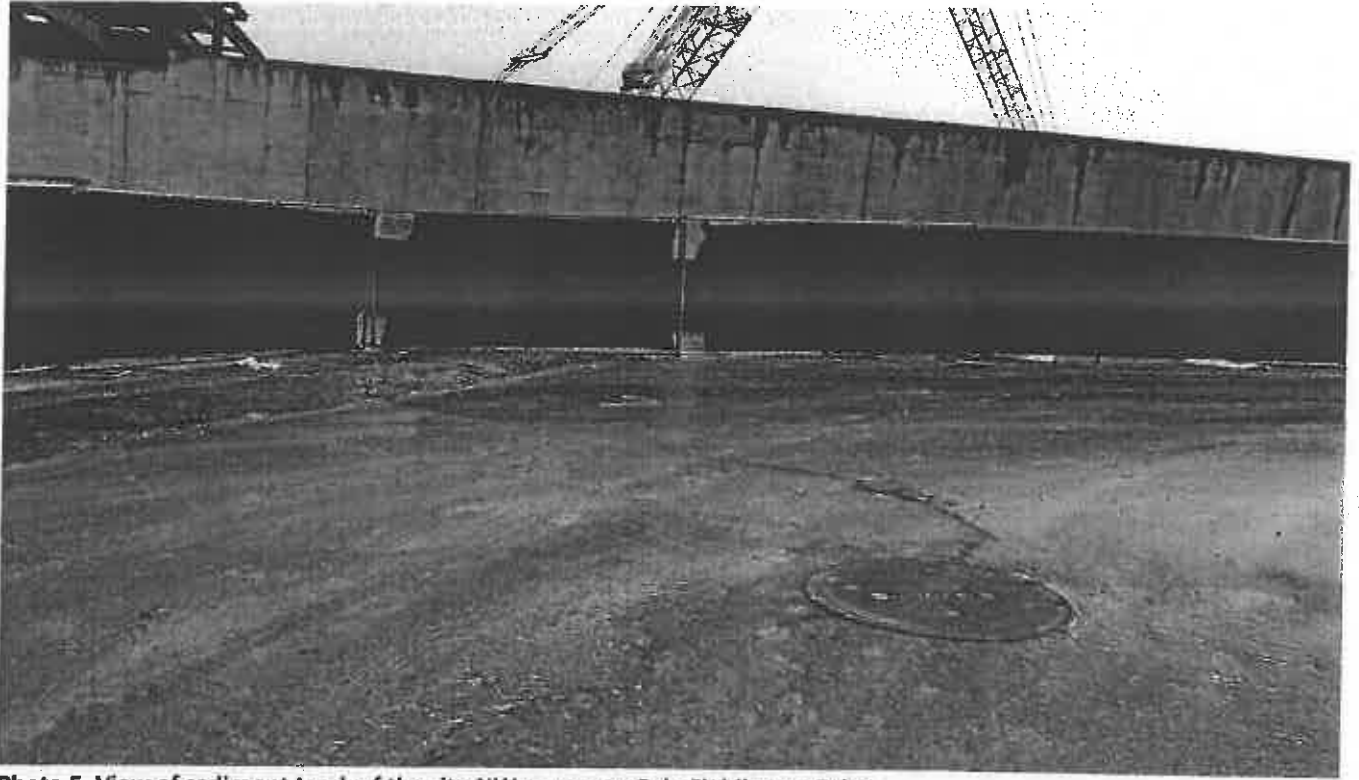
Photo 5. View of sediment track of the site NW corner on Cole Fieldhouse Drive.

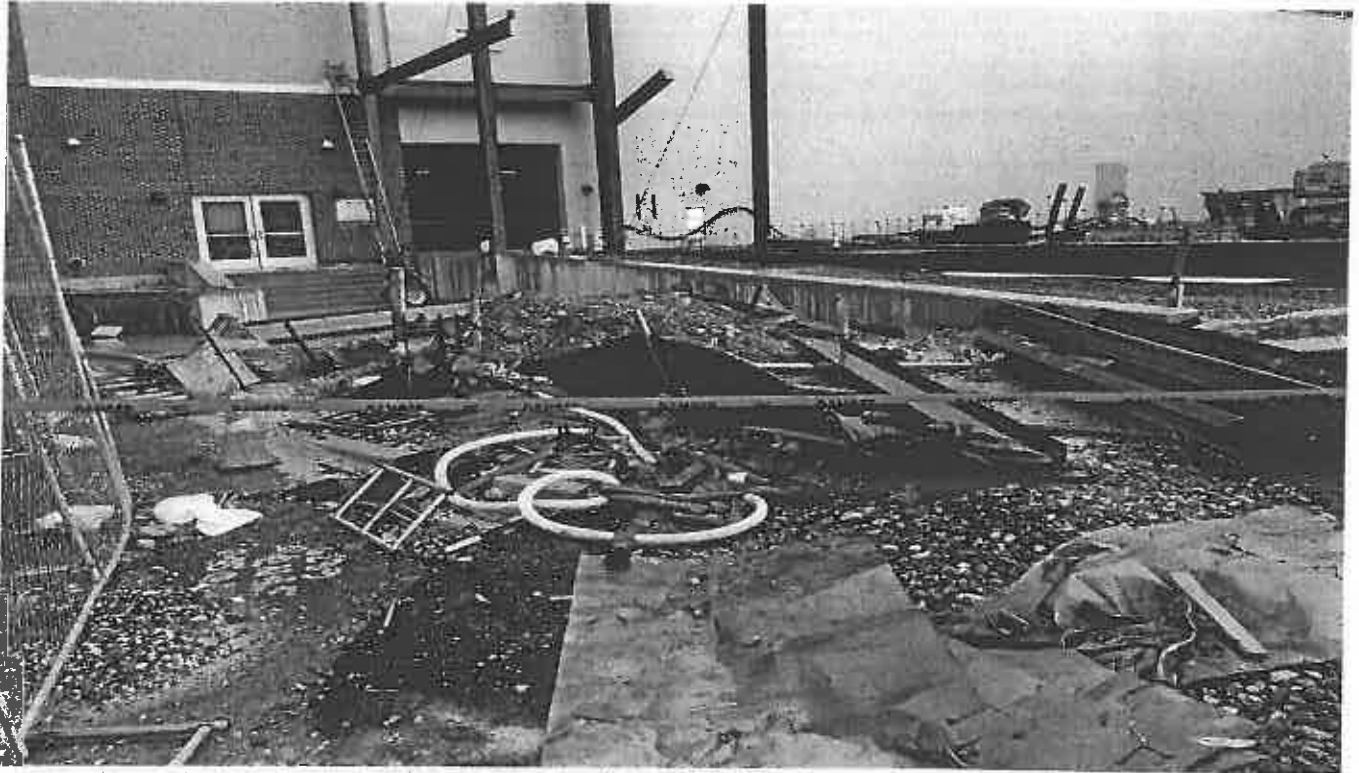
Photo 7. Super Silt Fence overwhelmed with pile of sediment NE of the site

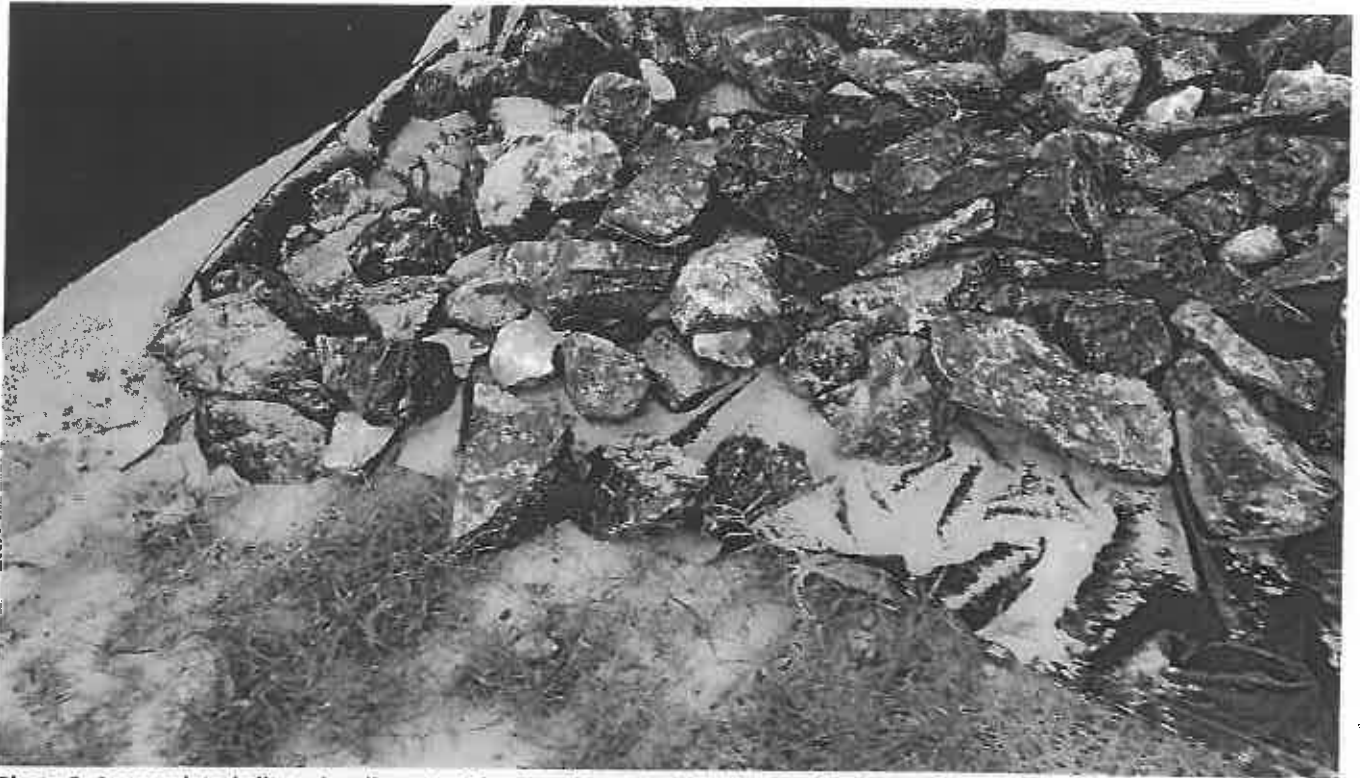
Photo 9. Accumulated silt and sediment at the E and S control footings at the Slope of the Tunnel Project

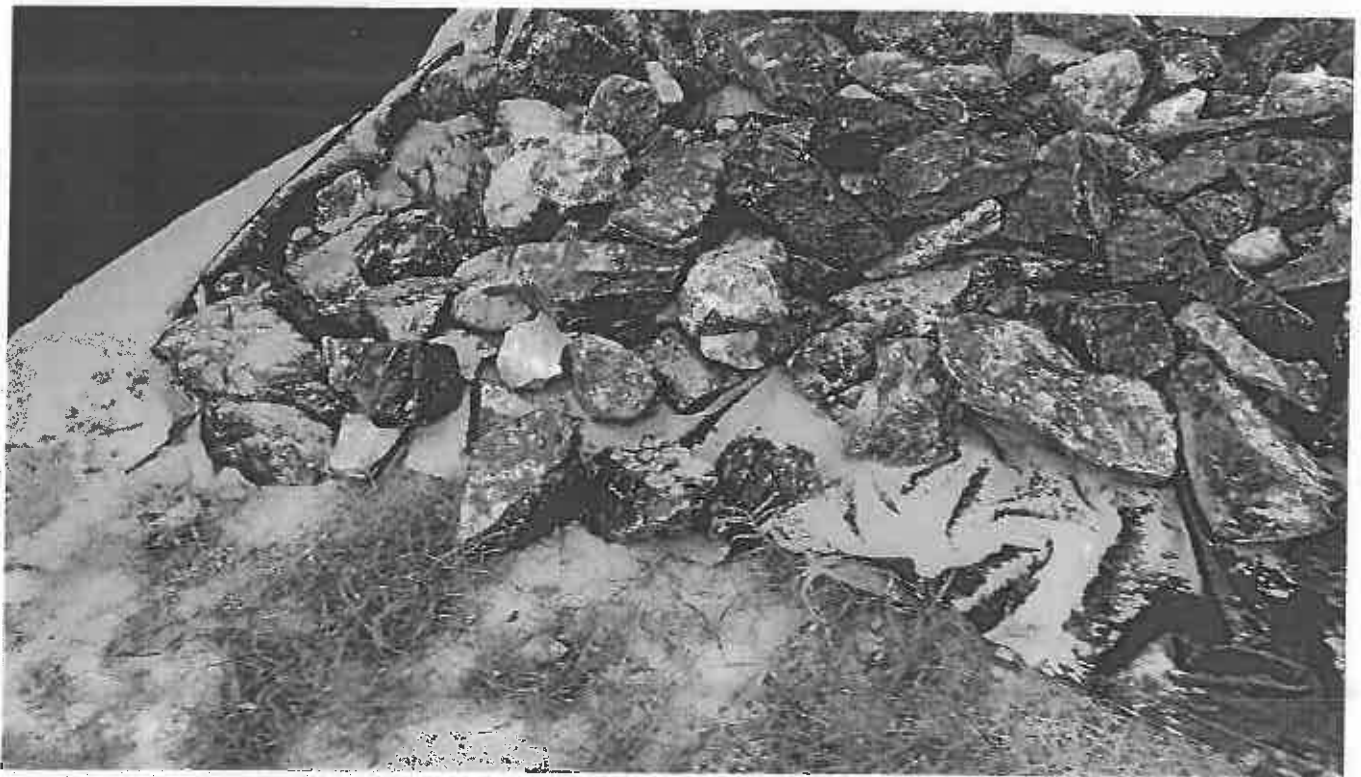
Photo 10. Accumulated silt and sediment at the E and S control footings at the Slope of the Tunnel Project

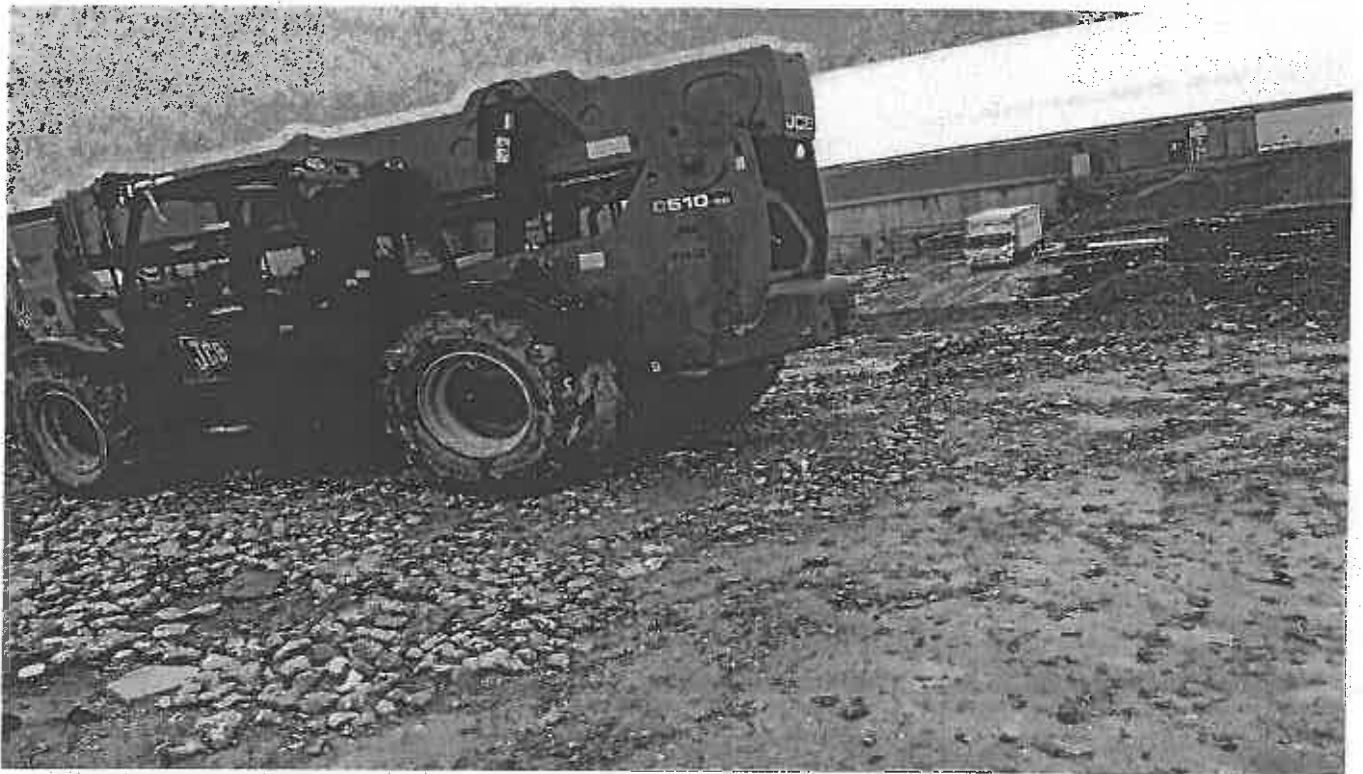
Photo 12. Stabilized Construction Entrance with little or no stones despite ongoing rain event.

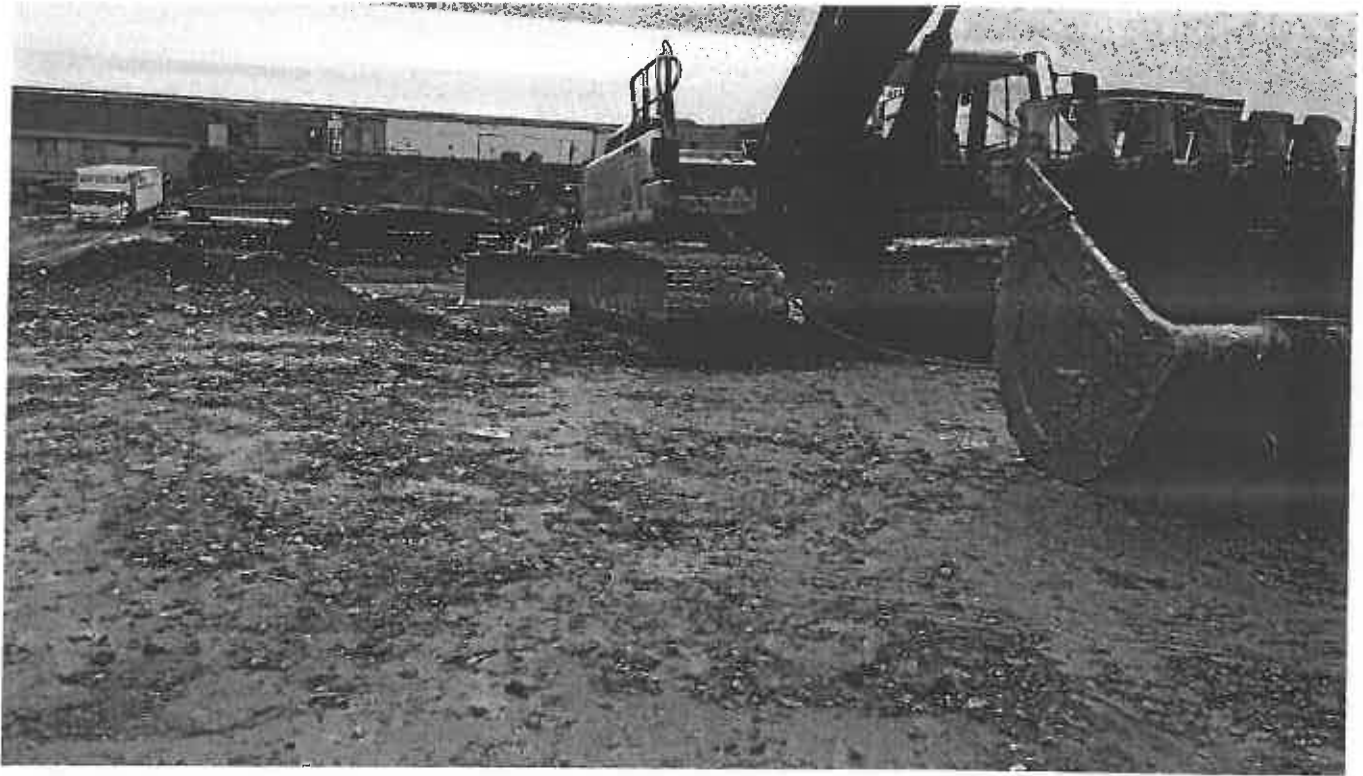
Photo 14. Stabilized Construction Entrance with little or no stones despite ongoing rain event.

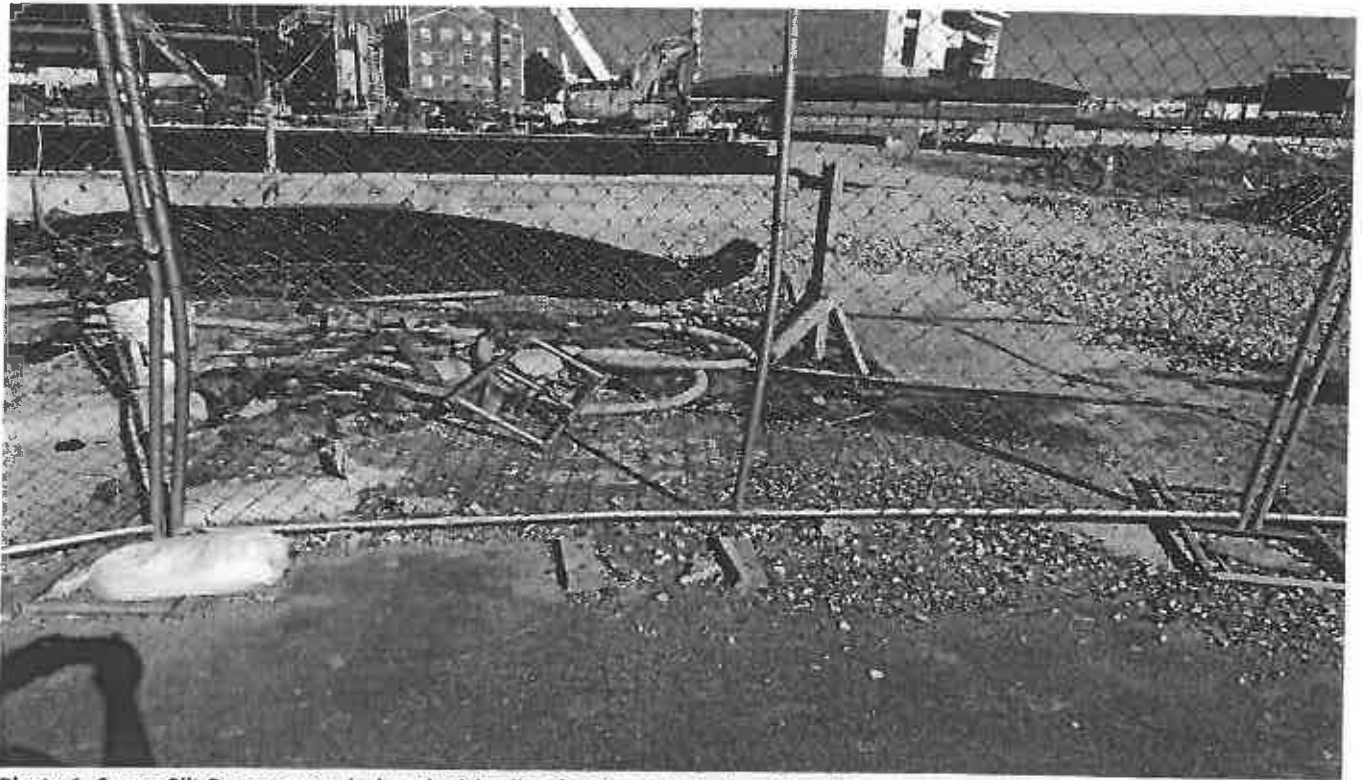
Photo 1. Super Silt Fence overwhelmed with pile of sediment North of the site

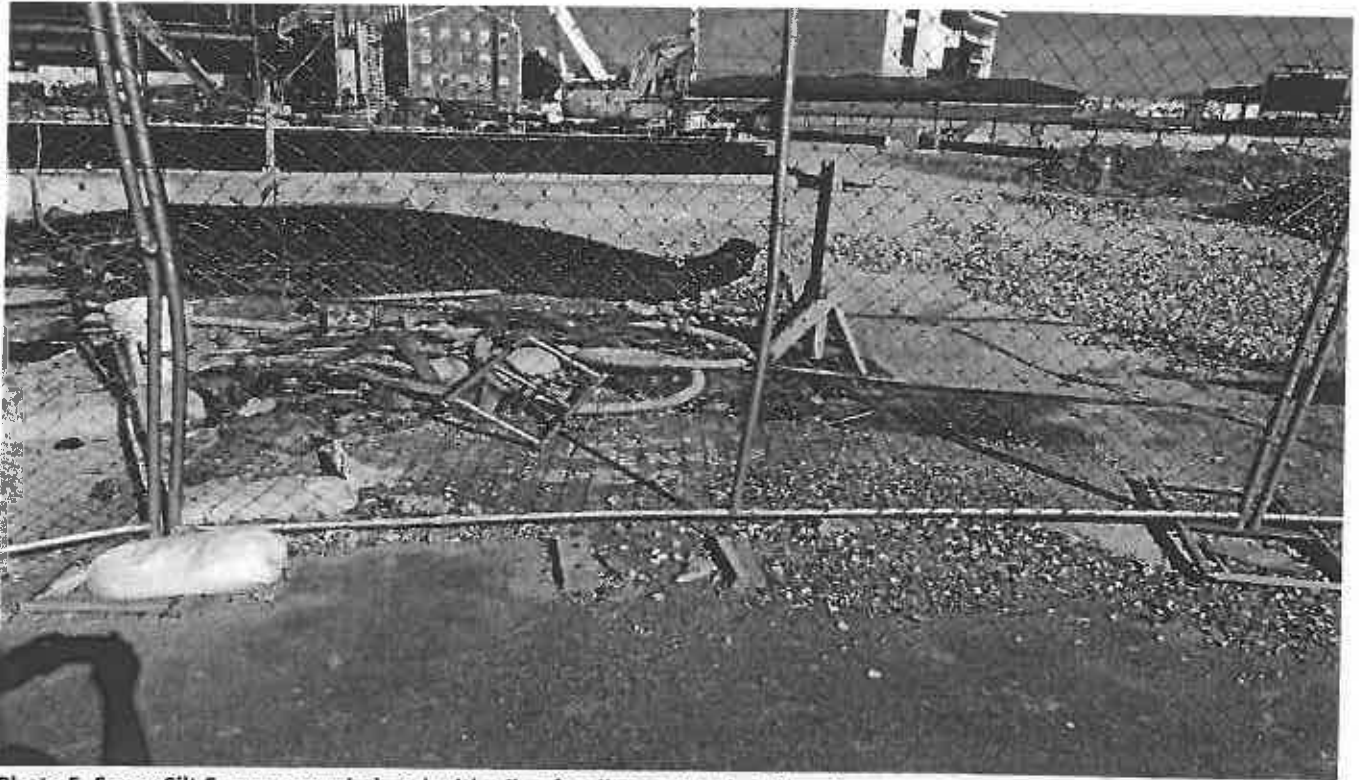
Photo 5. Super Silt Fence overwhelmed with pile of sediment North of the site
