Maryland Department of Environment
Water and Science Administration
Compliance Program - Western Division
91 Eastern Blvd, Hagerstown, MD 21740
301-665-2850

Site Name: New Cole Fieldhouse
Facility Address: 4090 Union Dr, College Park, MD 20742
County: Prince George's County

Inspection Date: November 5, 2018 **Start Date/Time:** November 5, 2018, 09:00 AM
End Date/Time: November 5, 2018, 10:00 AM

Media Type(s): NPDES Construction Activity, State/federal SWM

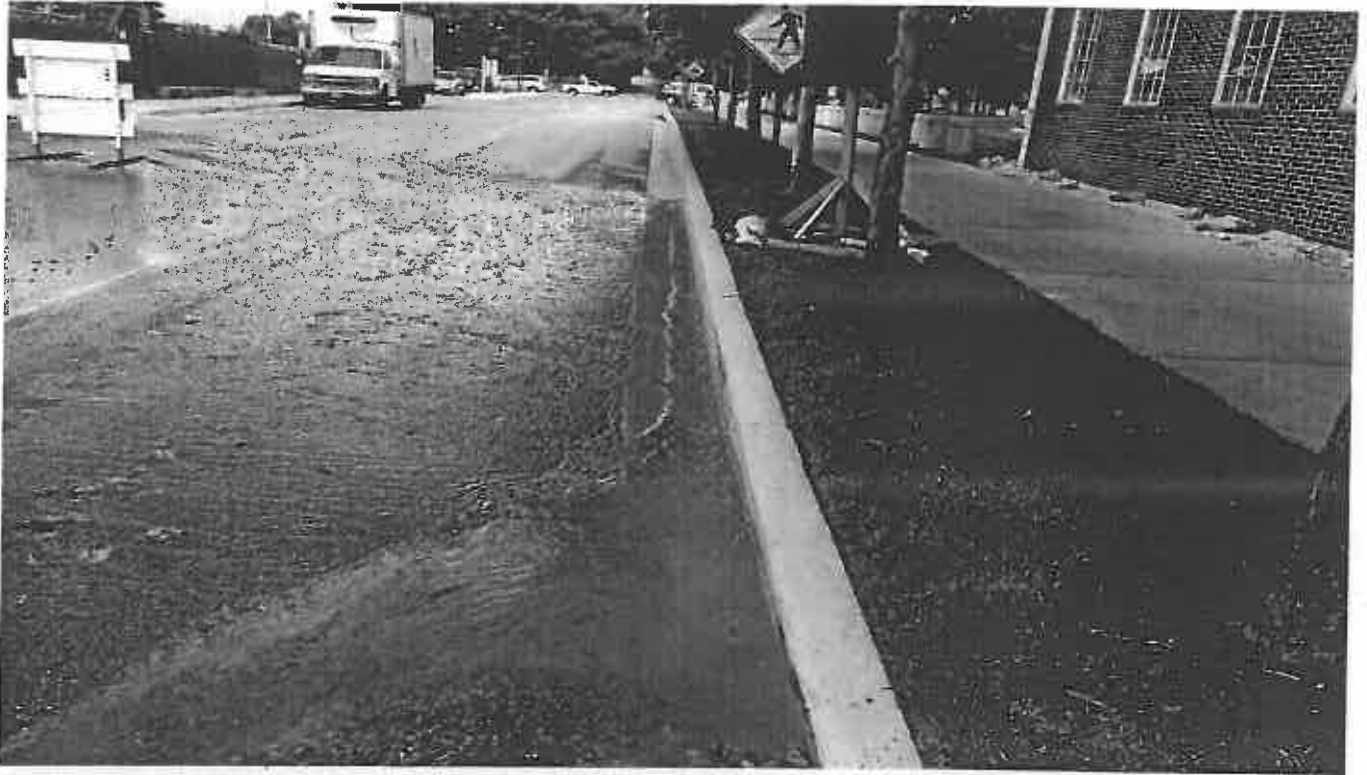
Photo 1. Ongoing pumping of Sediment laden stormwater into stormdrain on Cole Fieldhouse Drive NW off site

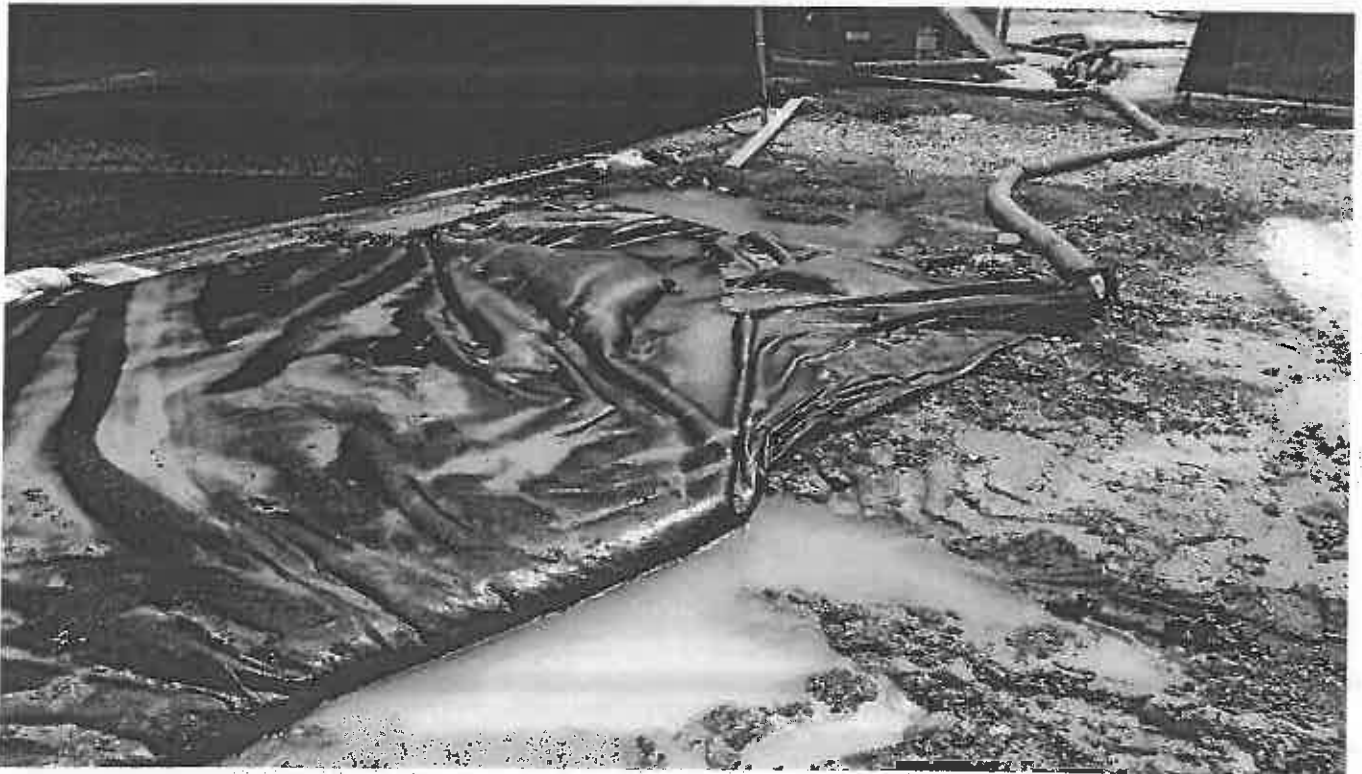
Photo 2. Sediment filter bag placed on exposed soil NW of the site near the sediment tank going into stormdrain

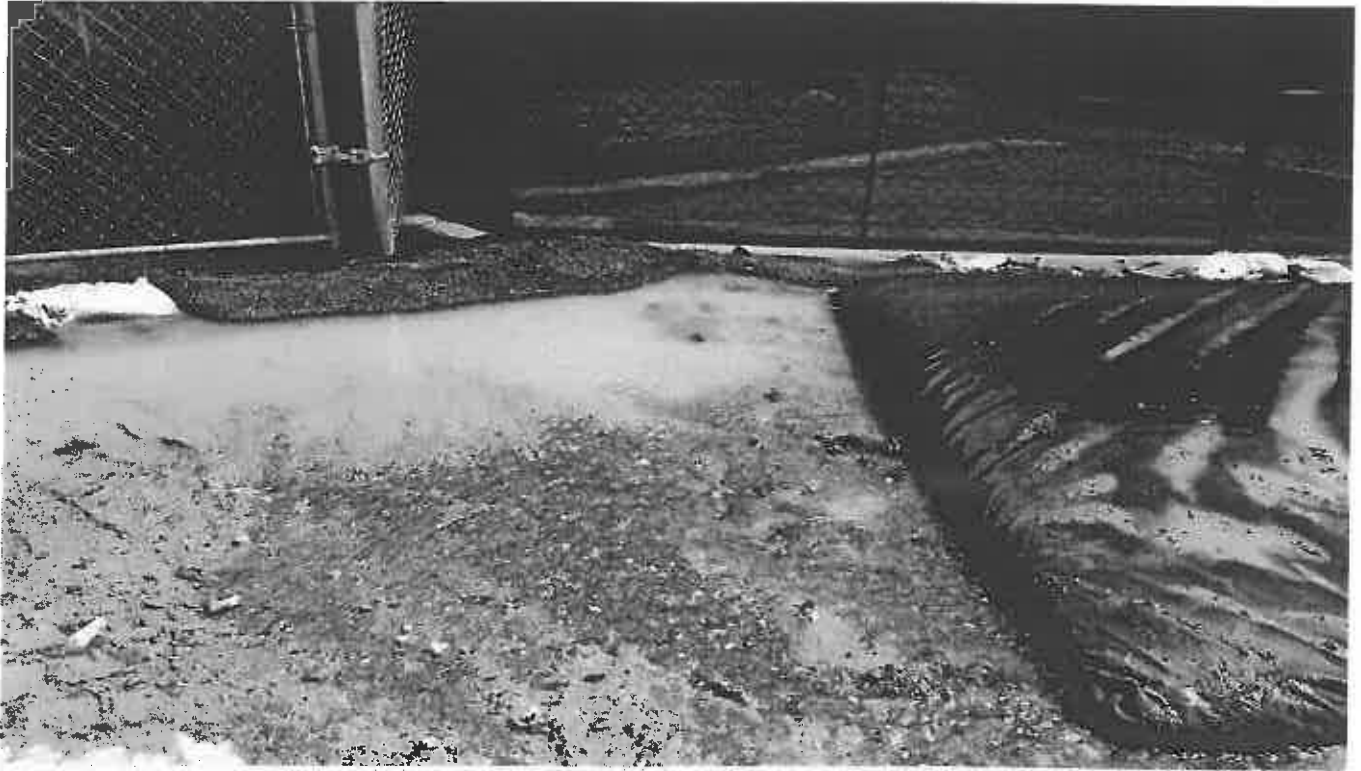
Photo 3. Sediment filter bag placed on exposed soil NW of the site near the sediment tank going into stormdrain

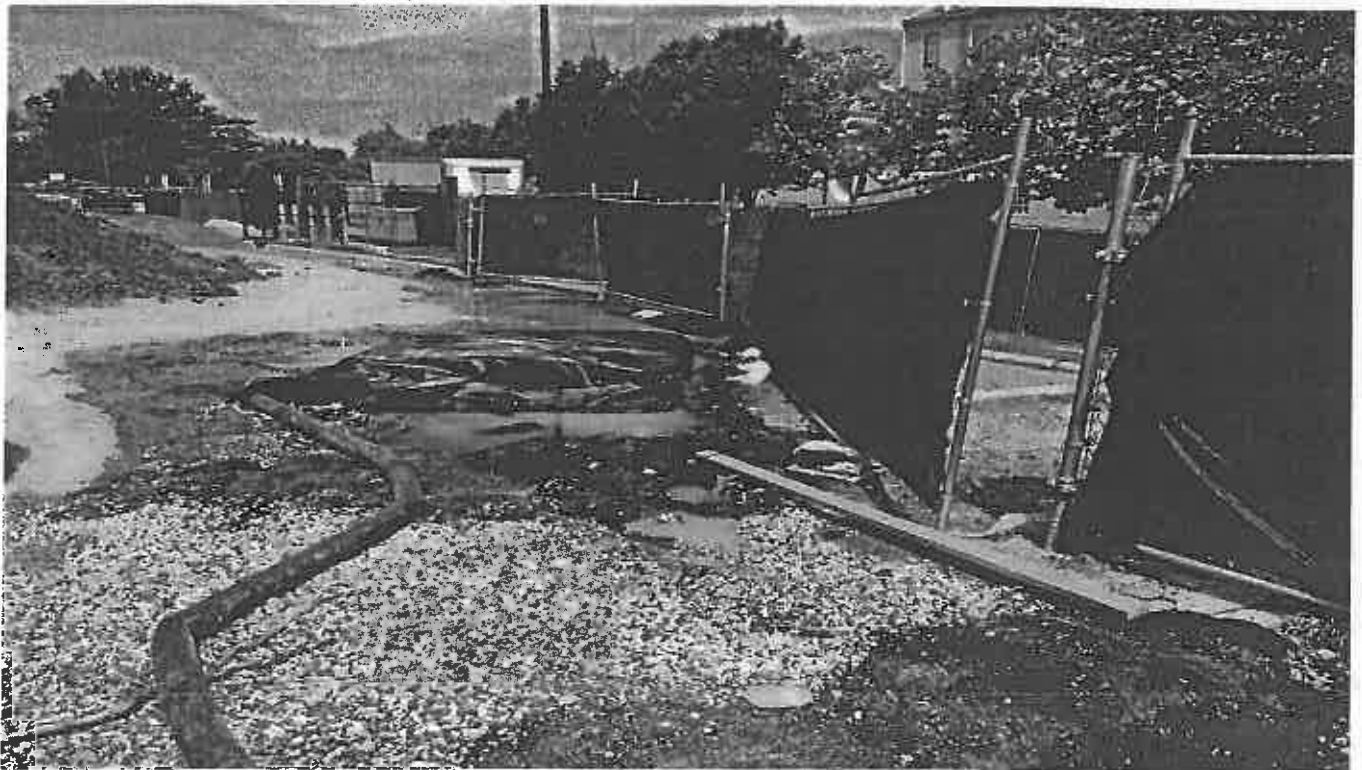
Photo 4. Sediment filter bag placed on exposed soil NW of the site near the sediment tank going into stormdrain

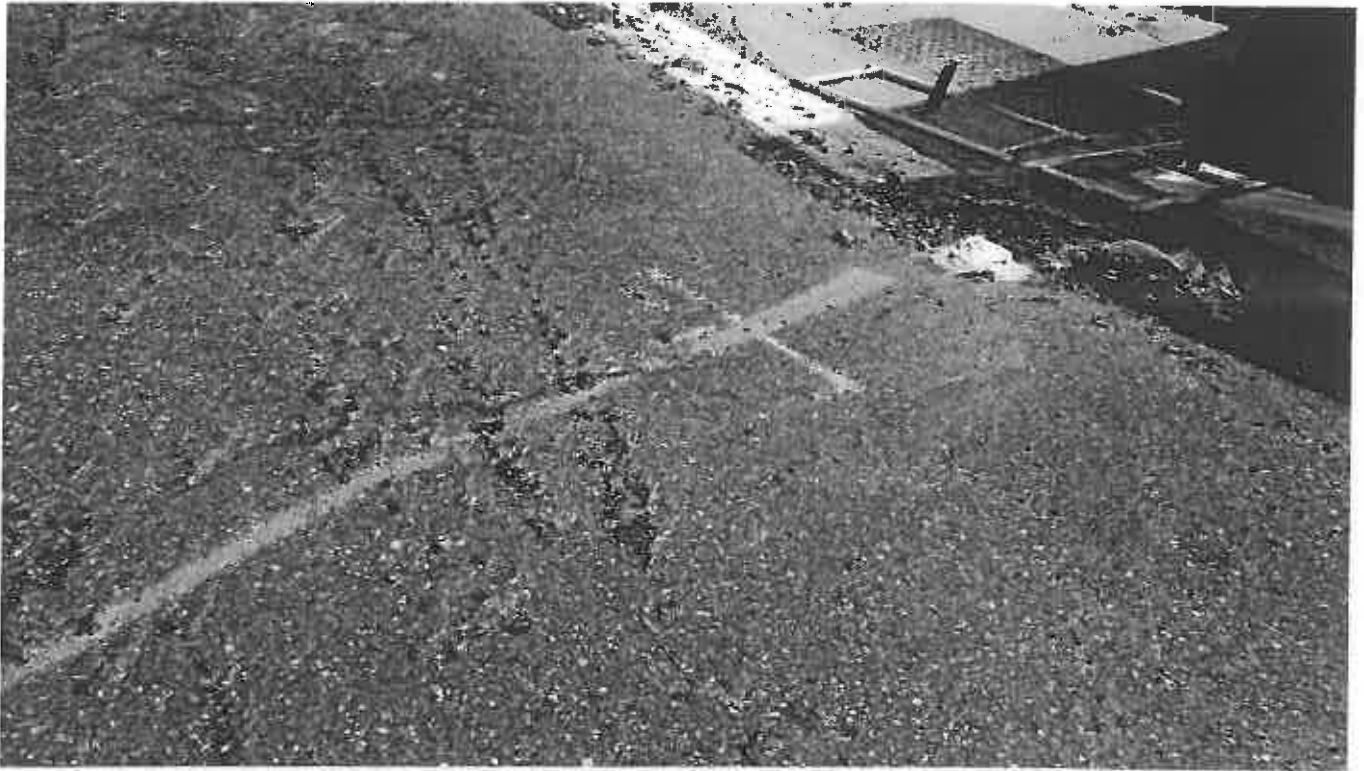
Photo 7. Sediment laden runoff from site to stormdrain on Cole Field Drive in photo 1 off the site.

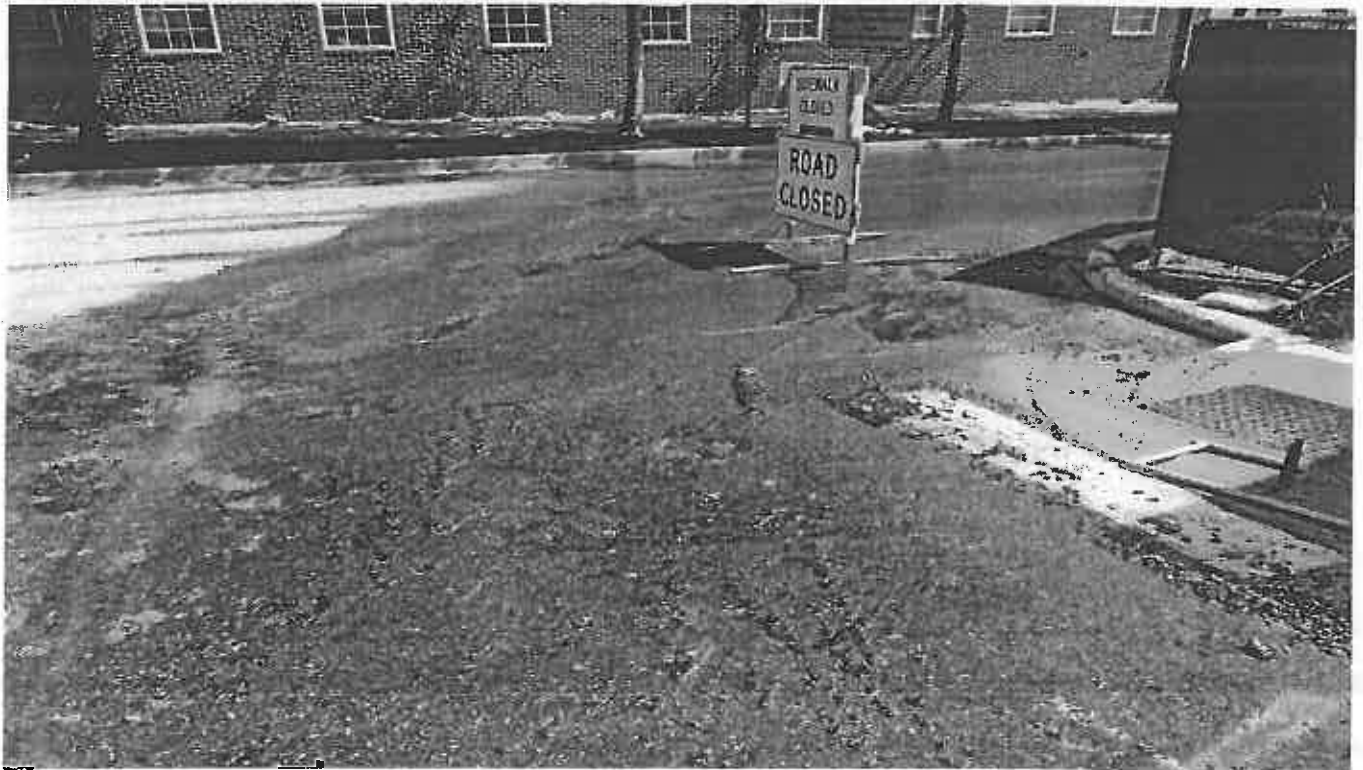
Photo 8. Sediment laden runoff from site to stormdrain on Cole Field Drive in photo 1 off the site.

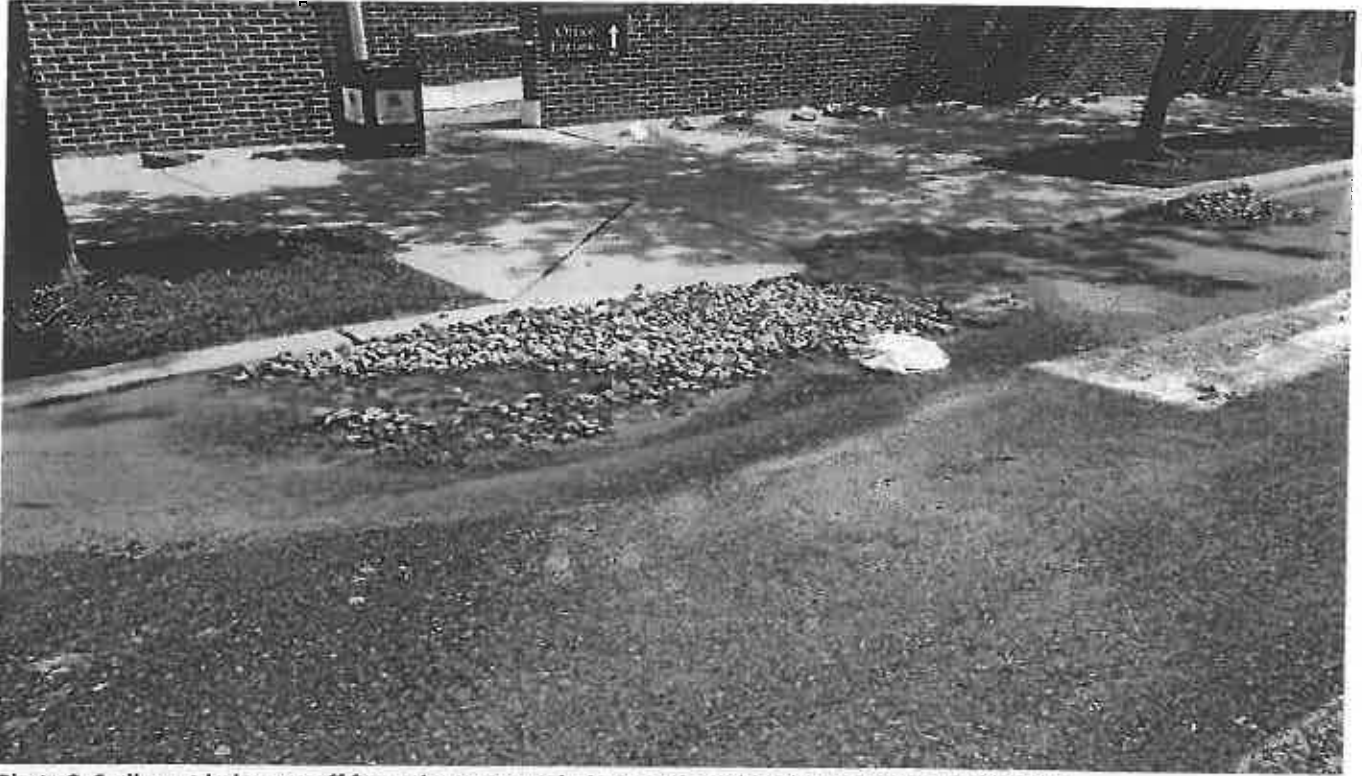
Photo 9. Sediment laden runoff from site to stormdrain on Cole Field Drive in photo 1 off the site.

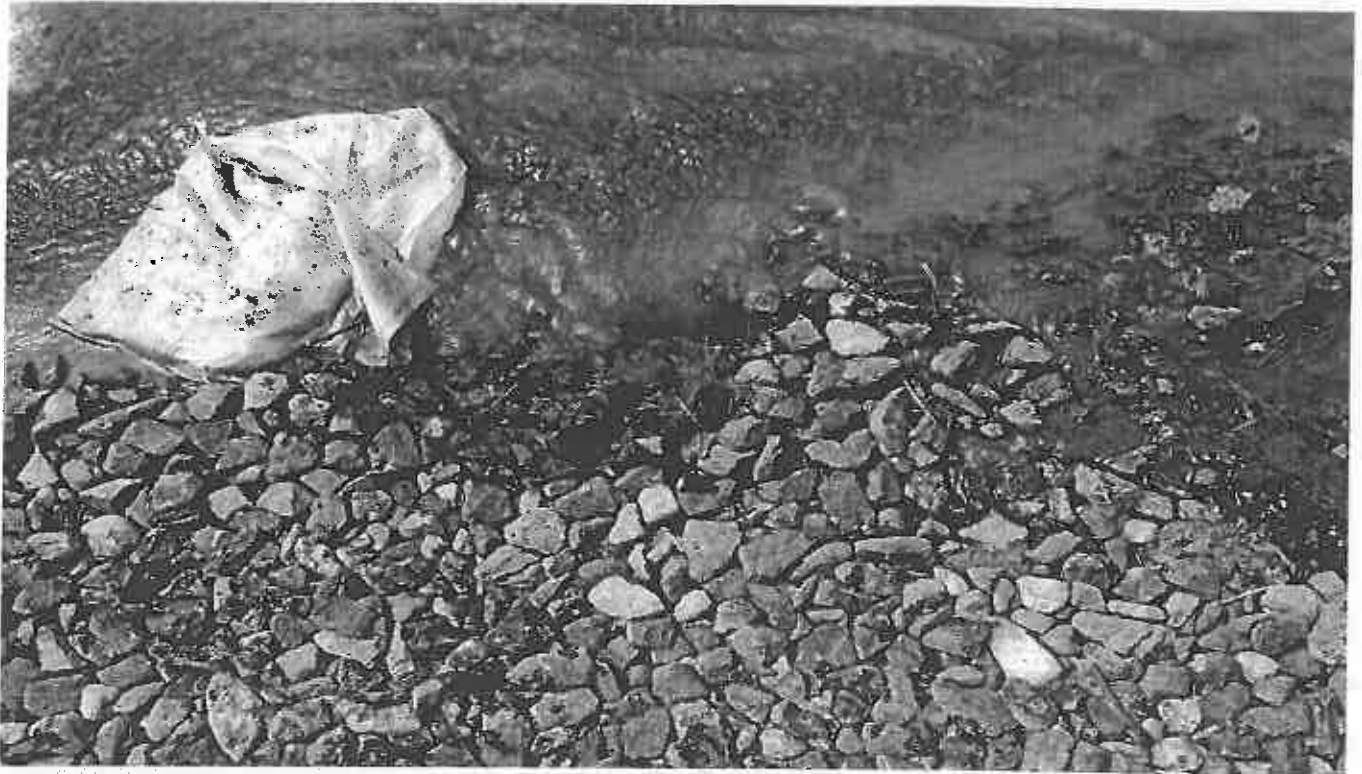
Photo 10. Sediment laden runoff from site to stormdrain on Cole Field Drive in photo 1 off the site.

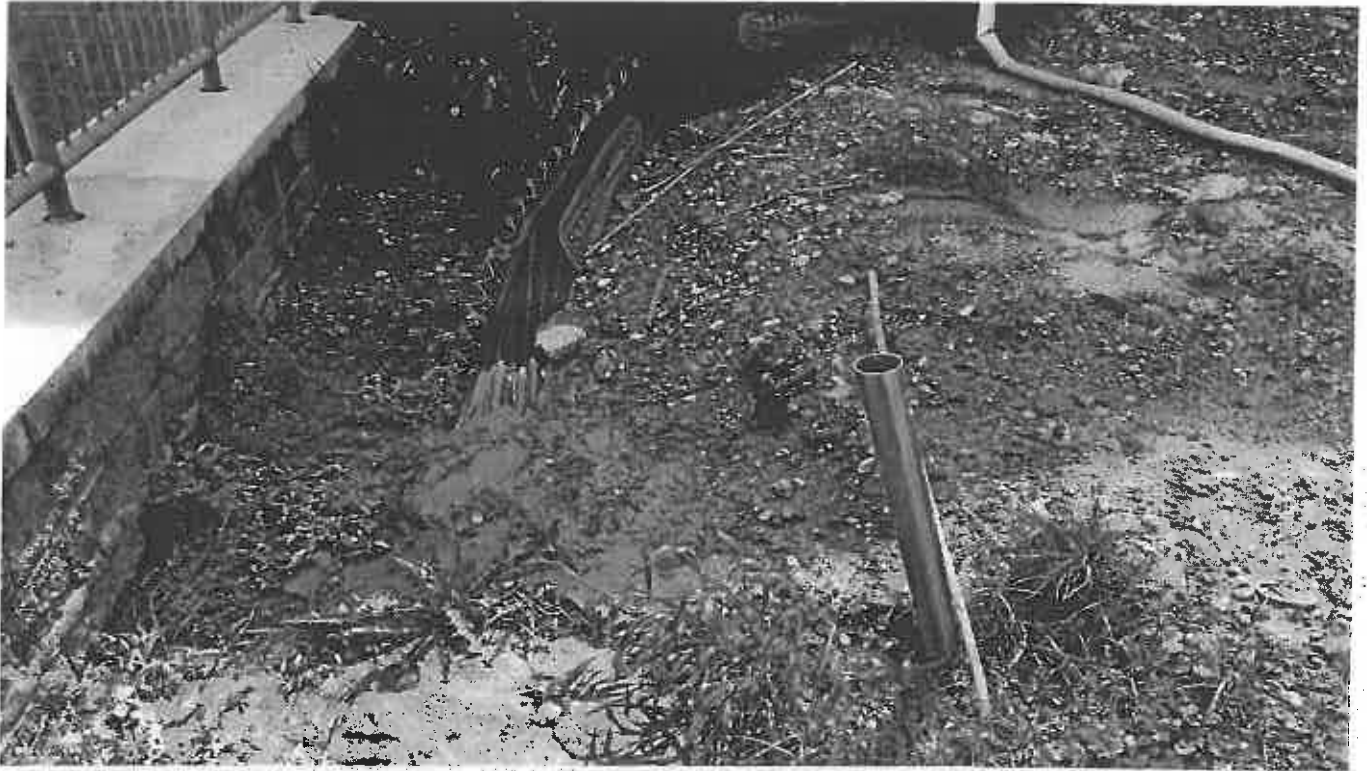
Photo 12. Unmaintained E and S controls at the Slope of the Tunnel Project North of the Site

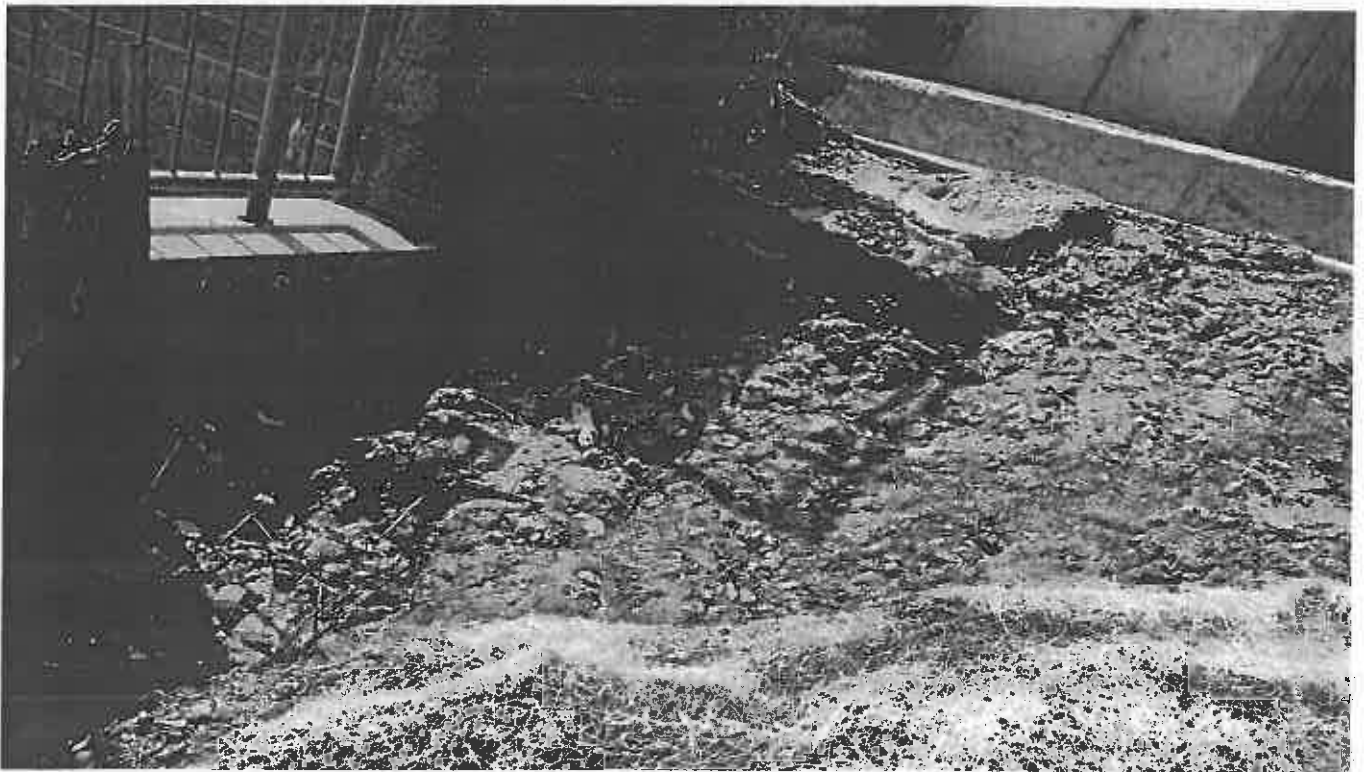
Photo 13. Unmaintained E and S controls at the Slope of the Tunnel Project North of the Site

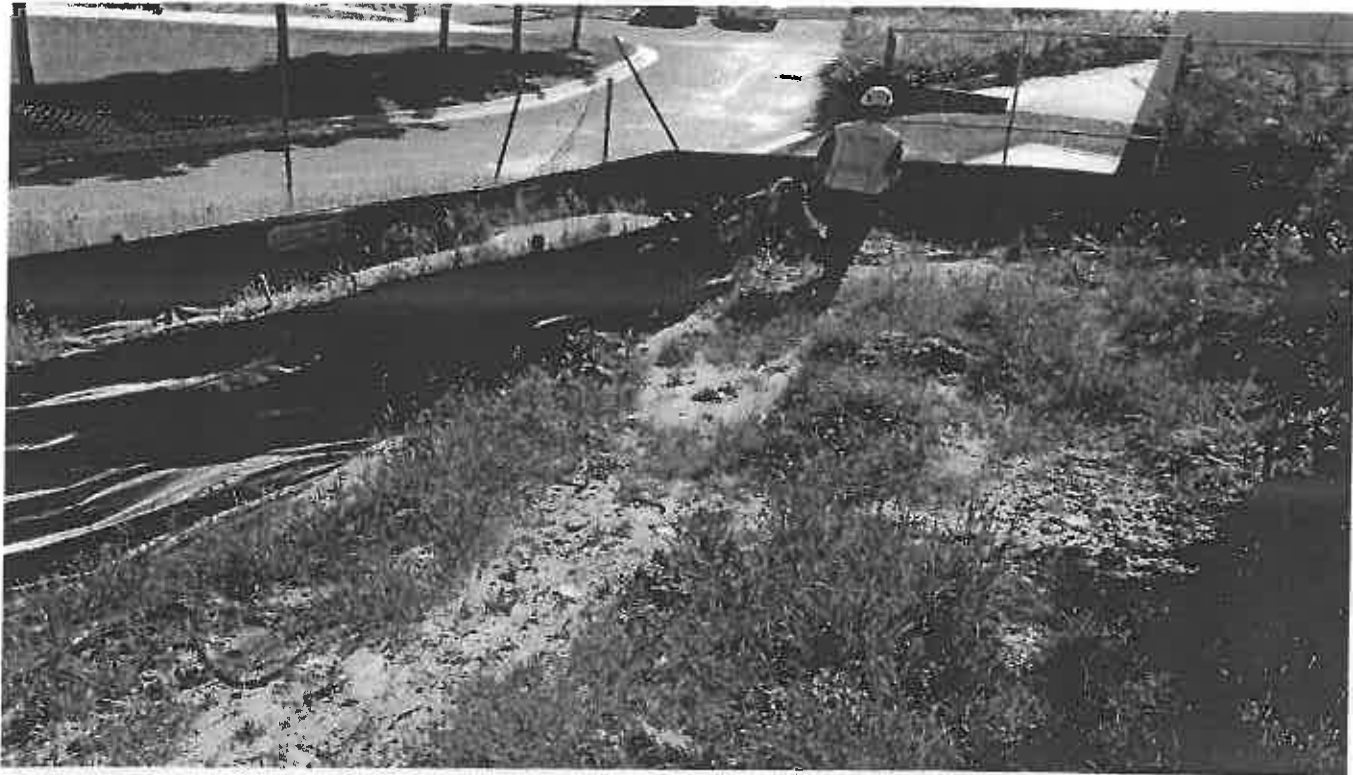
Photo 1. SSF not properly trenched to the ground at the Slope of the Tunnel Project North of the Site

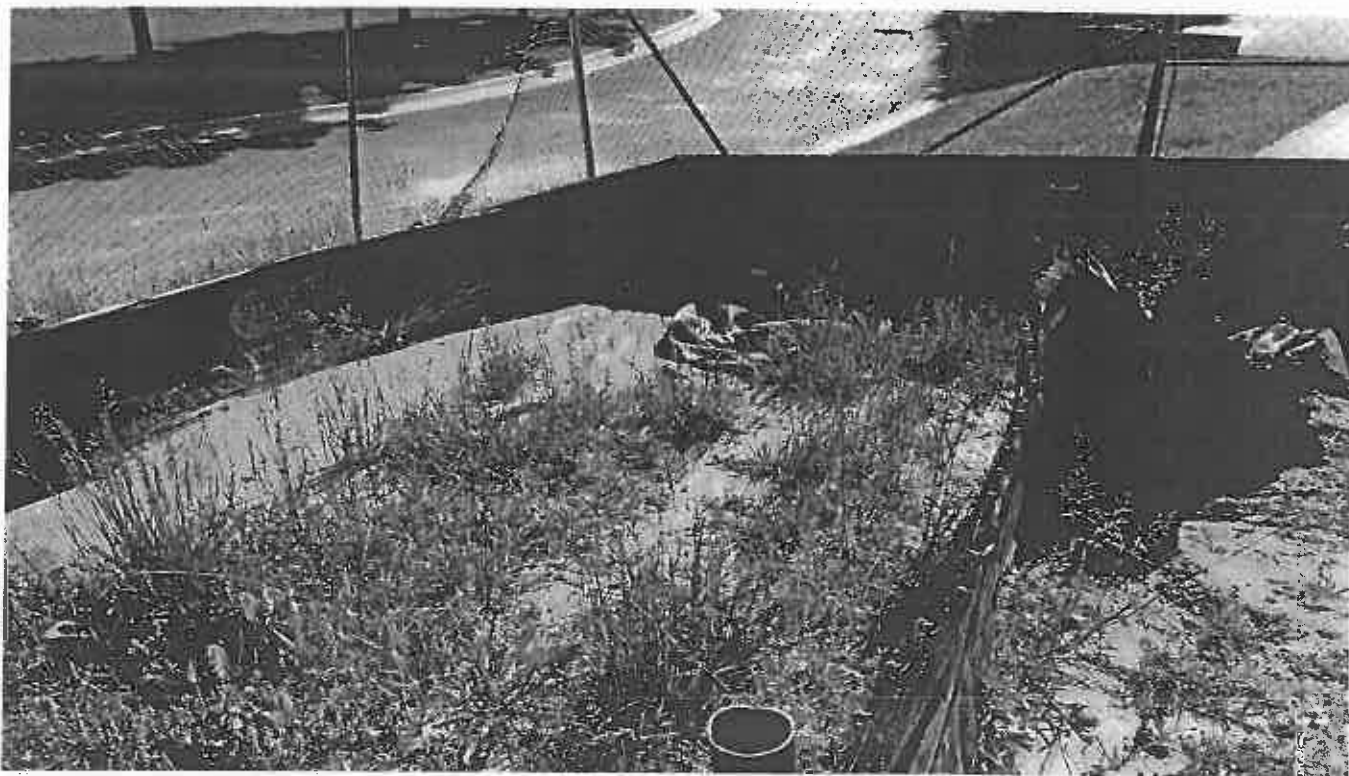
Photo 2. Accumulated silt and sediment at the E and S control footings at the Slope of the Tunnel Project North of the Site

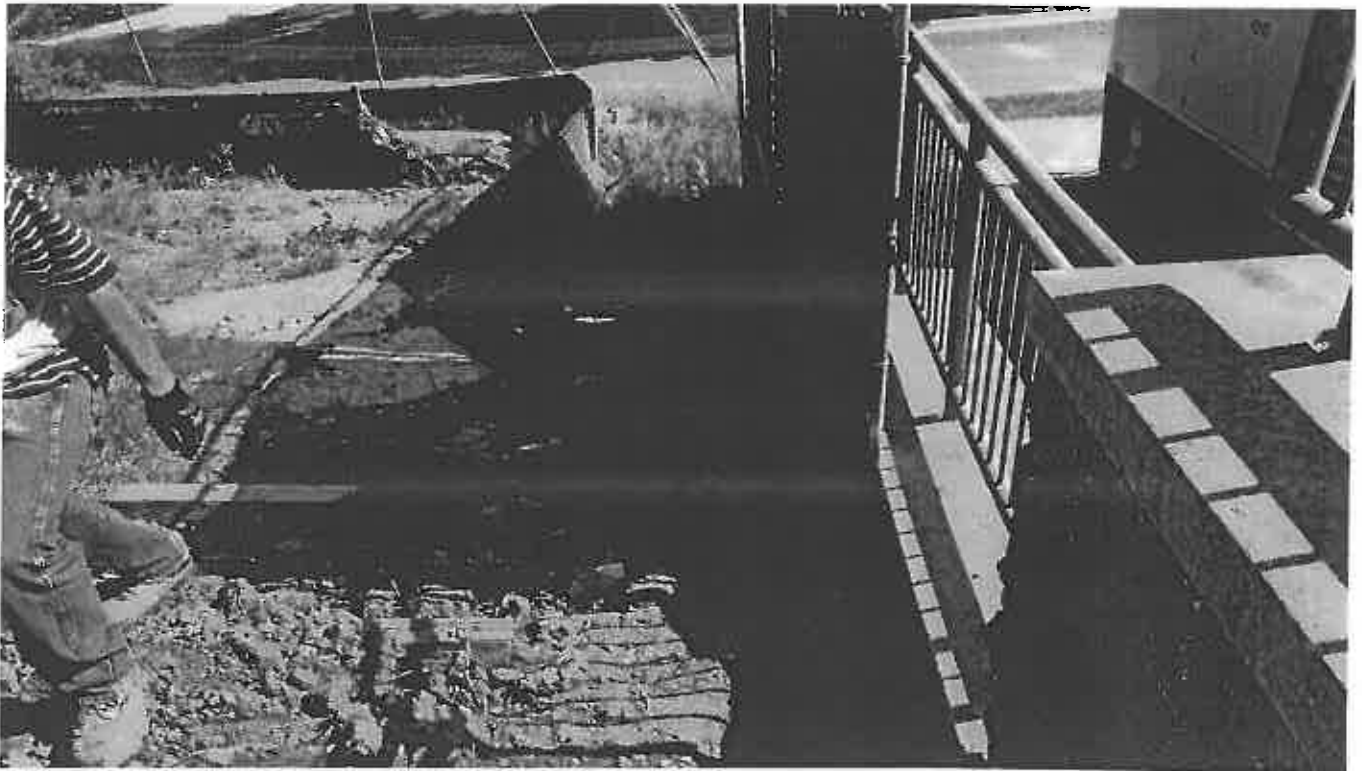
Photo 3. Unmaintained E and S controls at the Slope of the Tunnel Project North of the Site

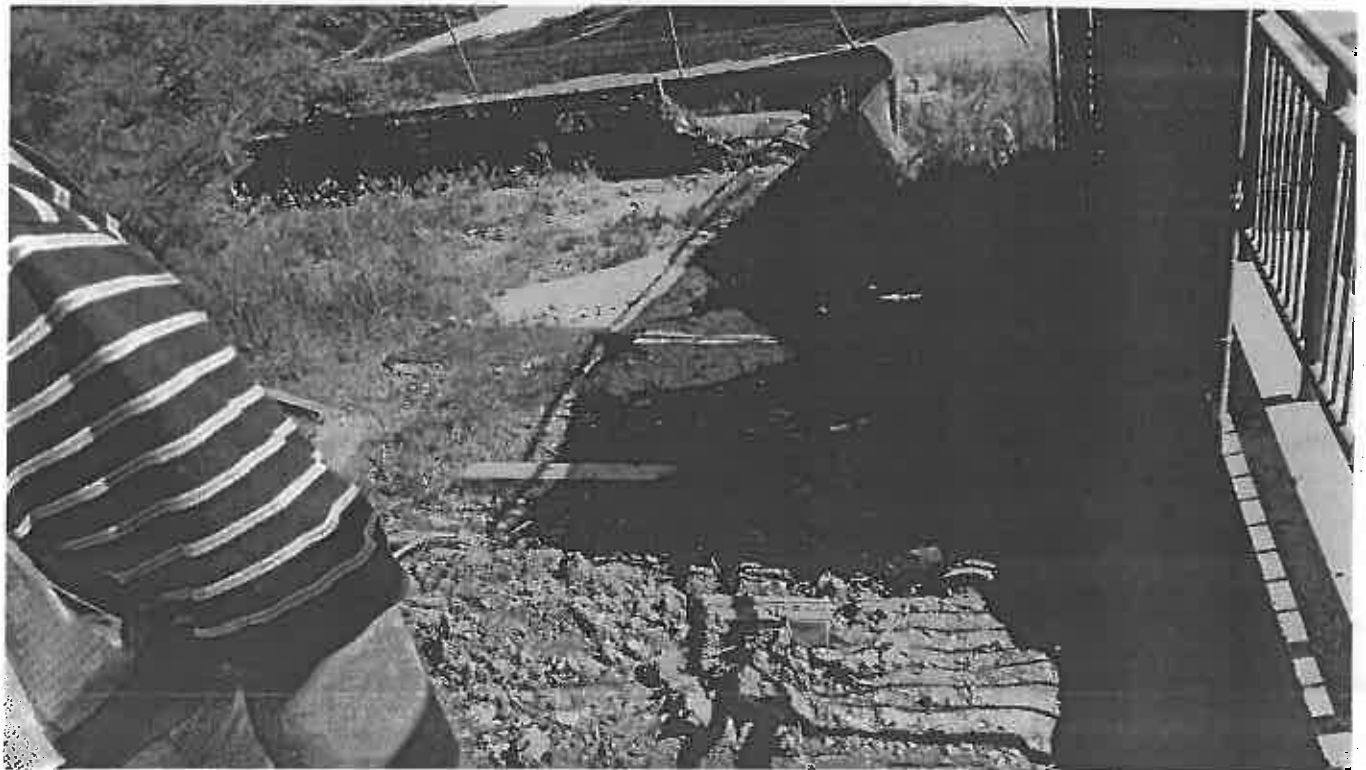
Photo 4. Unmaintained E and S controls at the Slope of the Tunnel Project North of the Site

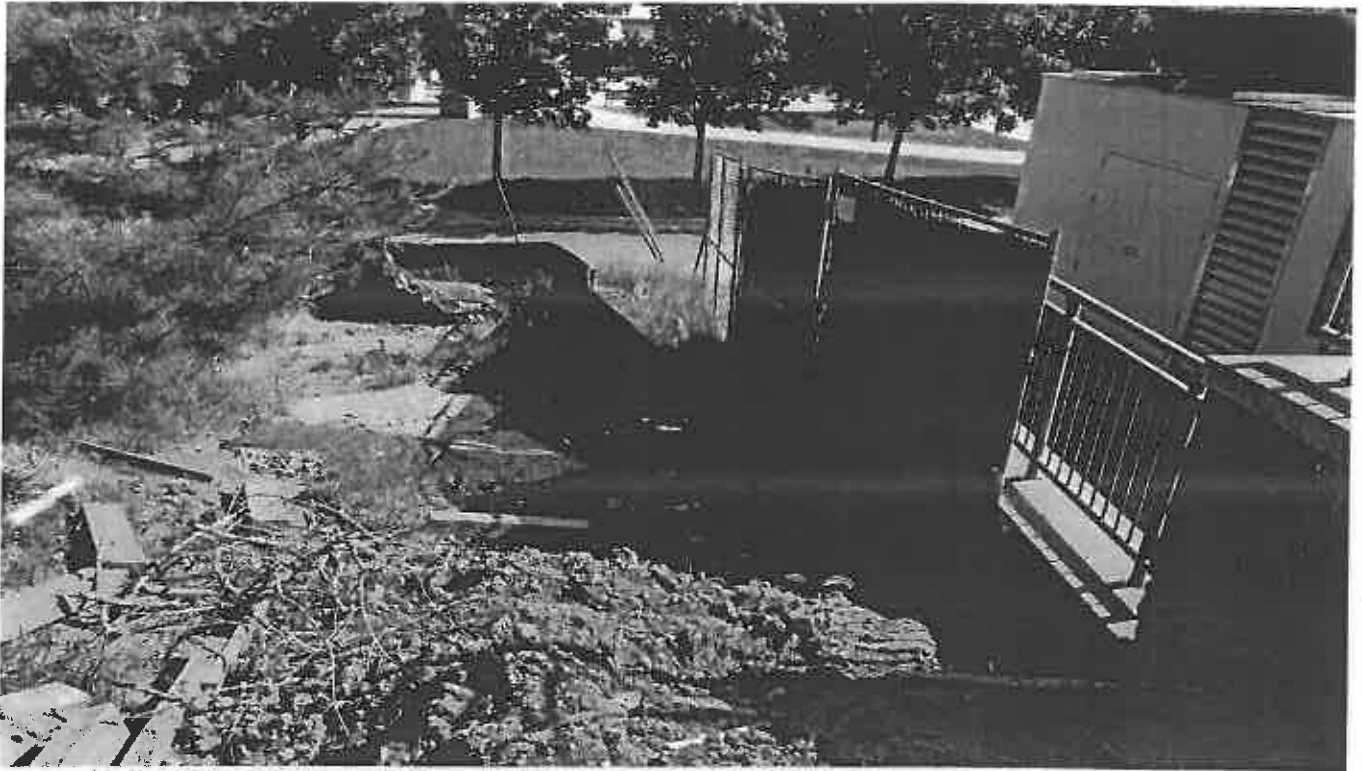
Photo 5. Unmaintained E and S controls at the Slope of the Tunnel Project North of the Site

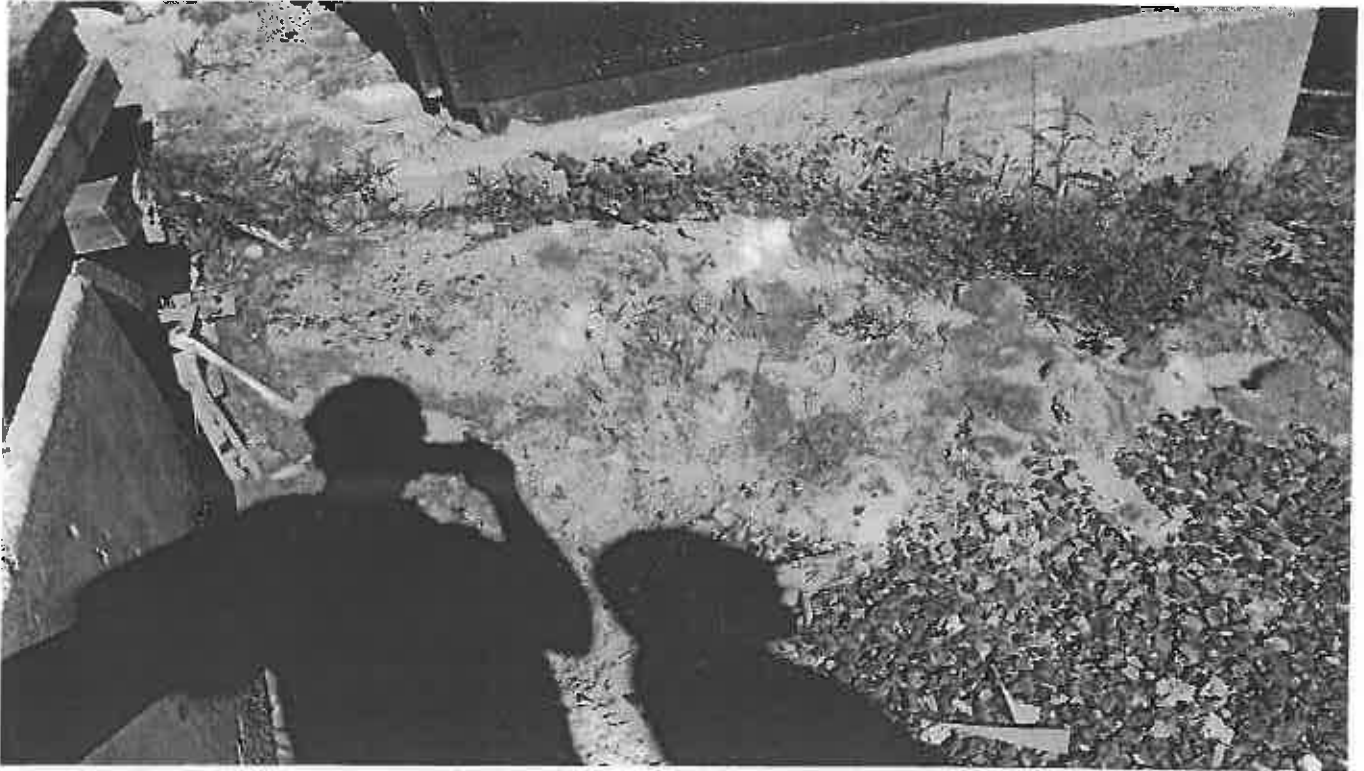
Photo 7. Exposed soil and unmaintained E and S controls at the Slope of the Tunnel Project North of the Site

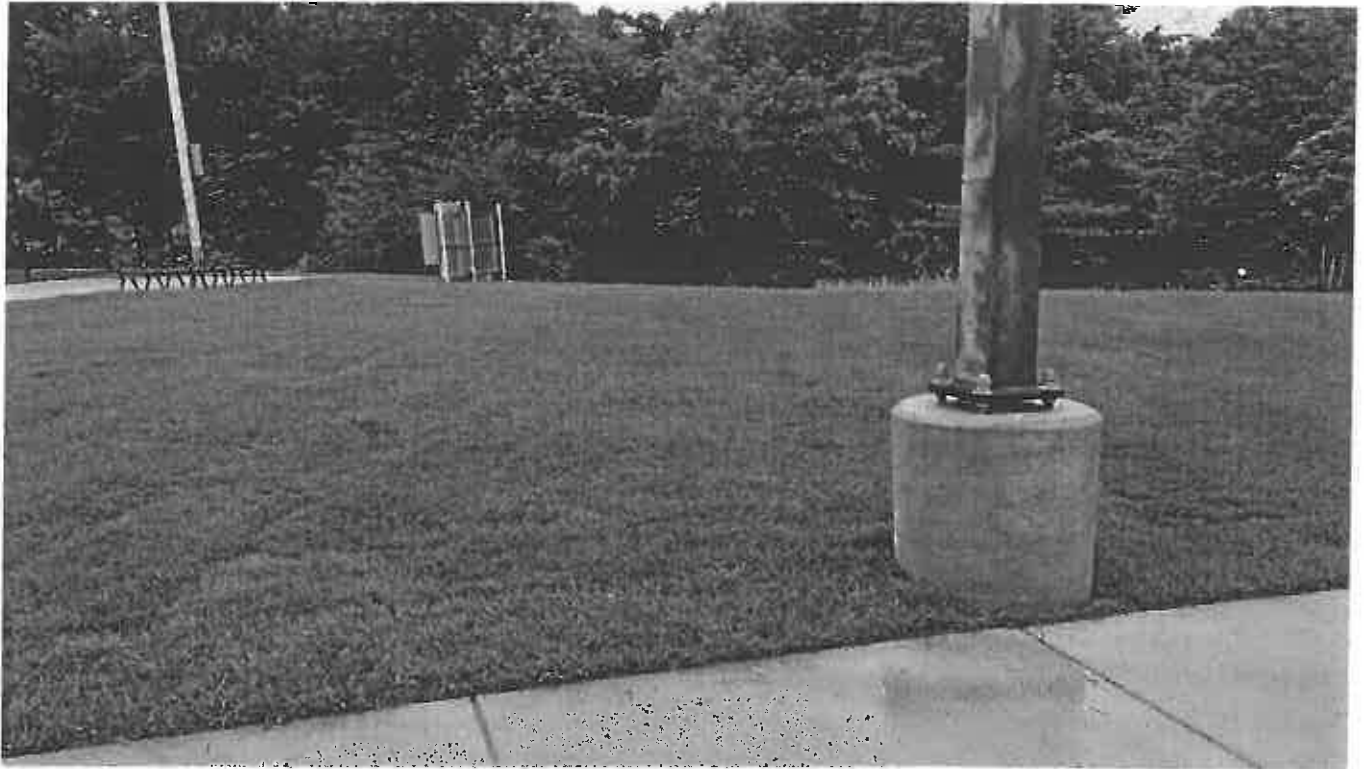
Photo 1. Shows sod stabilization adjacent the storm water management pond at the new tennis court

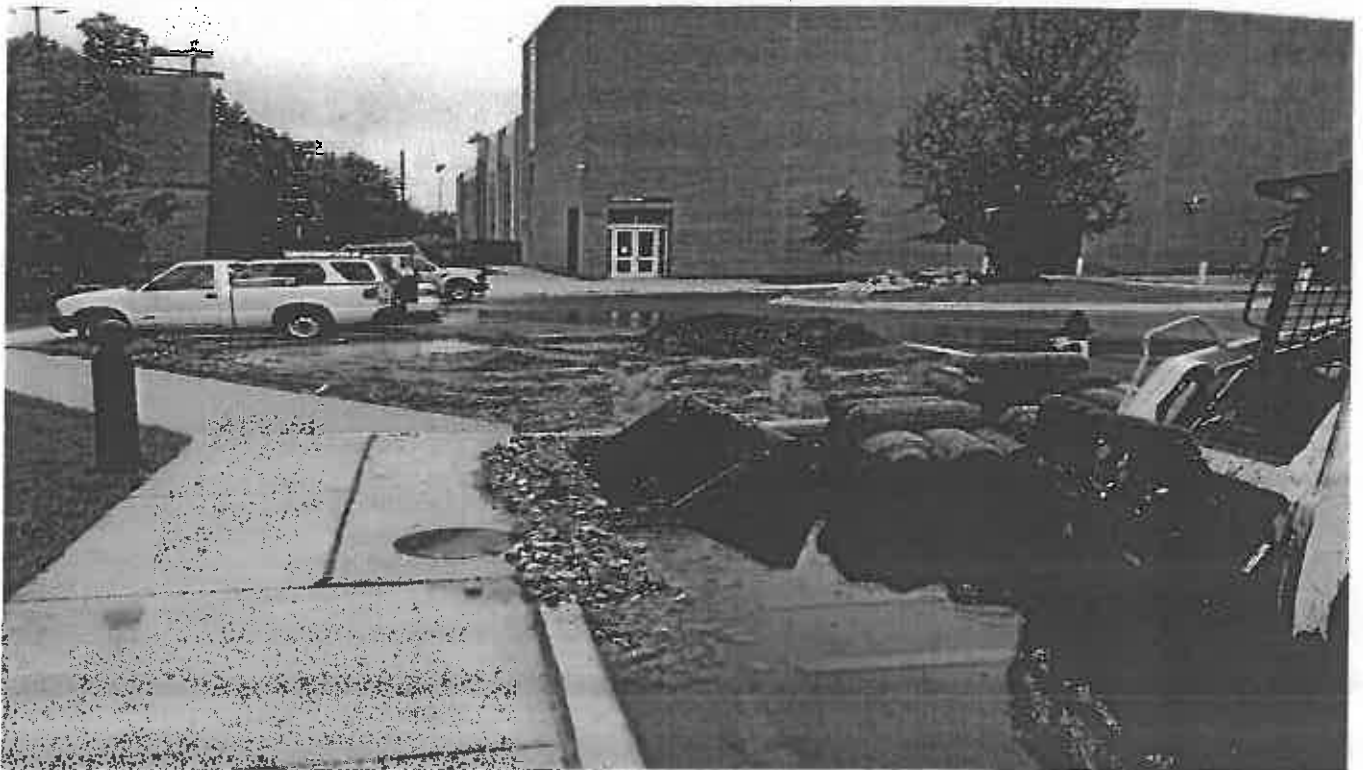
Photo 2. Shows sod and mud at the parking lot adjacent the sport center and the Curb Storm Drain

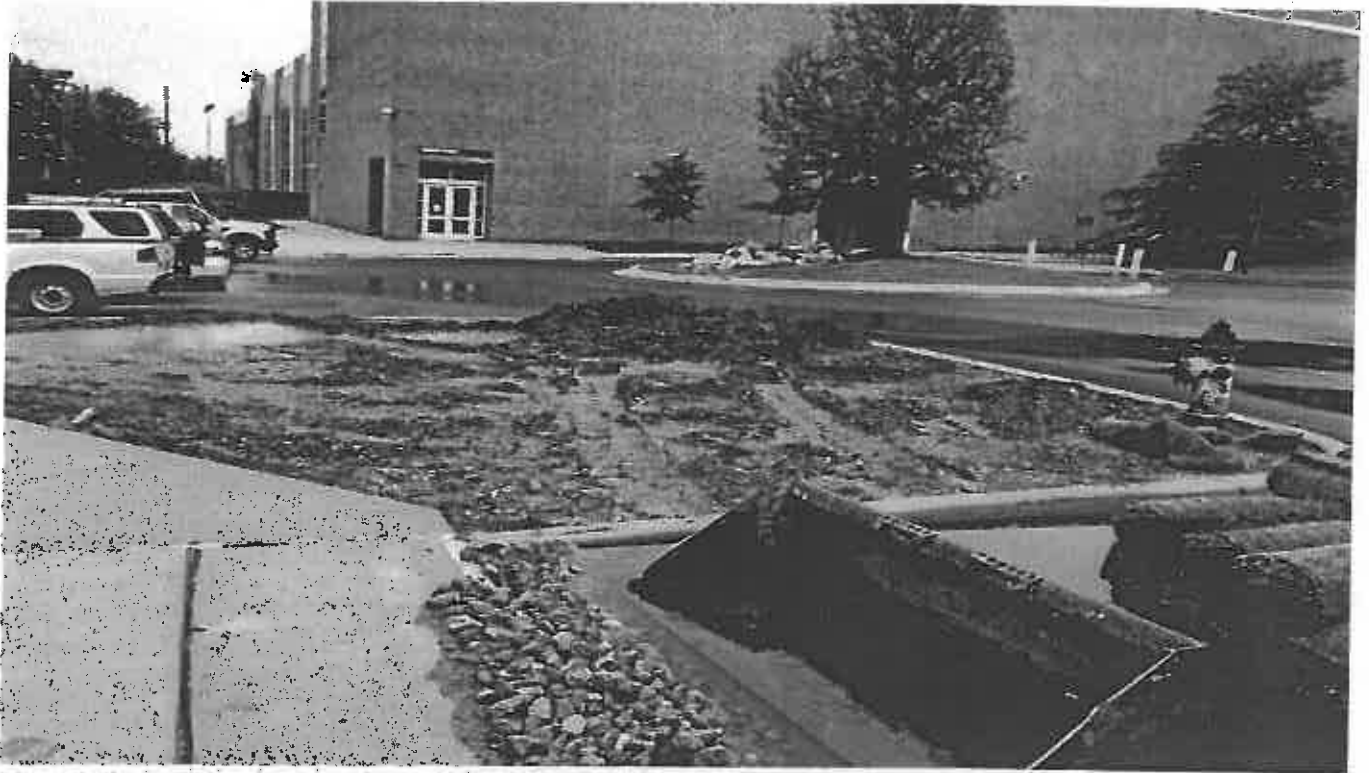
Photo 3. Shows sod and mud at the parking lot adjacent the sport center and the Curb storm Drain

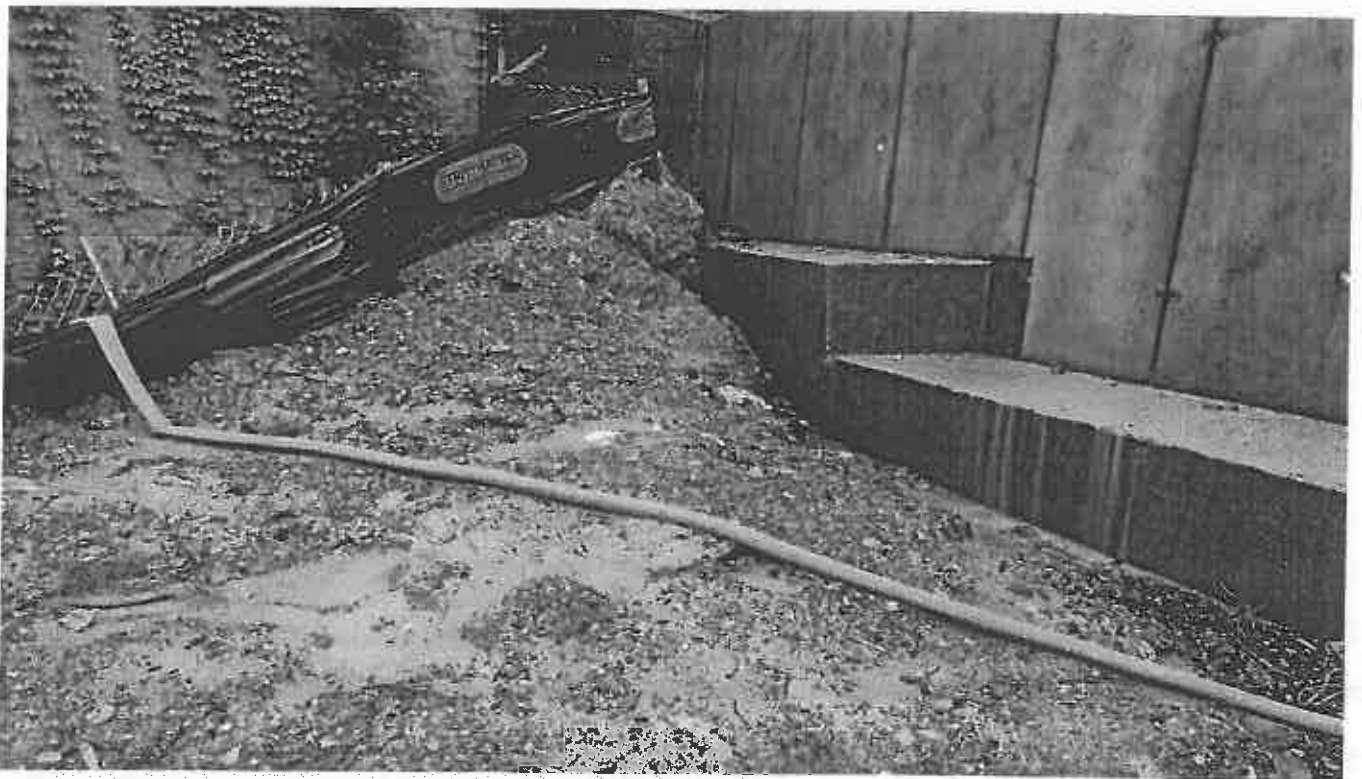
Photo 6. Unmaintained E and S controls at the Slope of the Tunnel Project North of the Site

Per my conversation with the aforementioned individuals today with exception of Justin Hooper, mend or remove the failing super silt fences (SSF) at the steep slope near the ongoing tunnel work north of the site, add more stones to the stabilized construction entrance on Cole Fieldhouse road, finally stabilize the exposed area at the new tennis court.

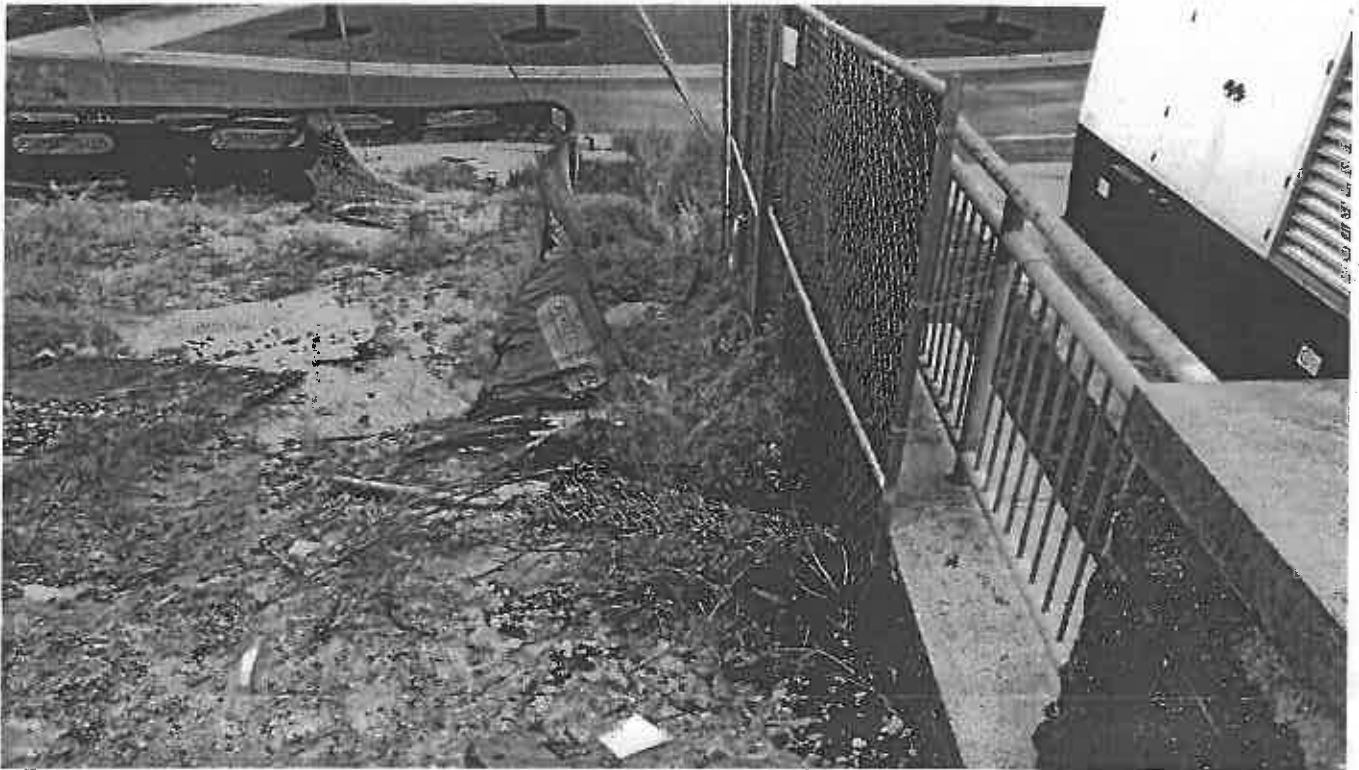
Photo 8. Unmaintained E and S controls at the Slope of the Tunnel Project North of the Site
