Maryland Department of Environment
Water and Science Administration
Compliance Program - Western Division
91 Eastern Blvd, Hagerstown, MD 21740
301-665-2850

Site Name: New Cole Fieldhouse
Facility Address: 4090 Union Dr, College Park, MD 20742
County: Prince George's County

Inspection Date: November 5, 2018 **Start Date/Time:** November 5, 2018, 09:00 AM
End Date/Time: November 5, 2018, 10:00 AM

Media Type(s): NPDES Construction Activity, State/federal SWM

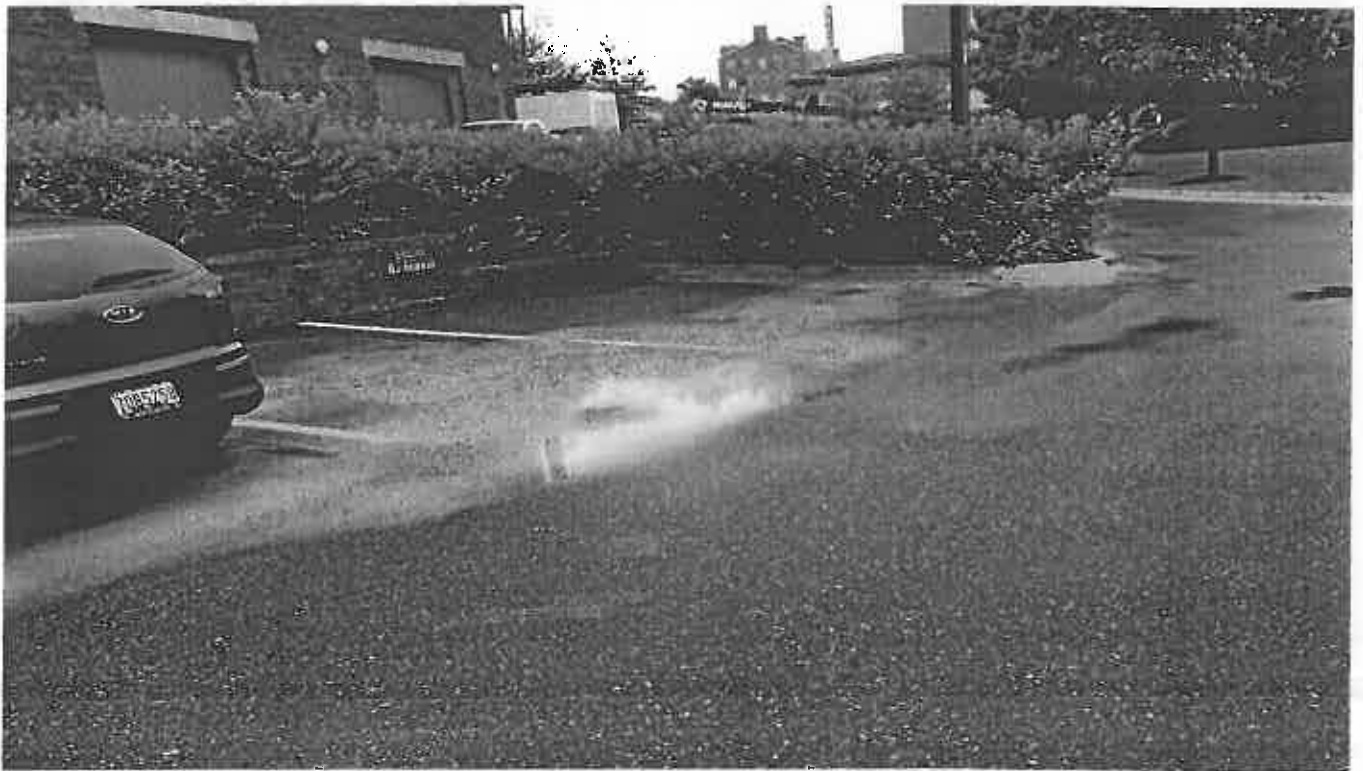
Photo 12. Sediment laden stormwater runoff from site to the stormdrain at Gossett Football Team House lot.

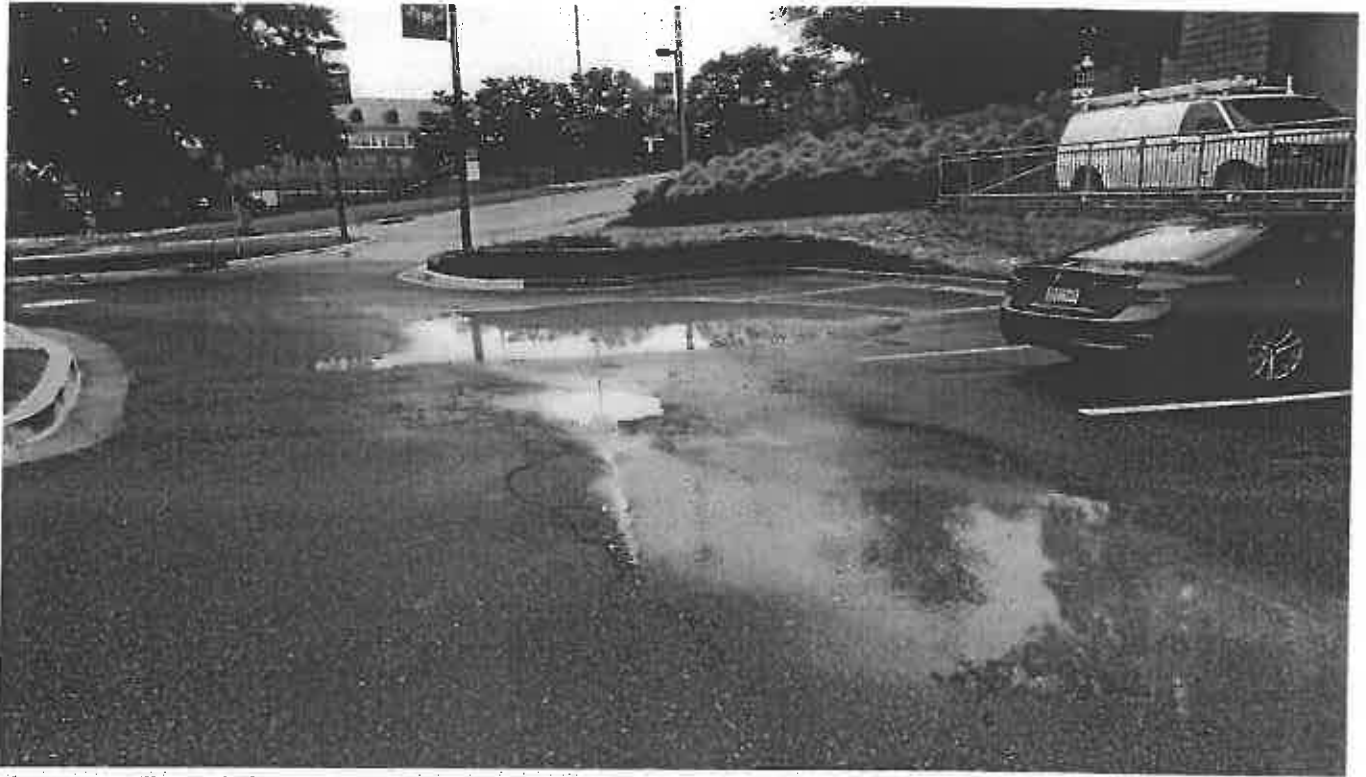
Photo 13. Sediment laden stormwater runoff from site to the stormdrain at Gossett Football Team House lot.

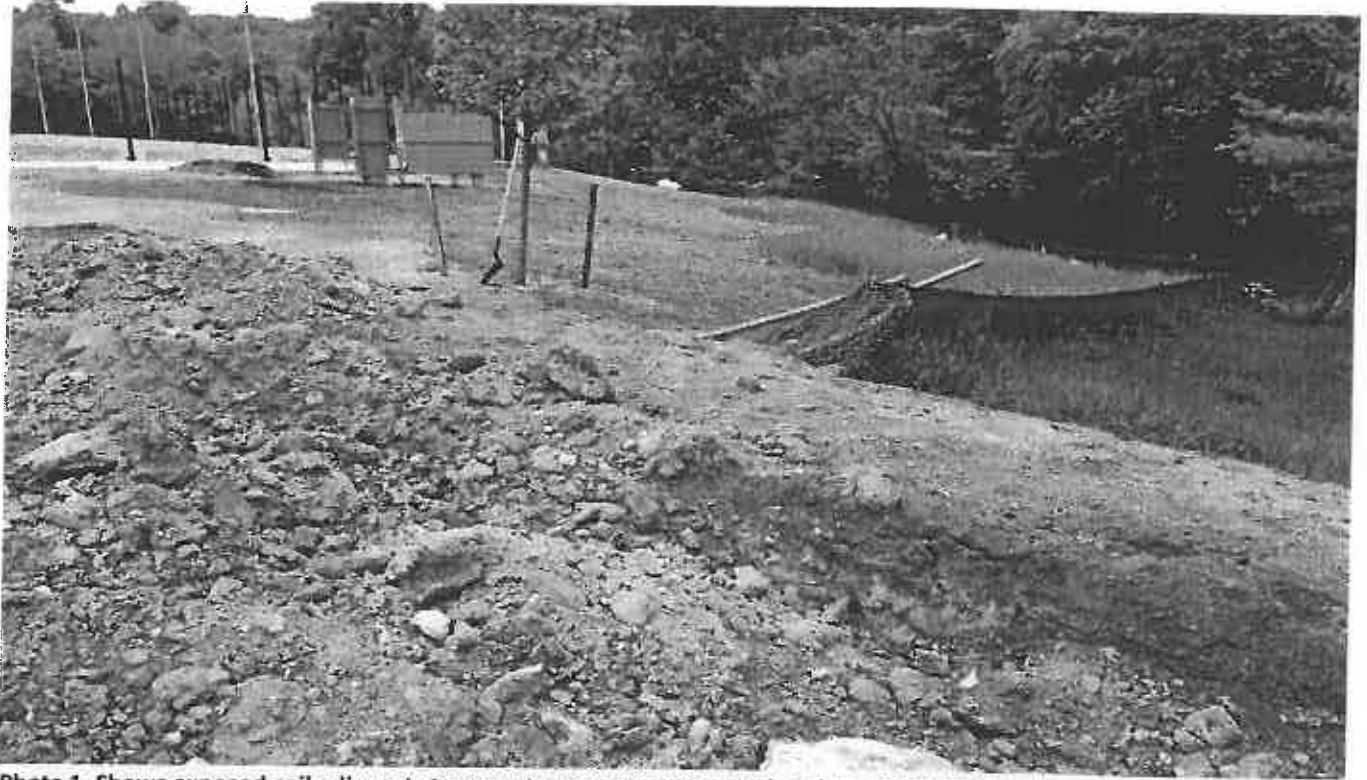
Photo 1. Shows exposed soil adjacent storm water management pond at the new tennis court

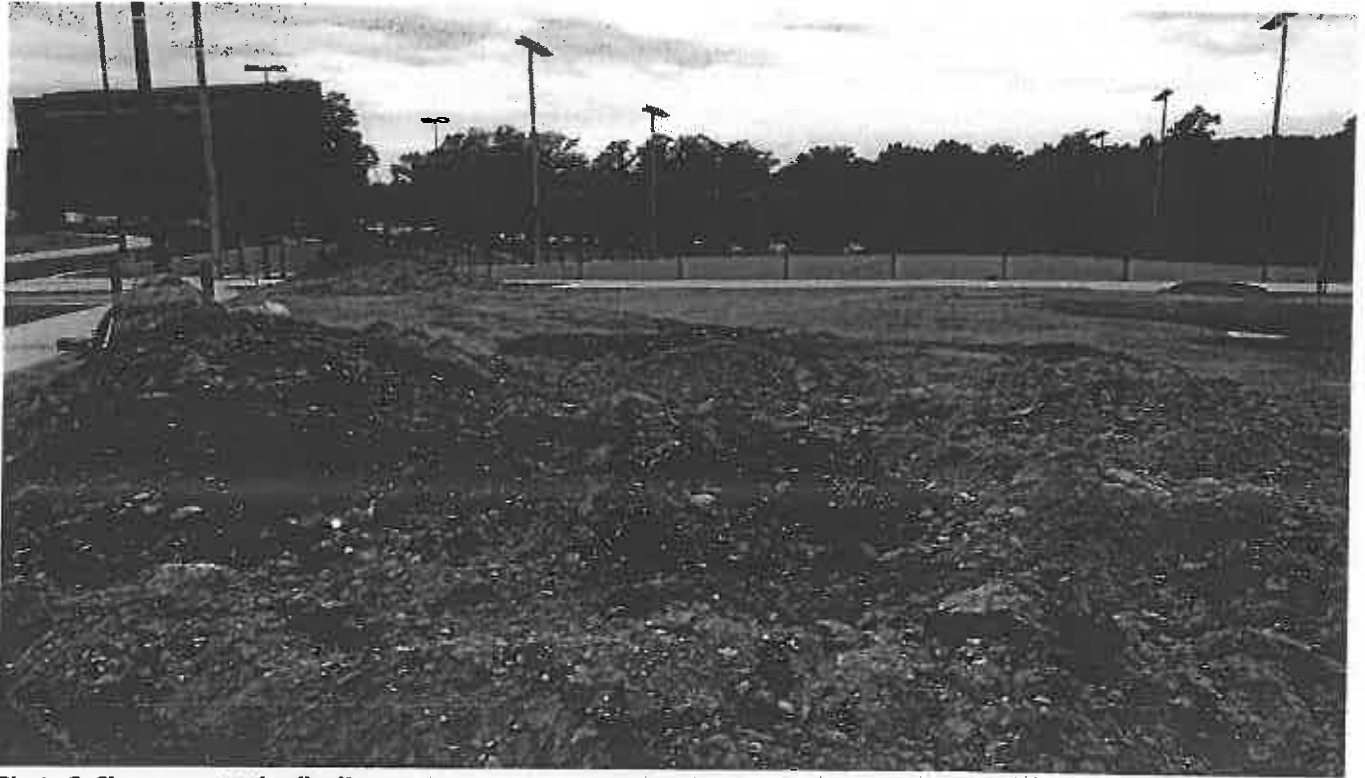
Photo 3. Shows exposed soil adjacent storm water management pond at the new tennis court

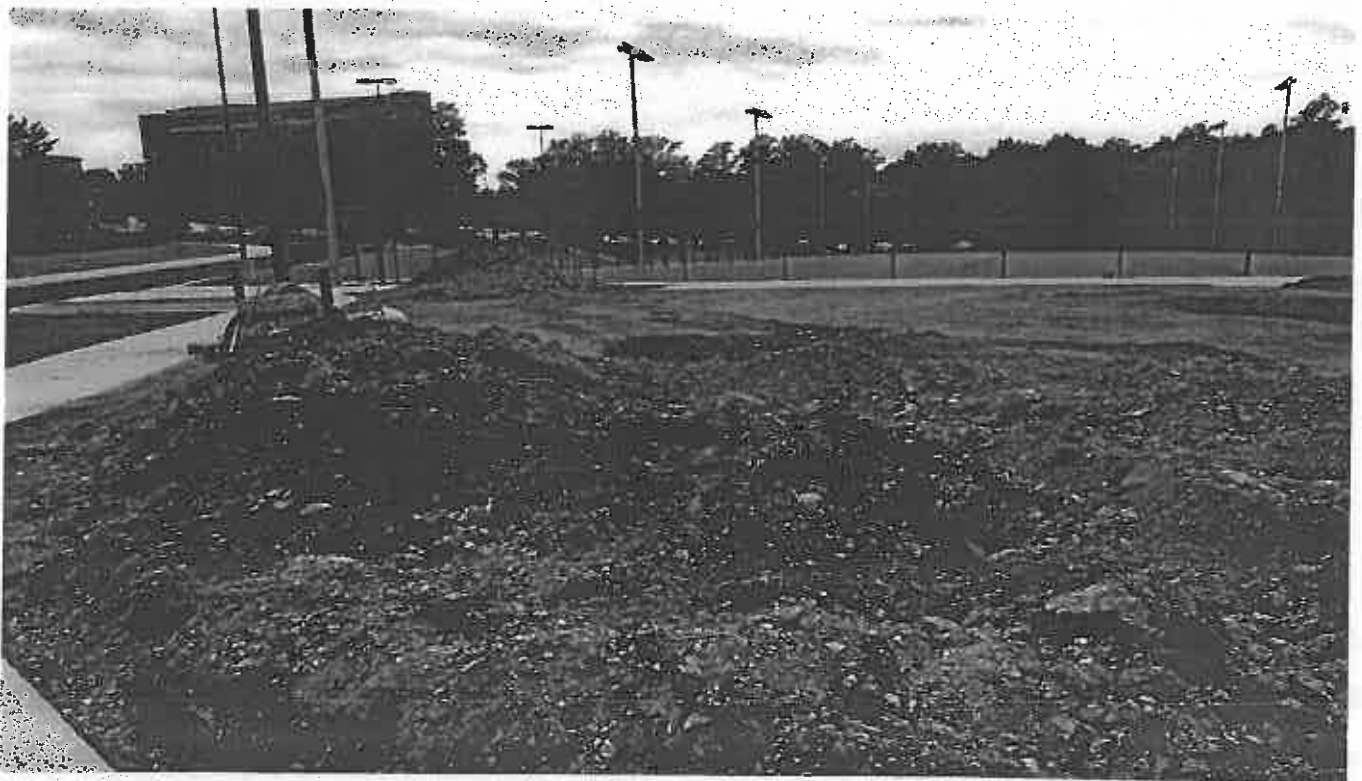
Photo 4. Shows exposed soil adjacent storm water management pond at the new tennis court

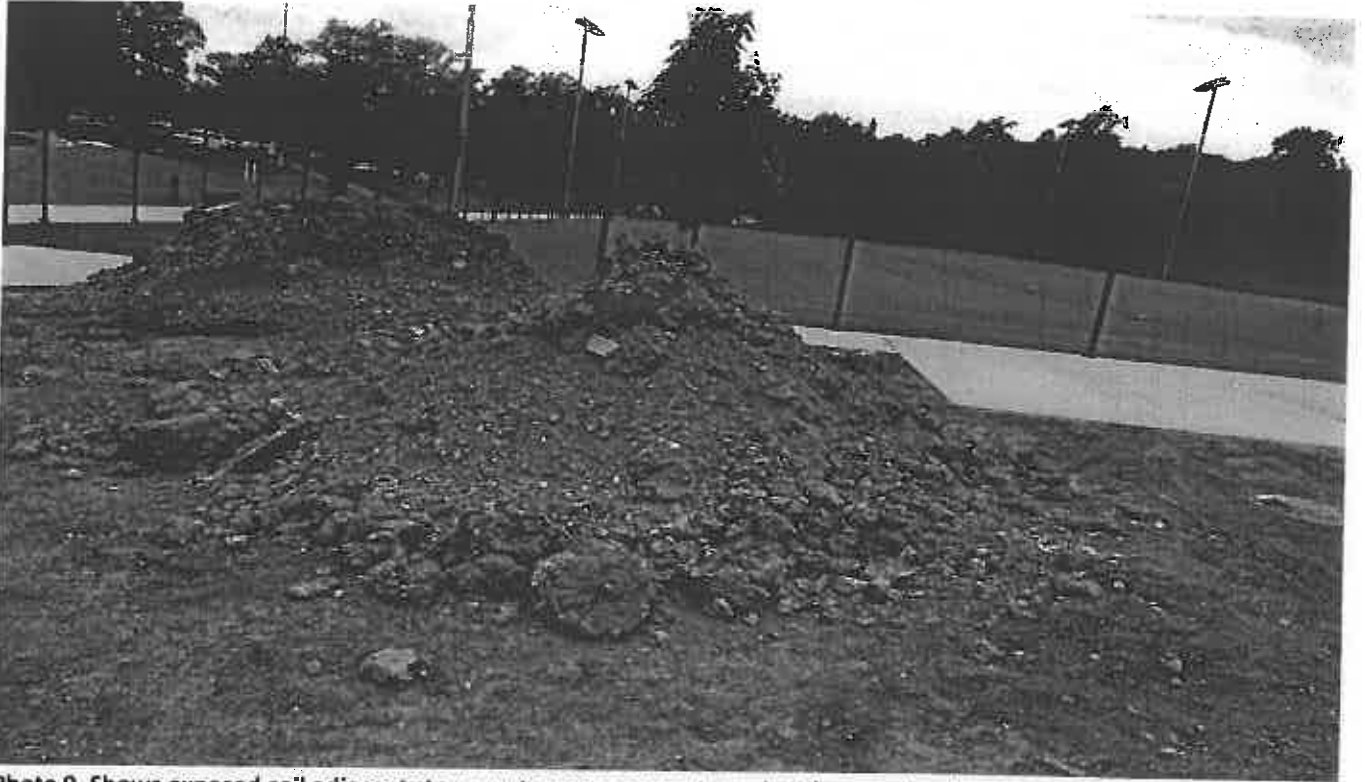
Photo 9. Shows exposed soil adjacent storm water management pond at the new tennis court

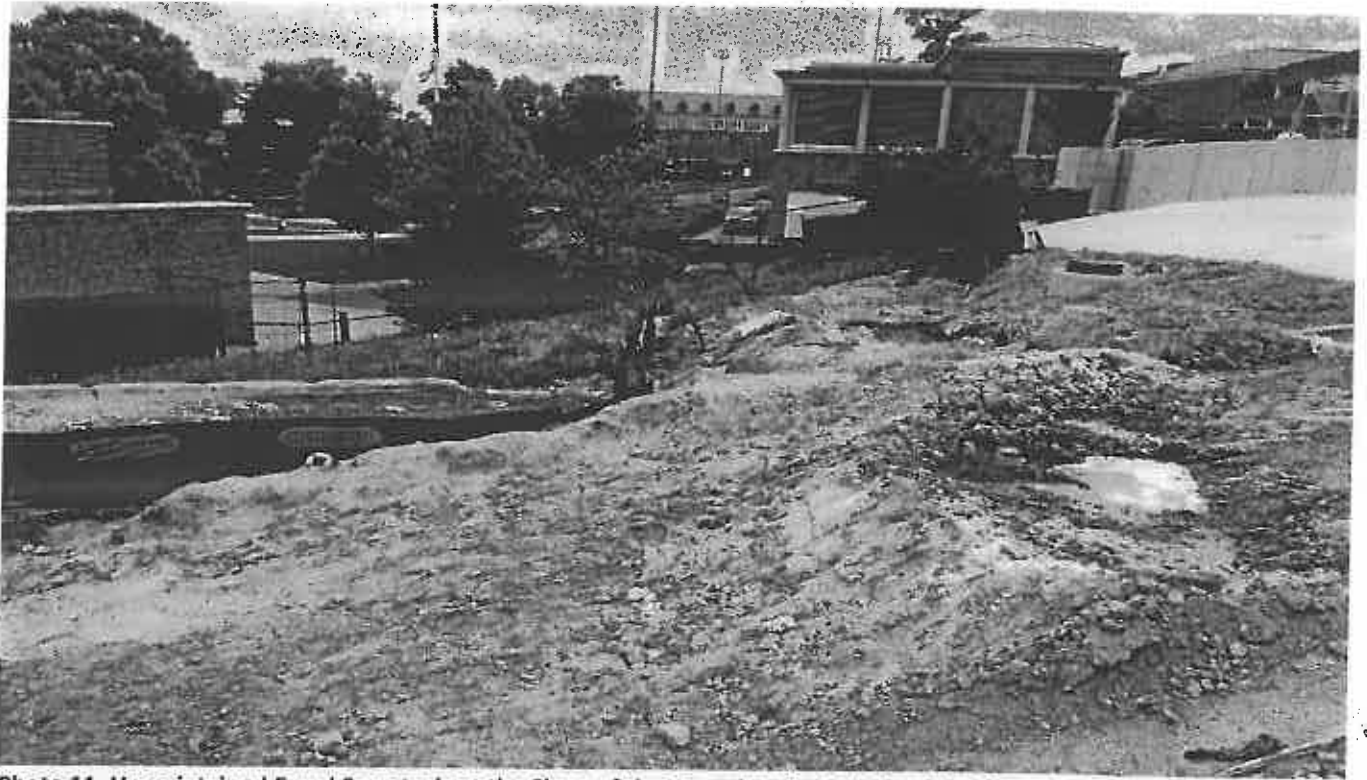
Photo 11. Unmaintained E and S controls at the Slope of the Tunnel Project North of the Site

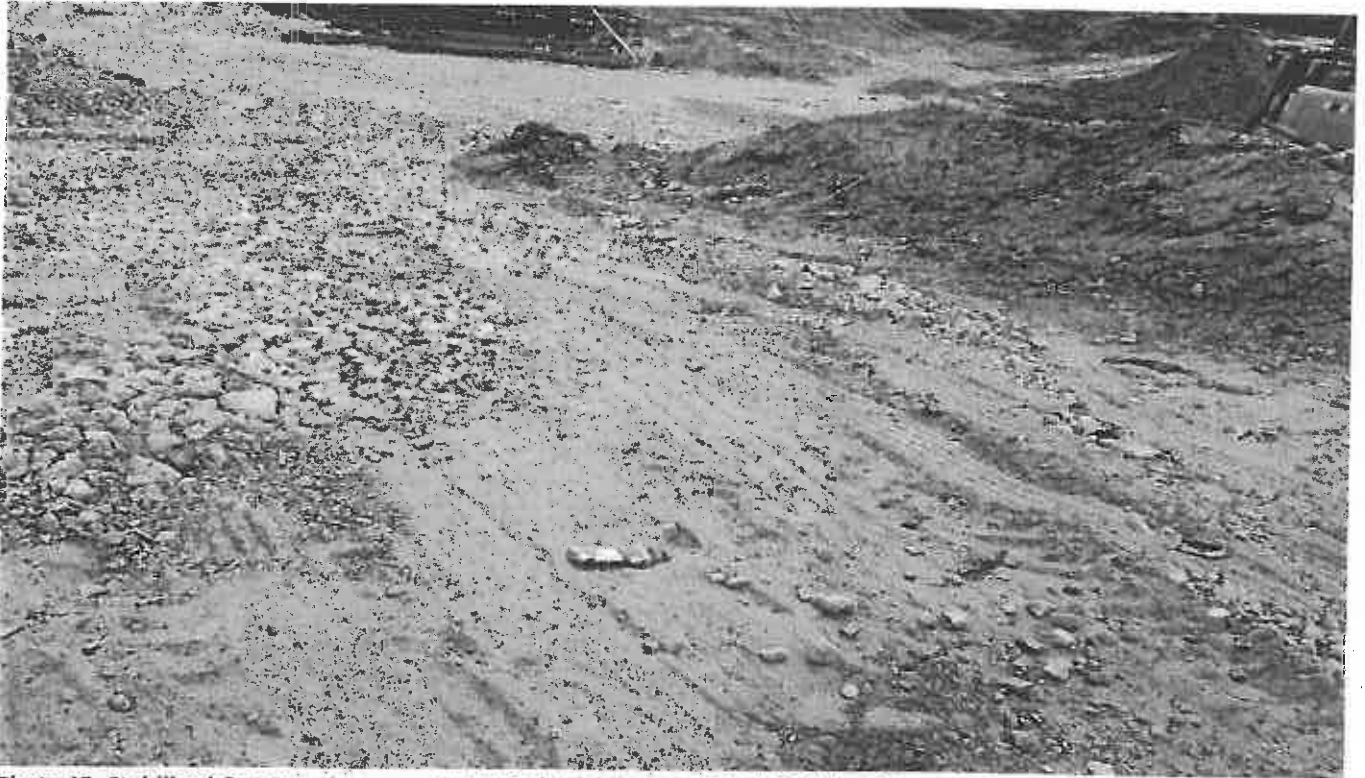
Photo 13. Stabilized Construction Entrance on Cole Fieldhouse Drive NE of the site

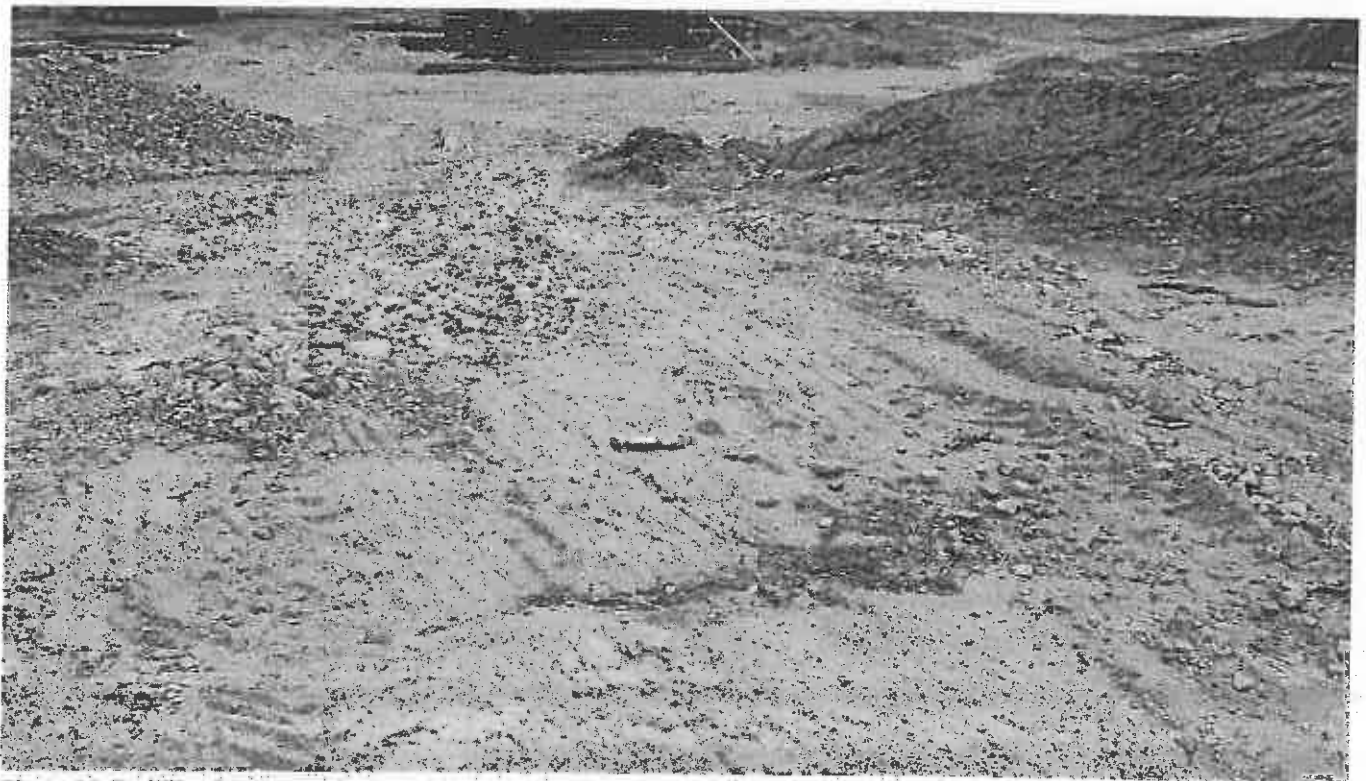
Photo 14. Stabilized Construction Entrance on Cole Fieldhouse Drive NE of the site

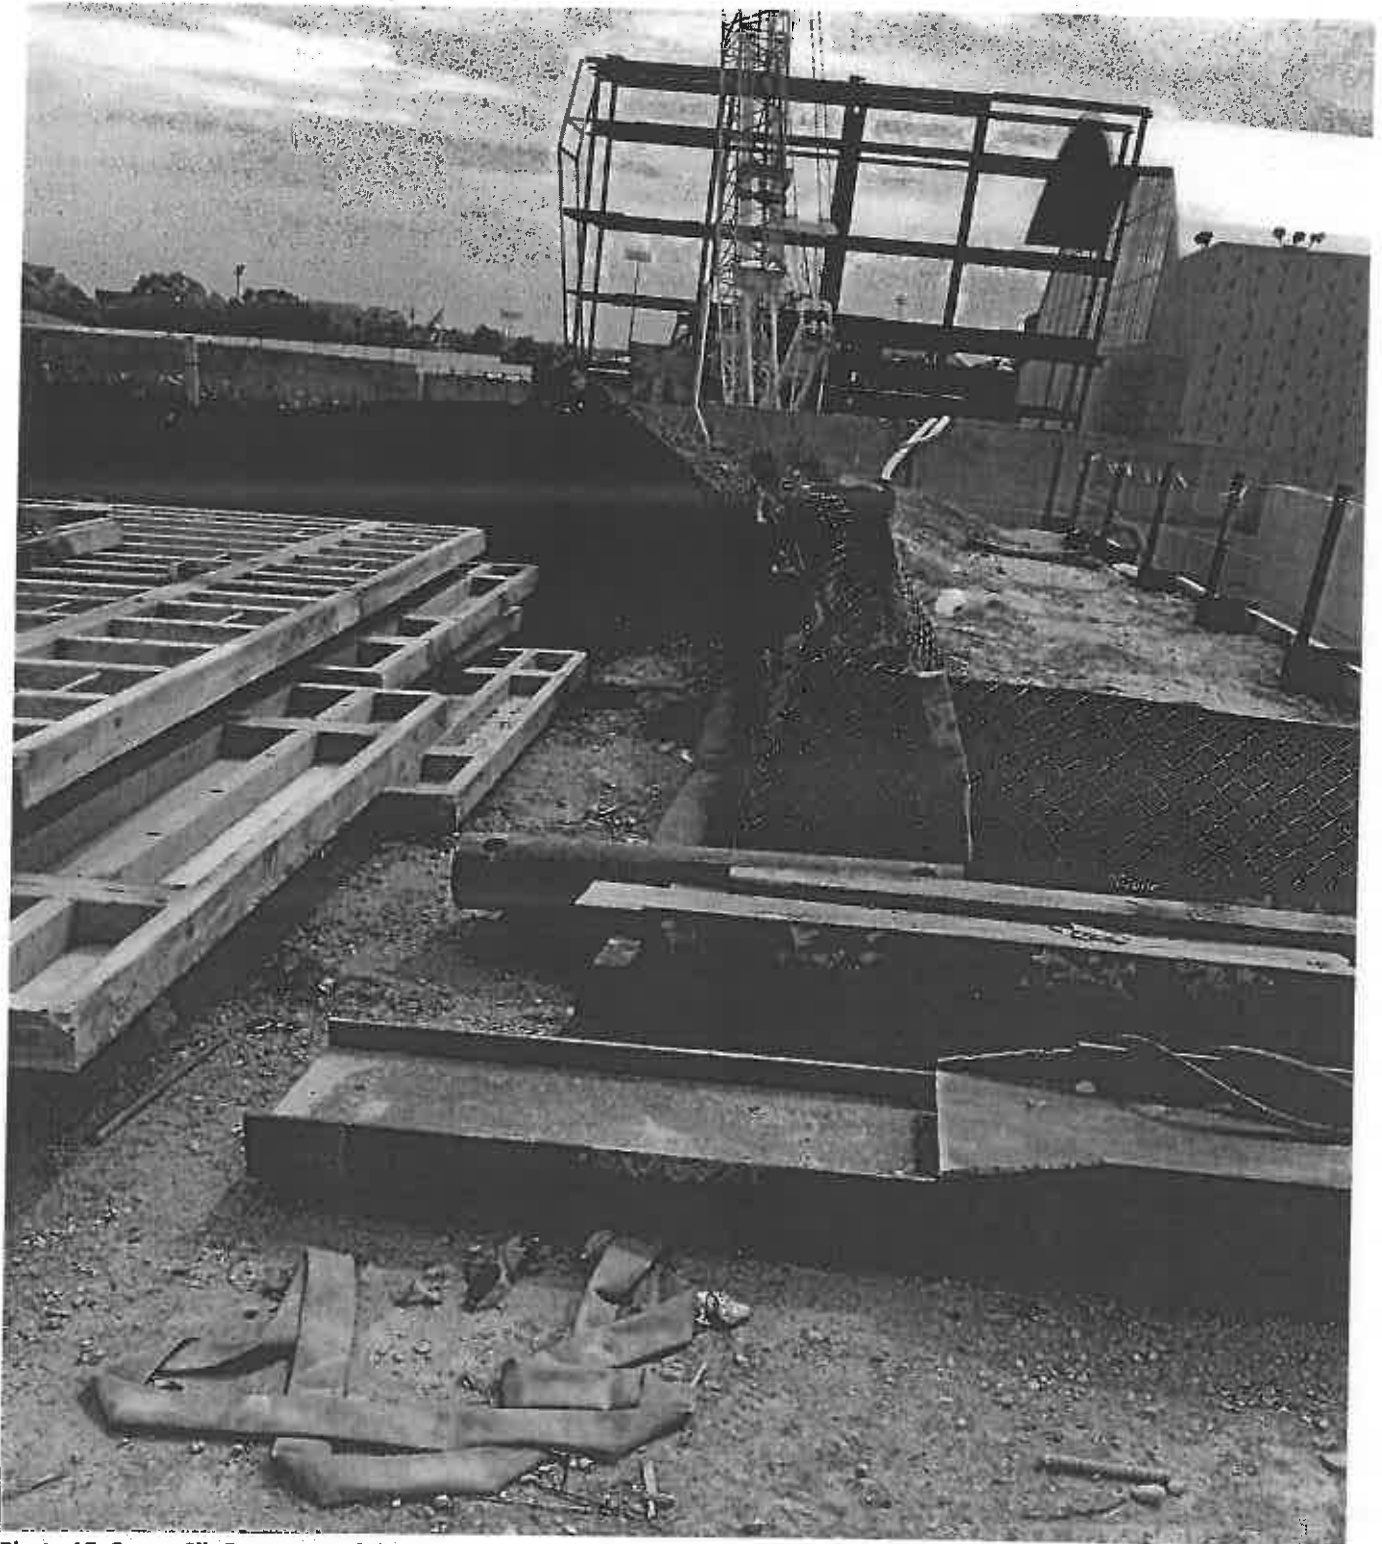
Photo 15. Super Silt Fence SW of the site

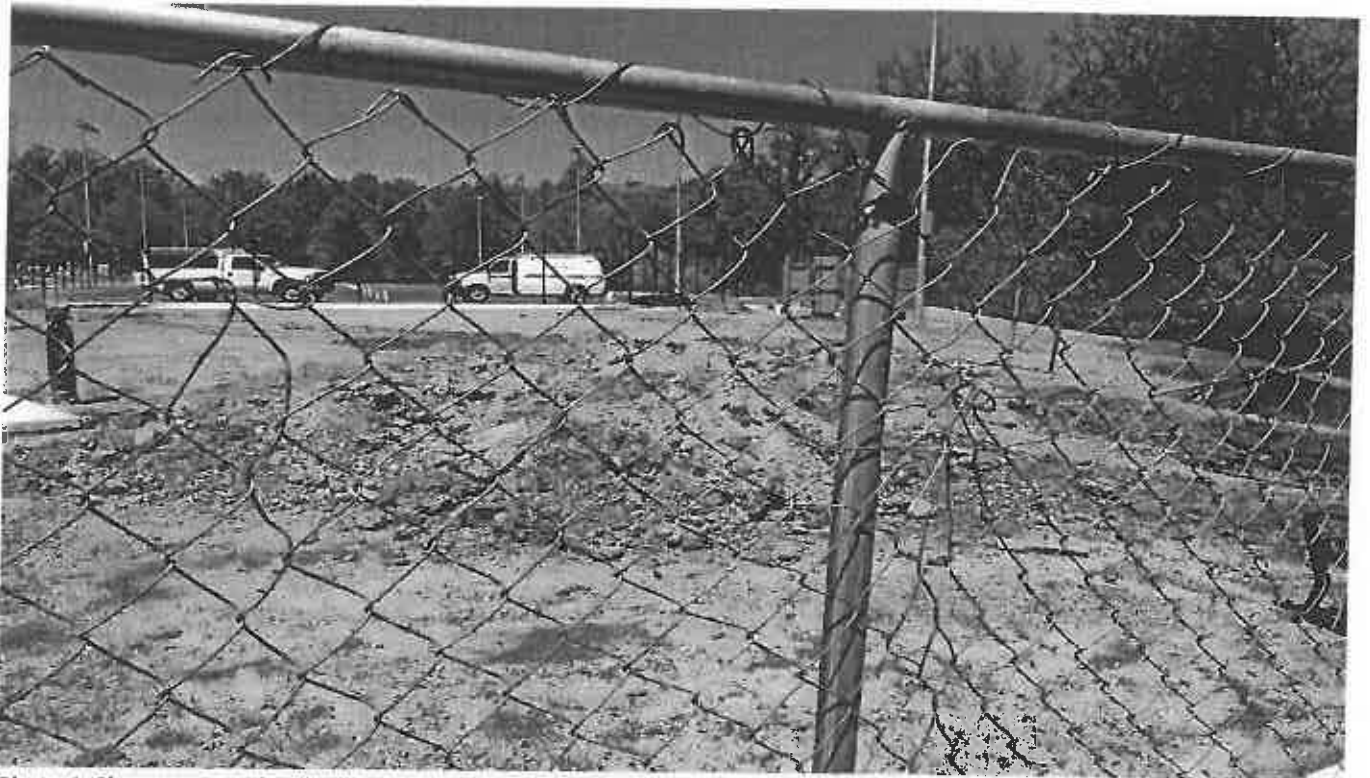
Photo 1. Shows exposed soil adjacent storm water management pond at the new tennis court

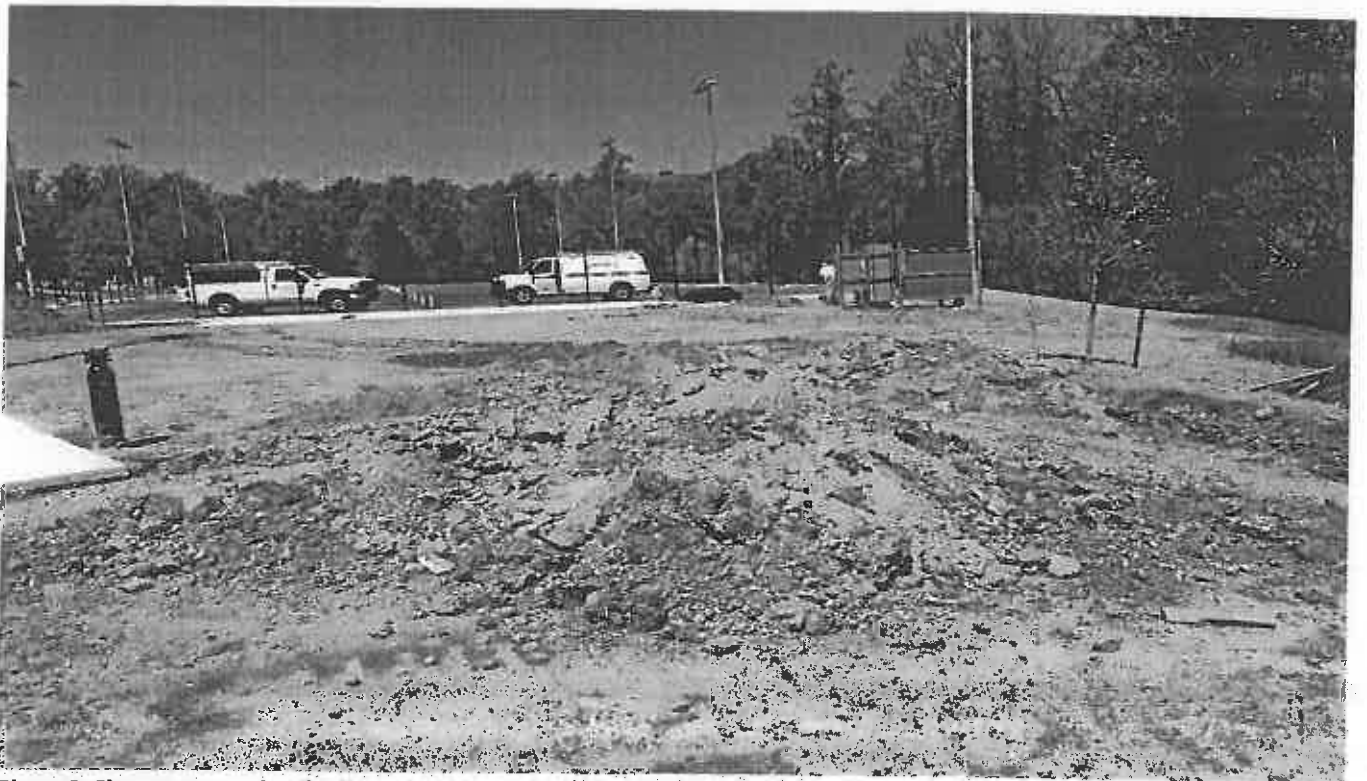
Photo 2. Shows exposed soil adjacent storm water management pond at the new tennis court

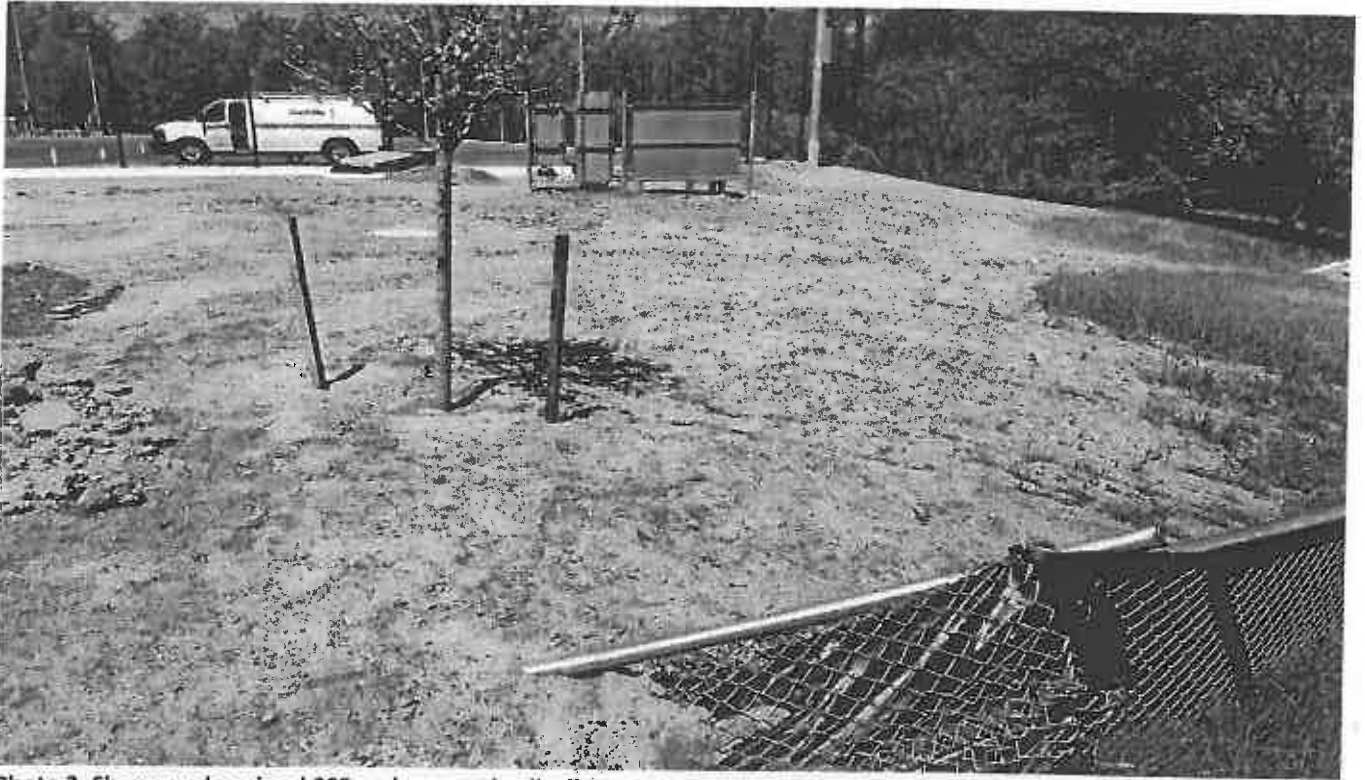
Photo 3. Shows undermined SSF and exposed soil adjacent stormwater management pond at the tennis court

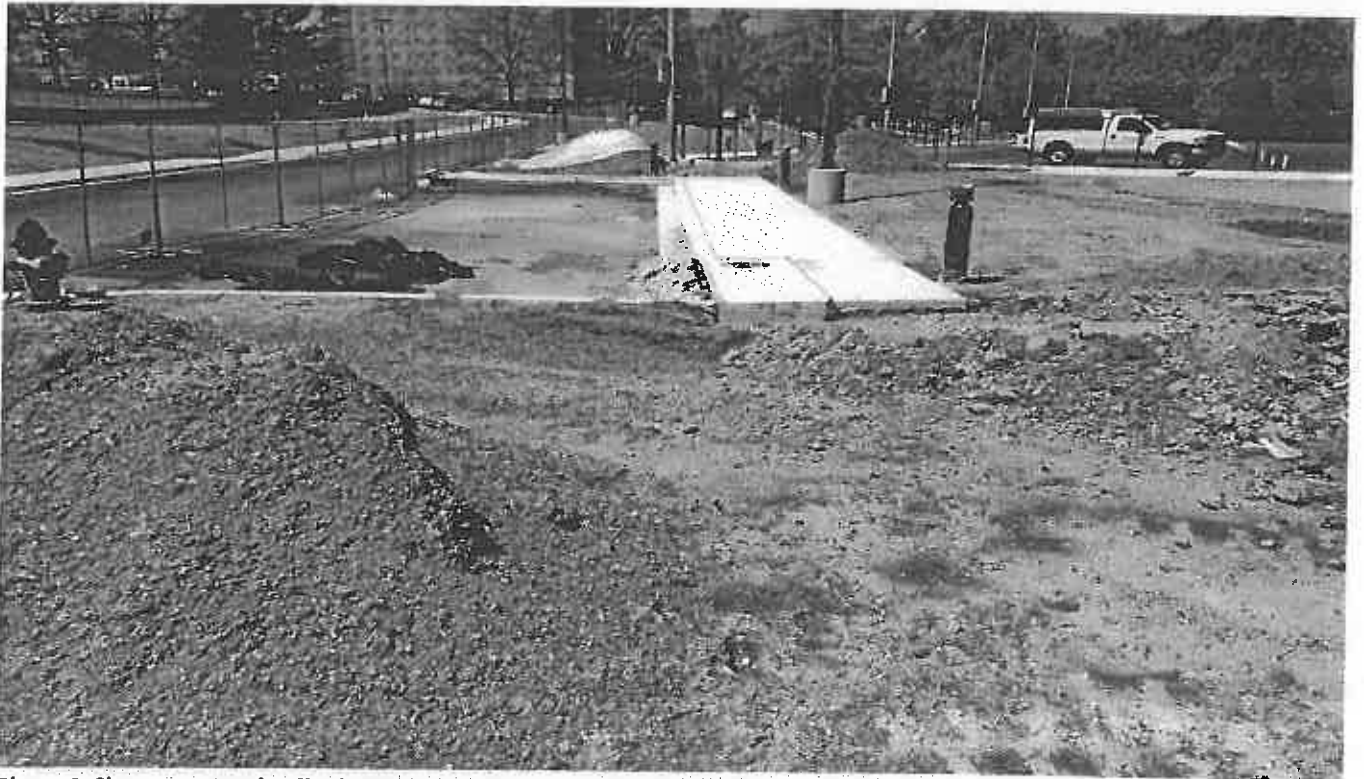
Photo 4. Shows exposed soil adjacent storm water management pond at the new tennis court

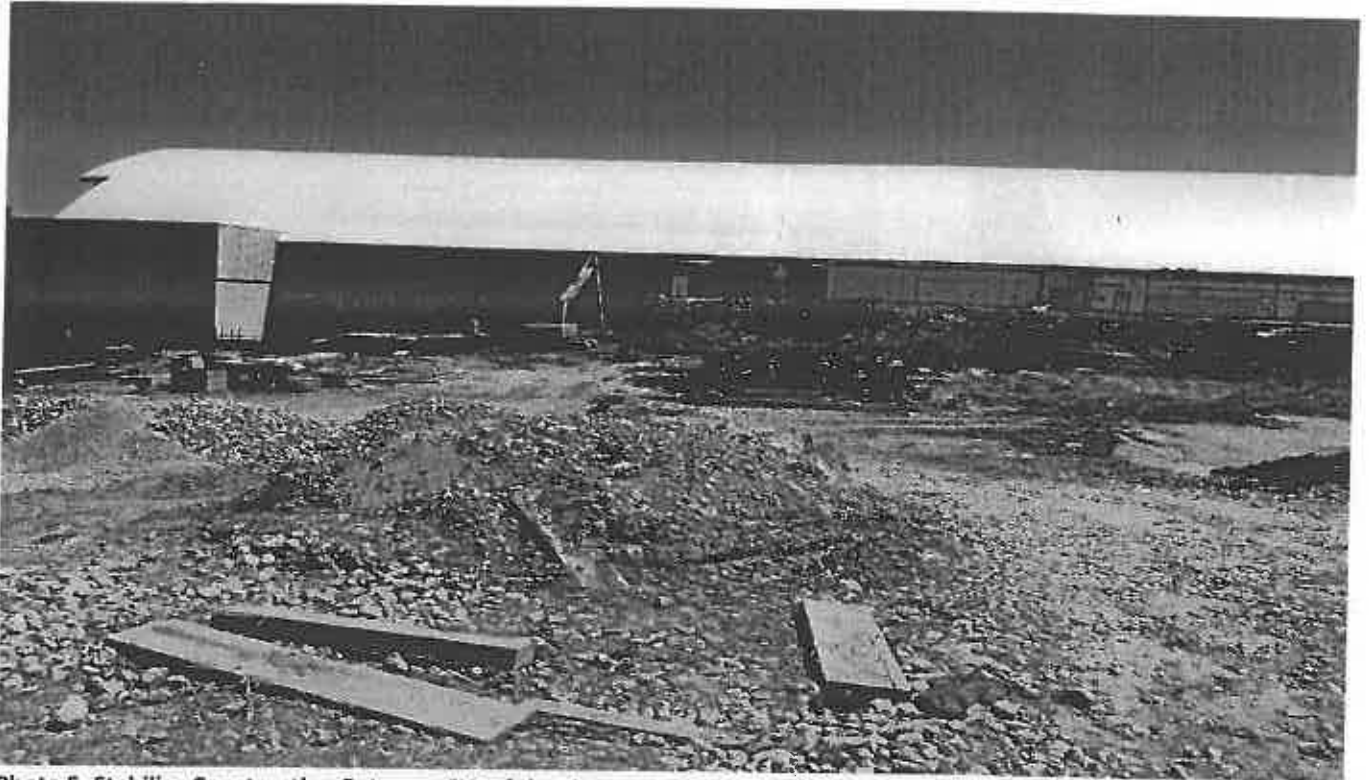
Photo 5. Stabilize Construction Entrance SW of the site

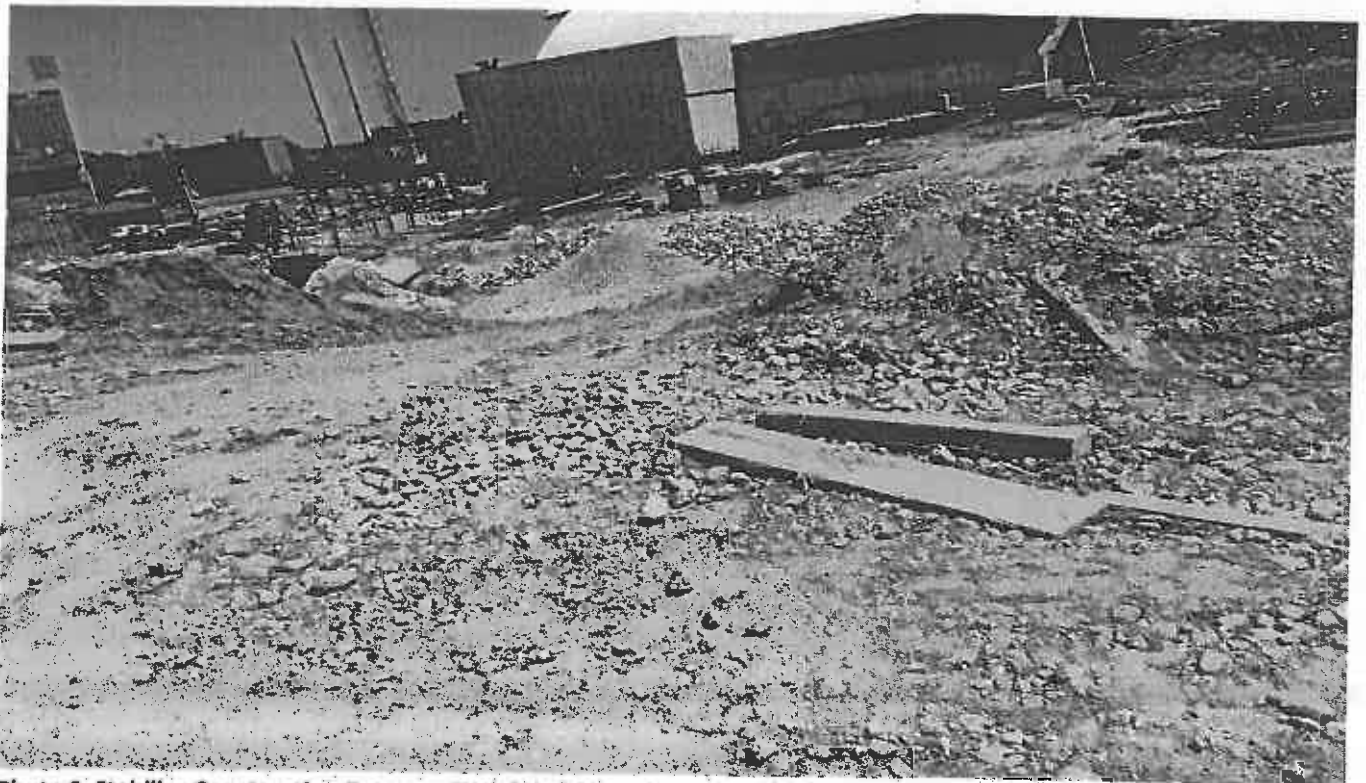
Photo 6. Stabilize Construction Entrance SW of the site

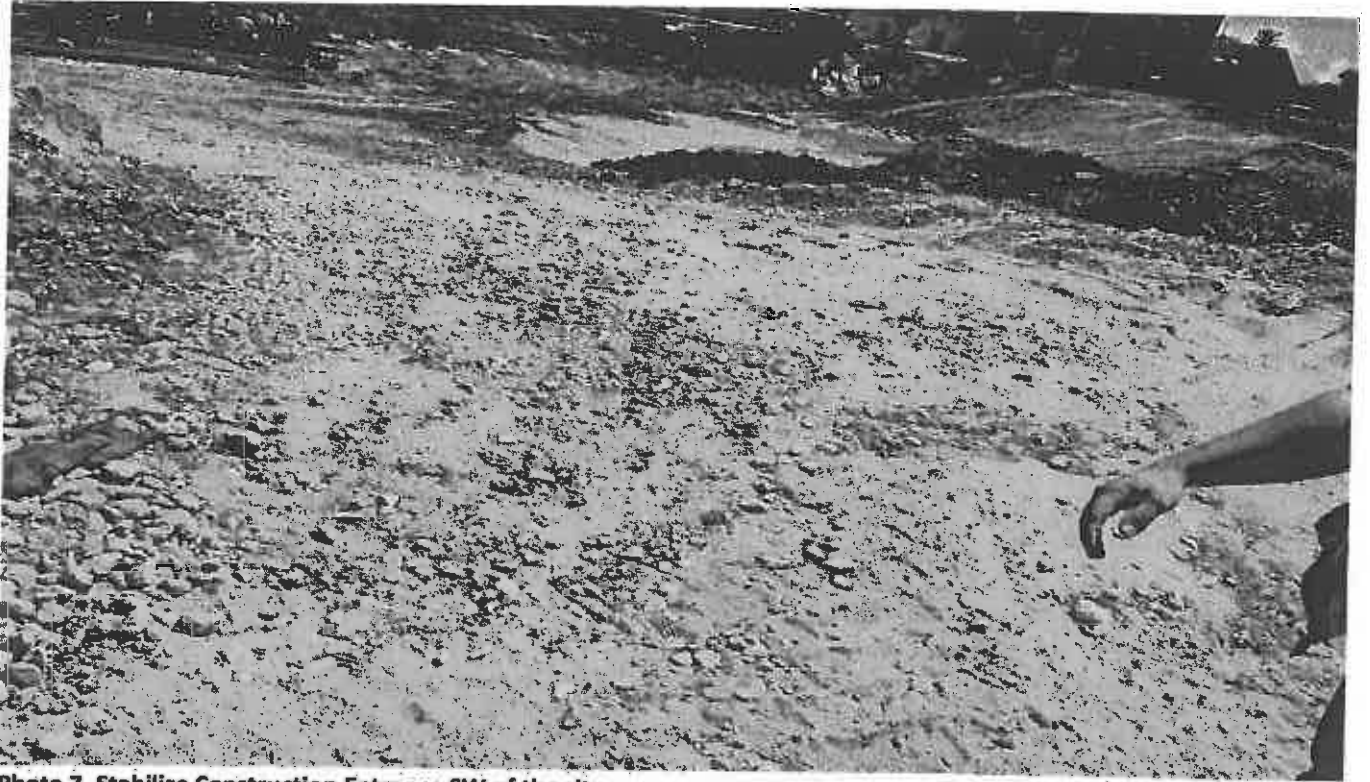
Photo 7. Stabilize Construction Entrance SW of the site

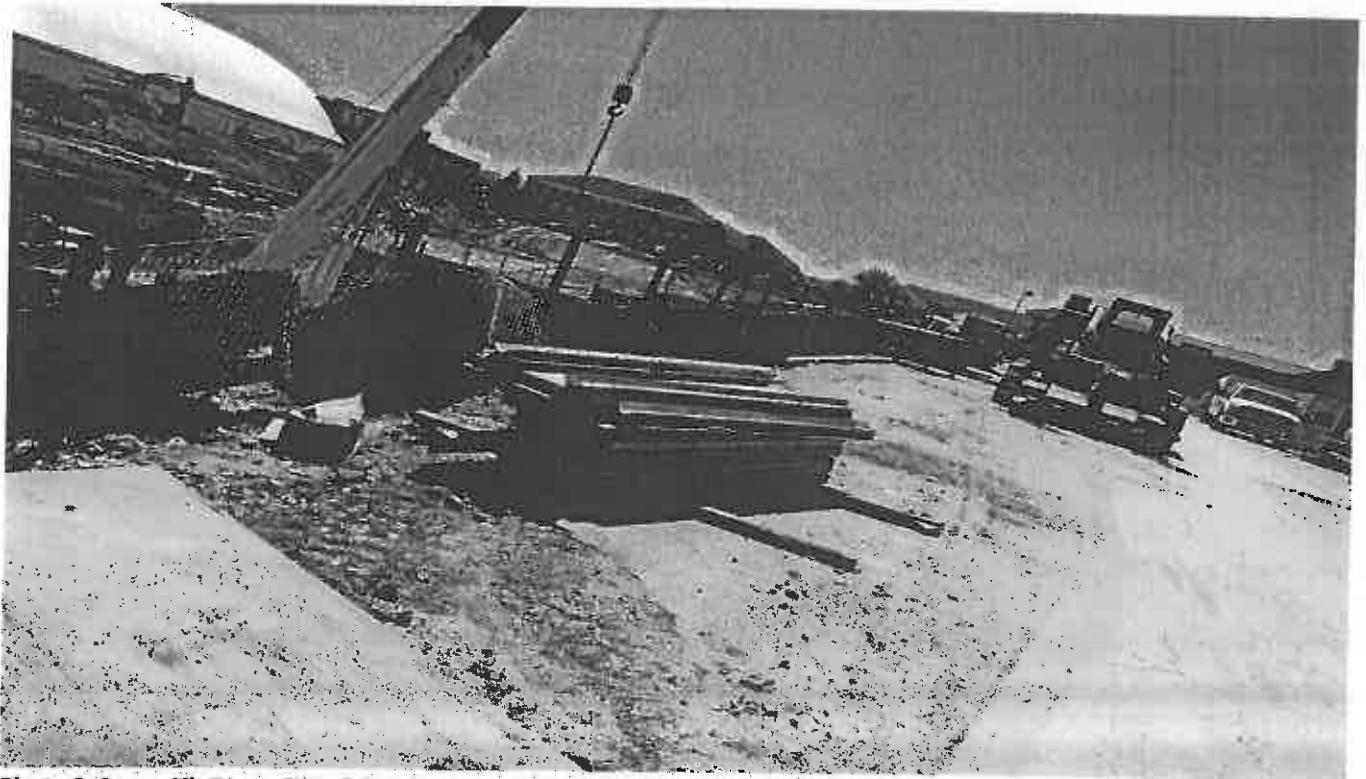
Photo 8. Super Silt Fence SW of the site

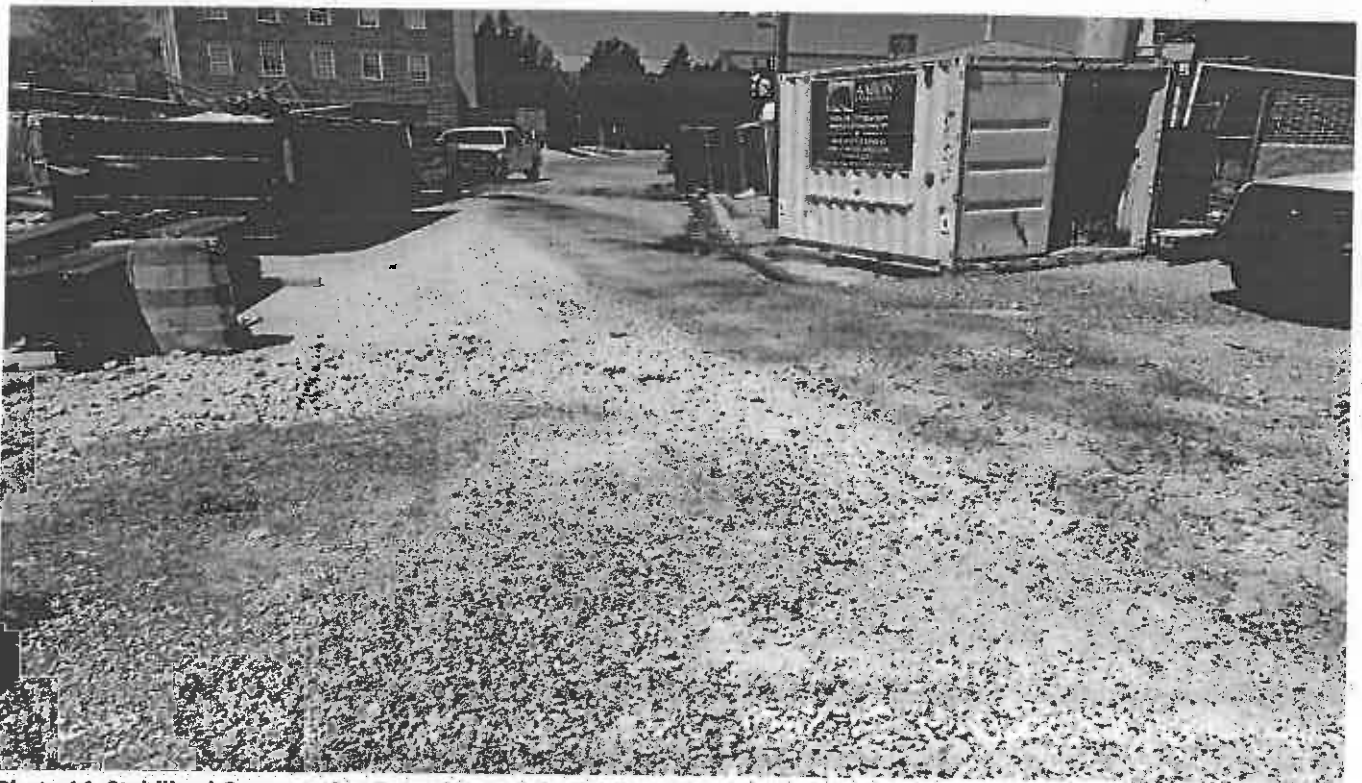
Photo 14. Stabilized Construction Entrance on Cole Fieldhouse Drive NW of the site

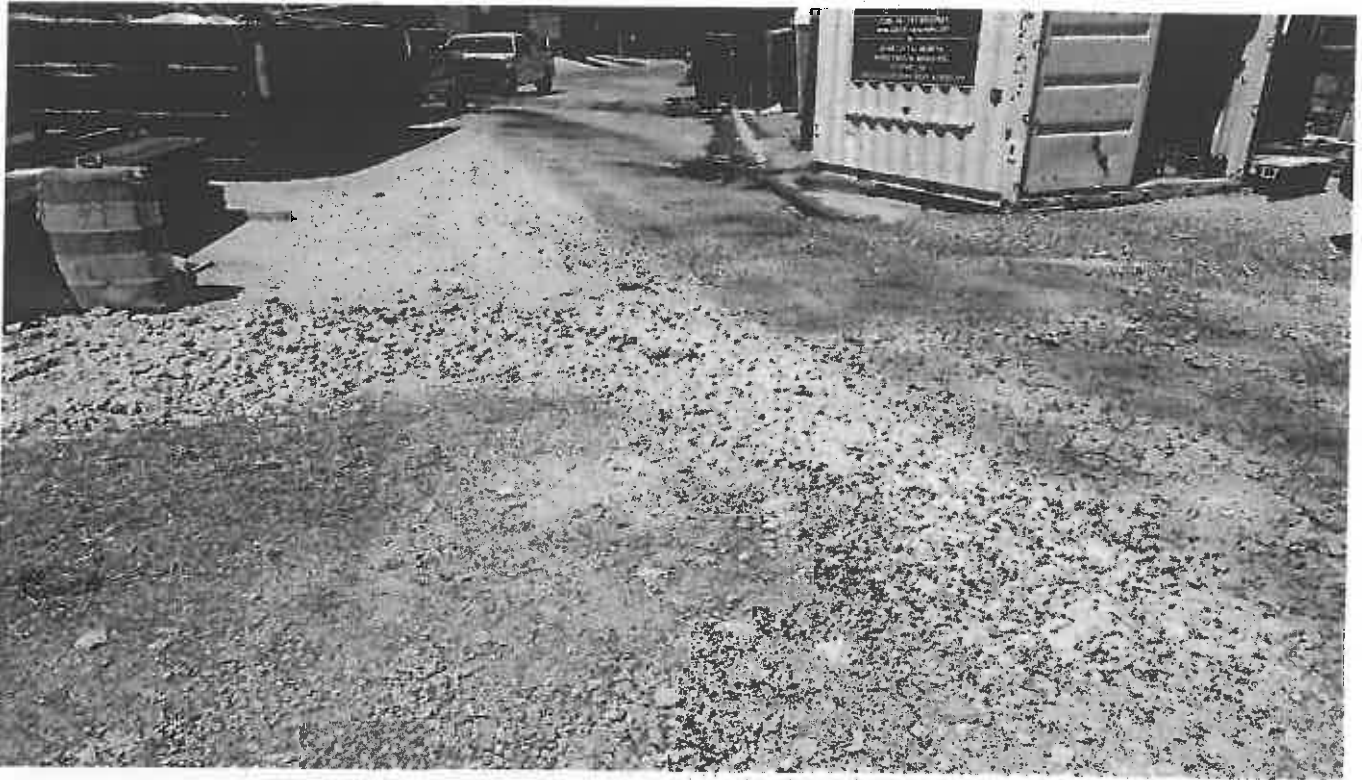
Photo 15. Stabilized Construction Entrance on Cole Fieldhouse Drive NW of the site
