Maryland Department of Environment
Water and Science Administration
Compliance Program - Western Division
91 Eastern Blvd, Hagerstown, MD 21740
301-665-2850

Site Name: New Cole Fieldhouse
Facility Address: 4090 Union Dr, College Park, MD 20742
County: Prince George's County

Inspection Date: November 5, 2018 **Start Date/Time:** November 5, 2018, 09:00 AM
End Date/Time: November 5, 2018, 10:00 AM

Media Type(s): NPDES Construction Activity, State/federal SWM

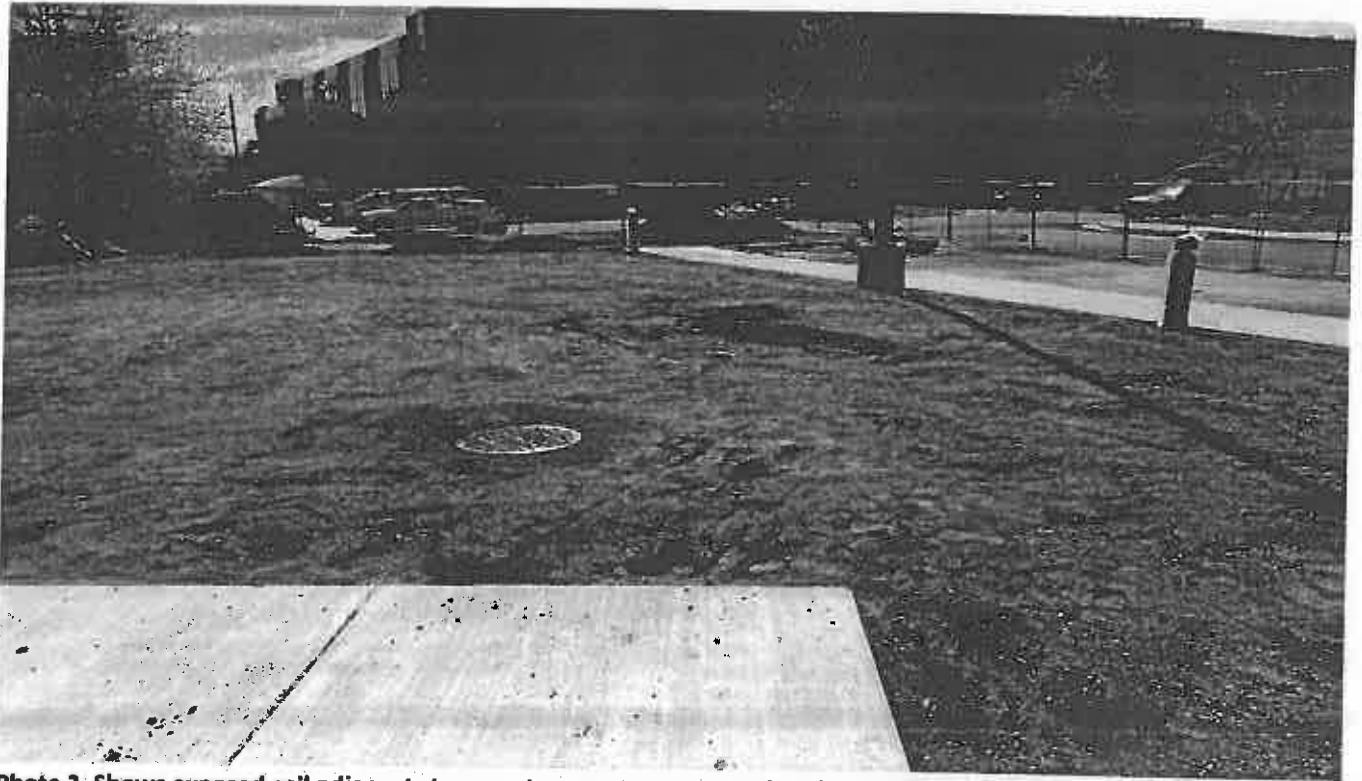
Photo 2. Shows exposed soil adjacent storm water management pond at the new tennis court

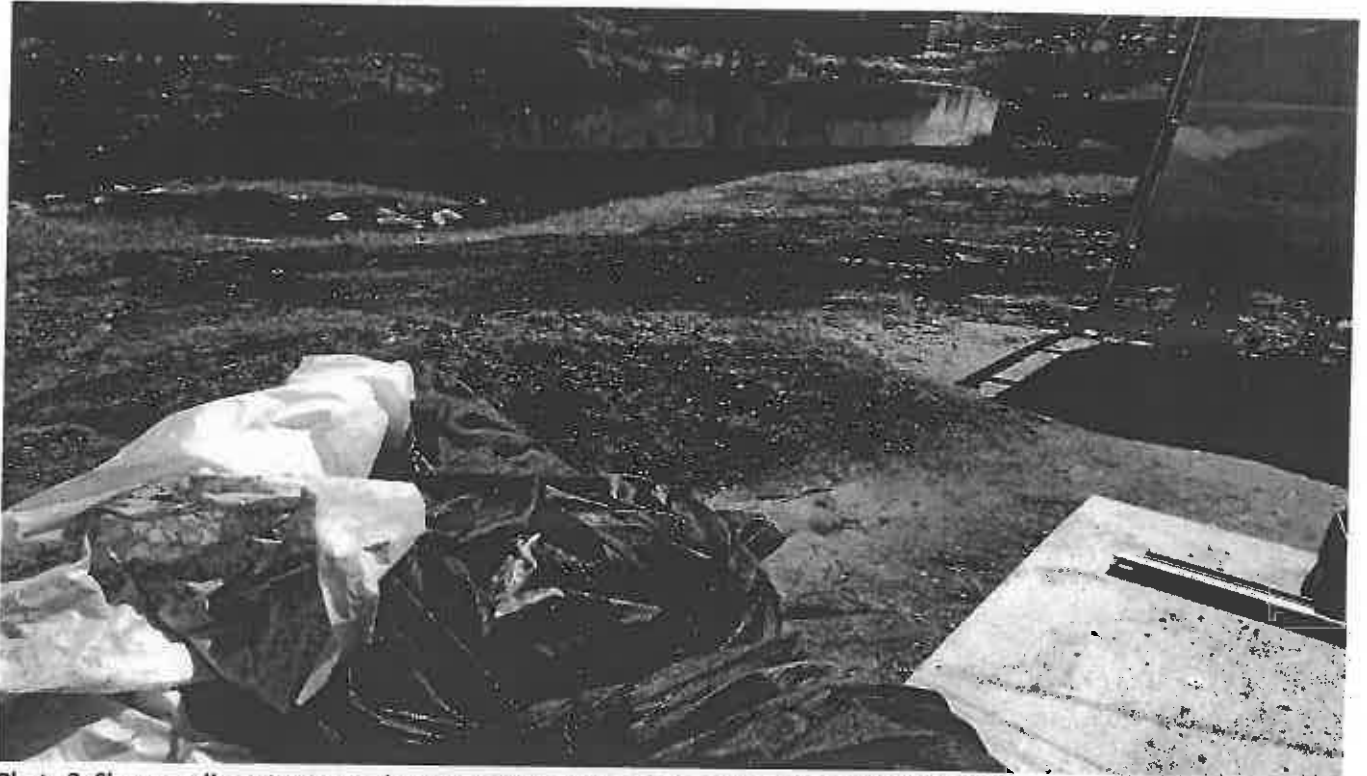
Photo 3. Shows sediment saturated storm water management pond at the new tennis Court.

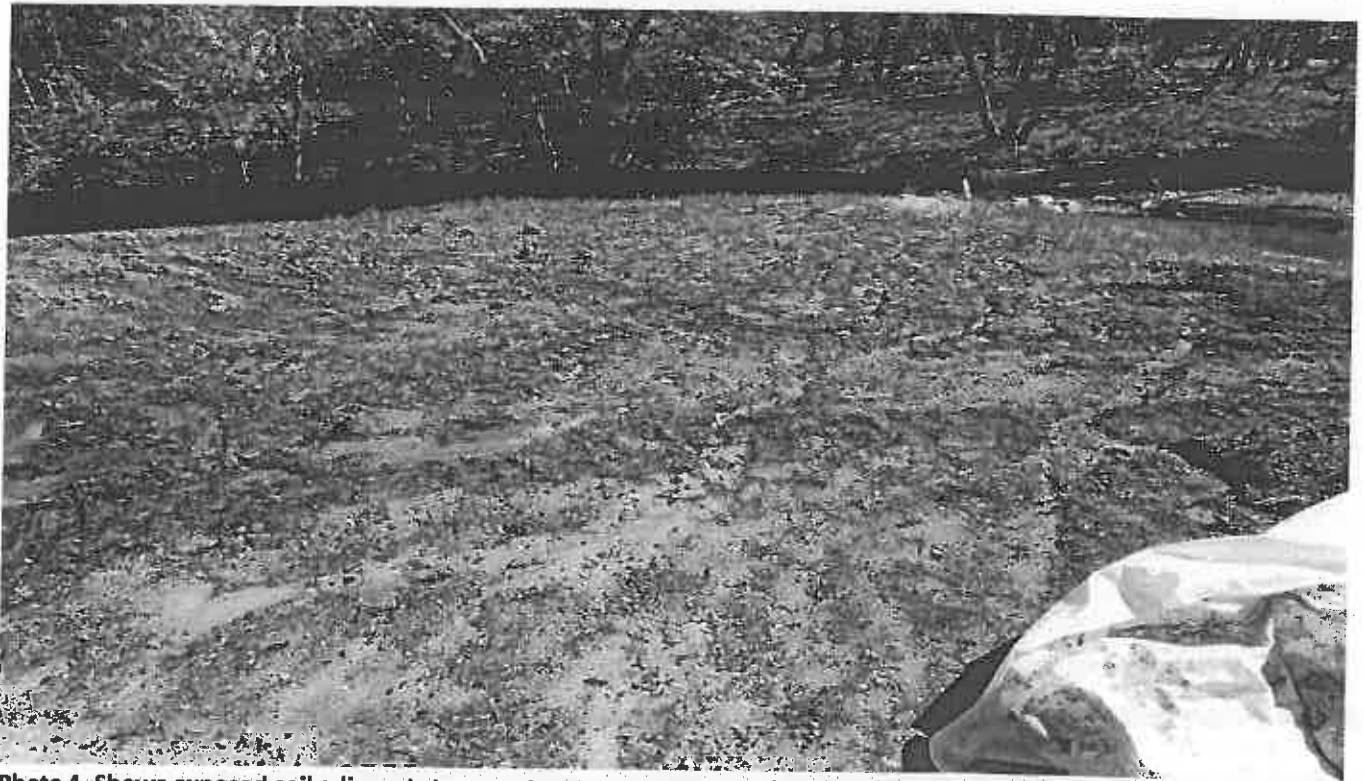
Photo 4. Shows exposed soil adjacent storm water management pond at the new tennis court

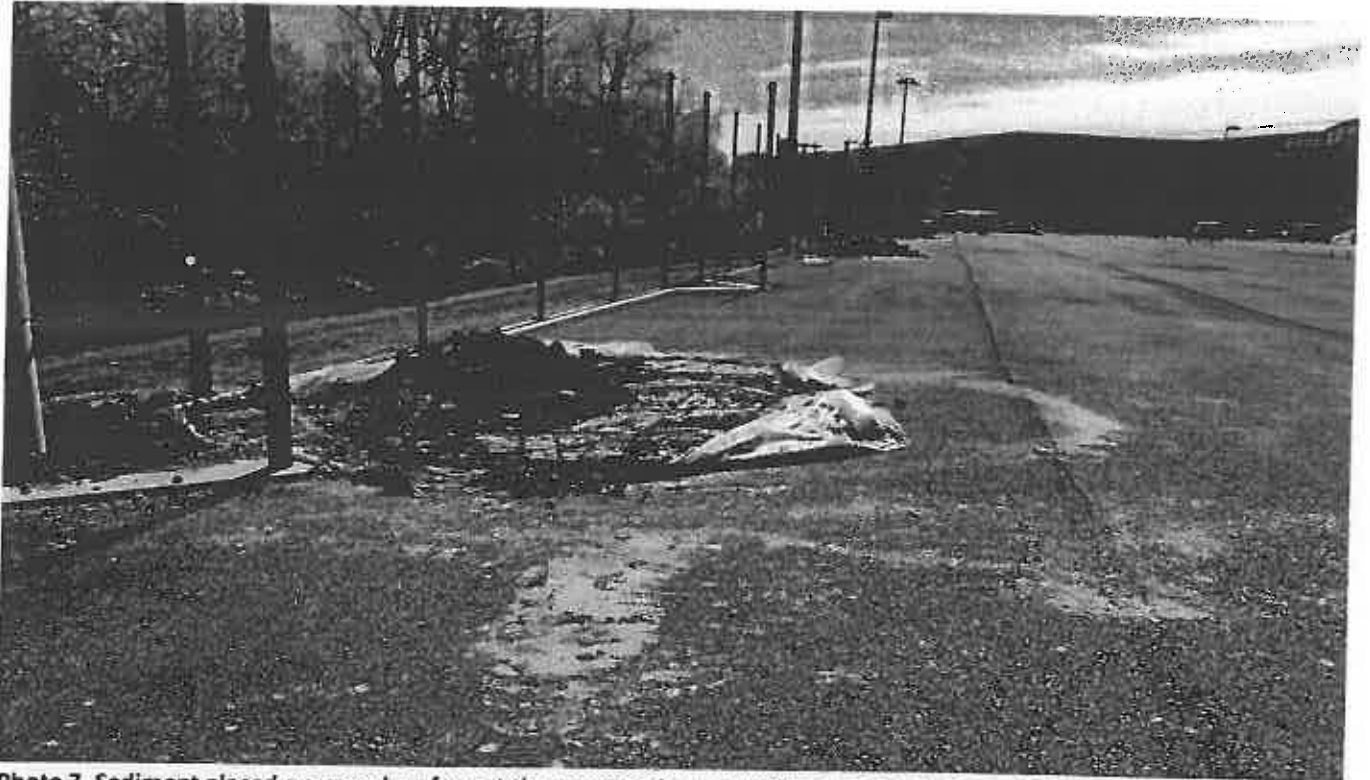
Photo 7. Sediment placed on paved surface at the new tennis court with potentials to impact the stormdrain

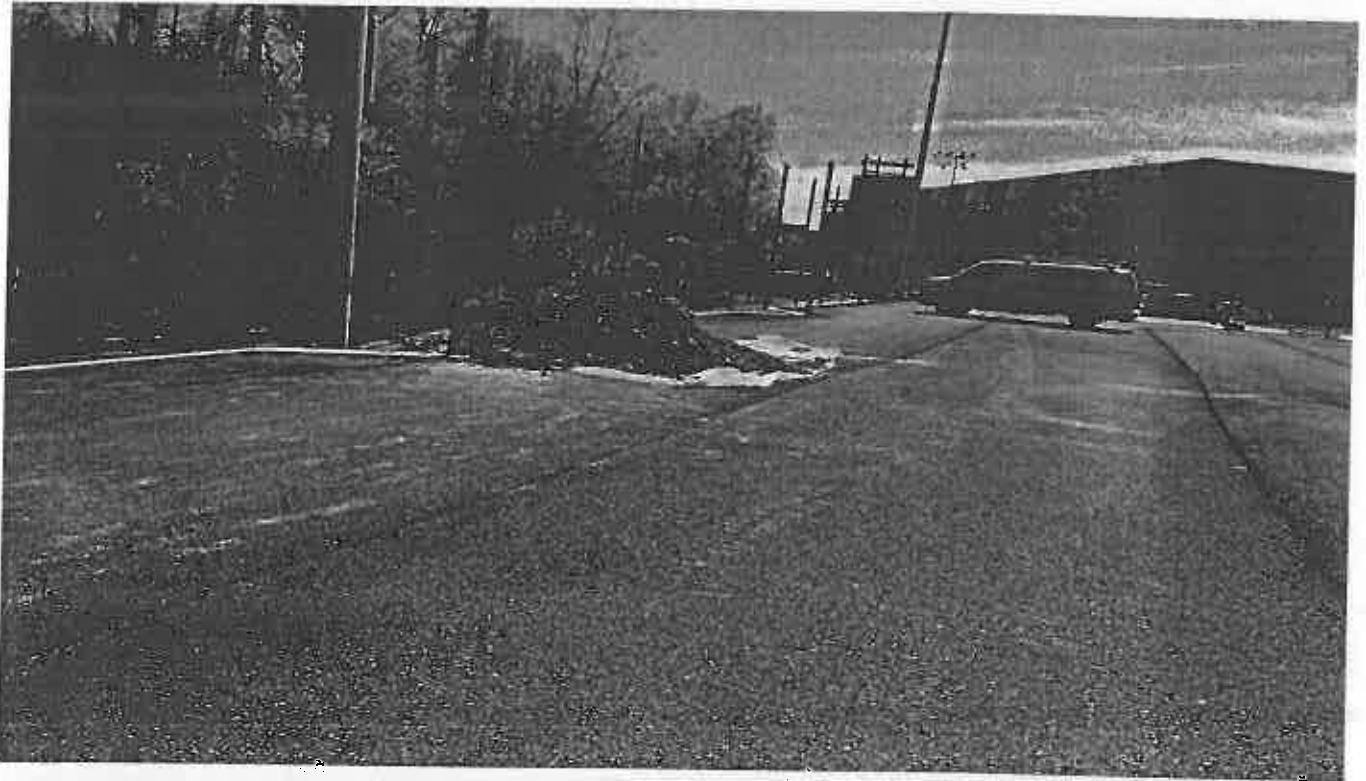
Photo 8. Sediment placed on paved surface at the new tennis court with potentials to impact the stormdrain

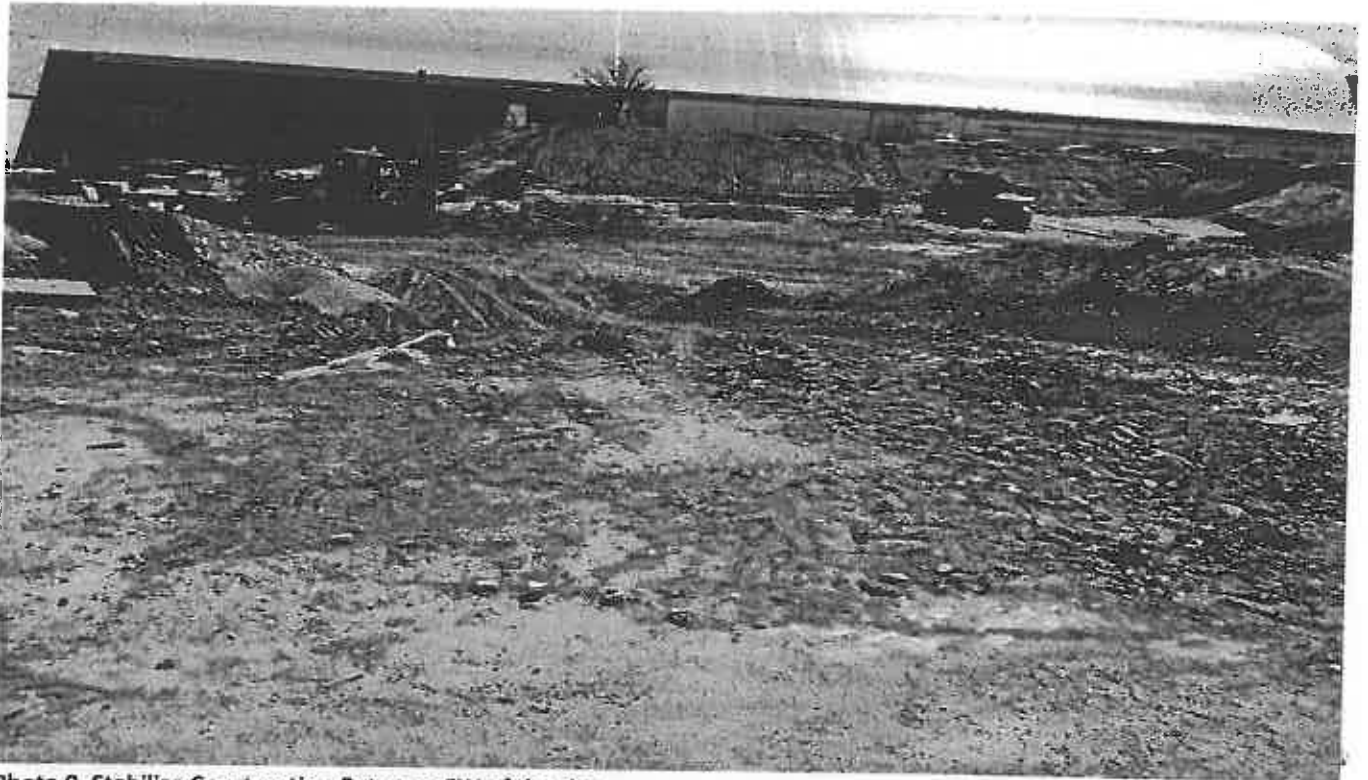
Photo 9. Stabilize Construction Entrance SW of the site

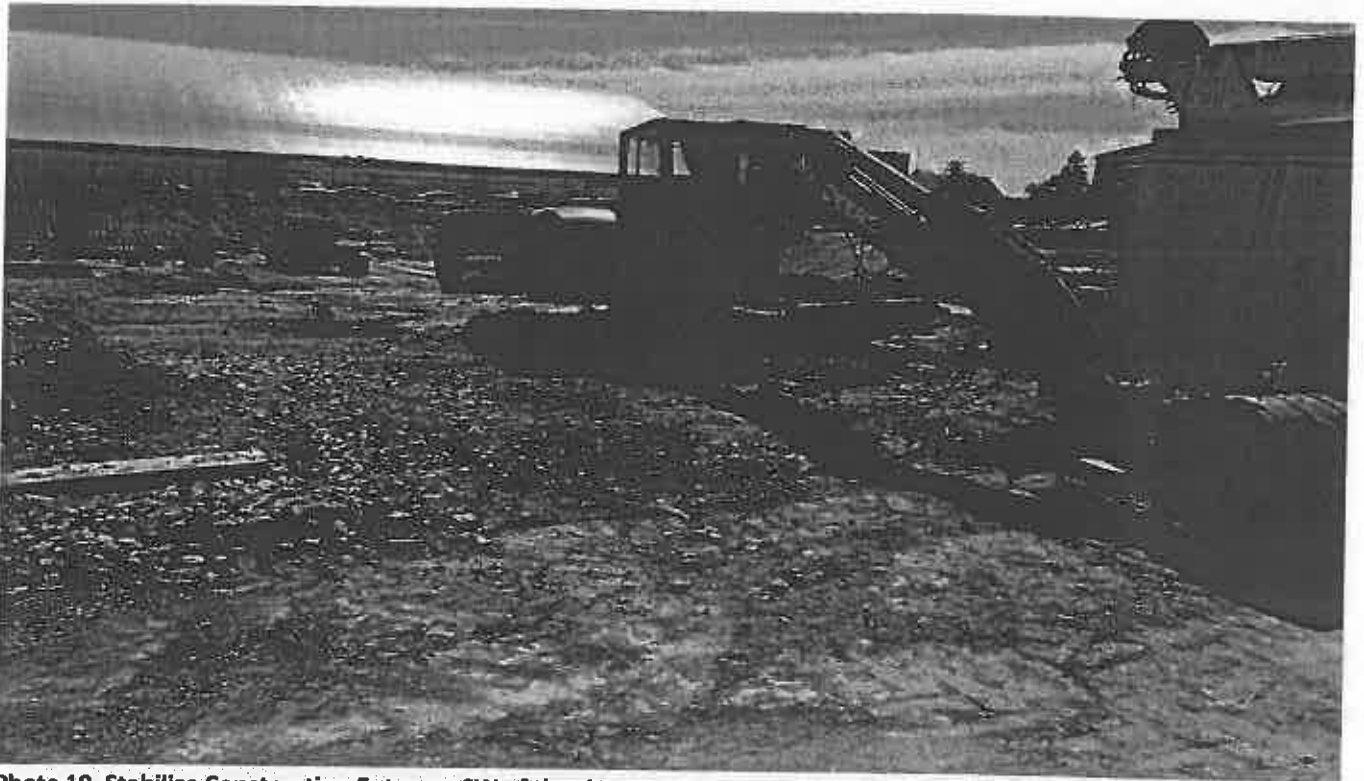
Photo 10. Stabilize Construction Entrance SW of the site

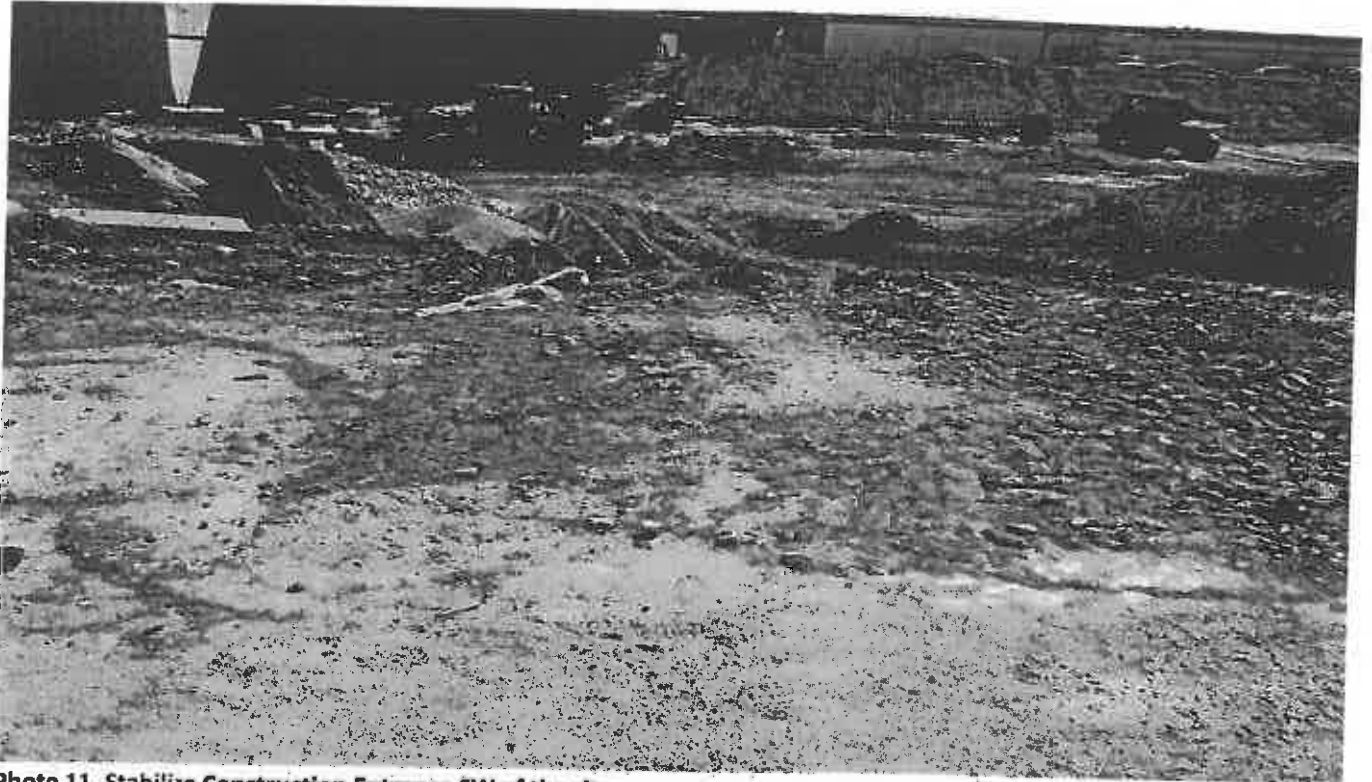
Photo 11. Stabilize Construction Entrance SW of the site

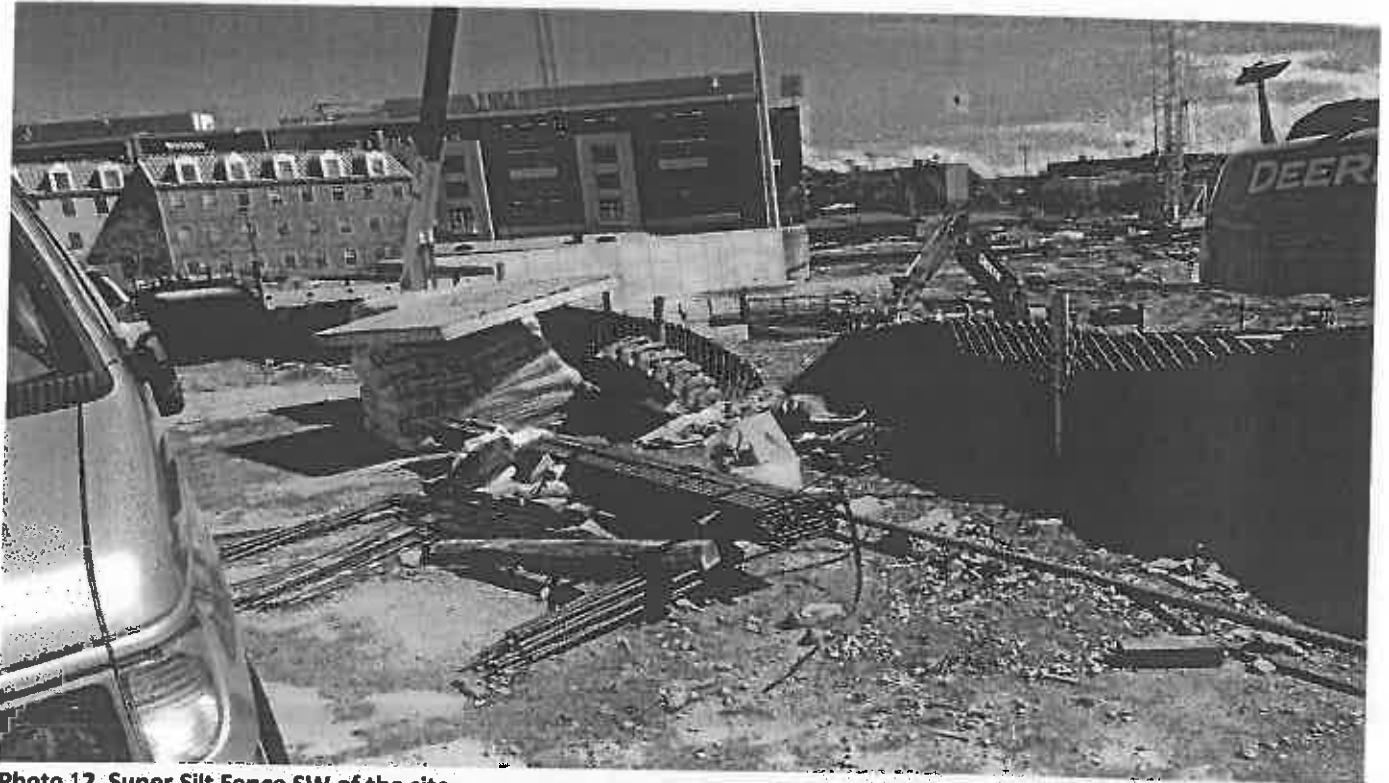
Photo 12. Super Silt Fence SW of the site

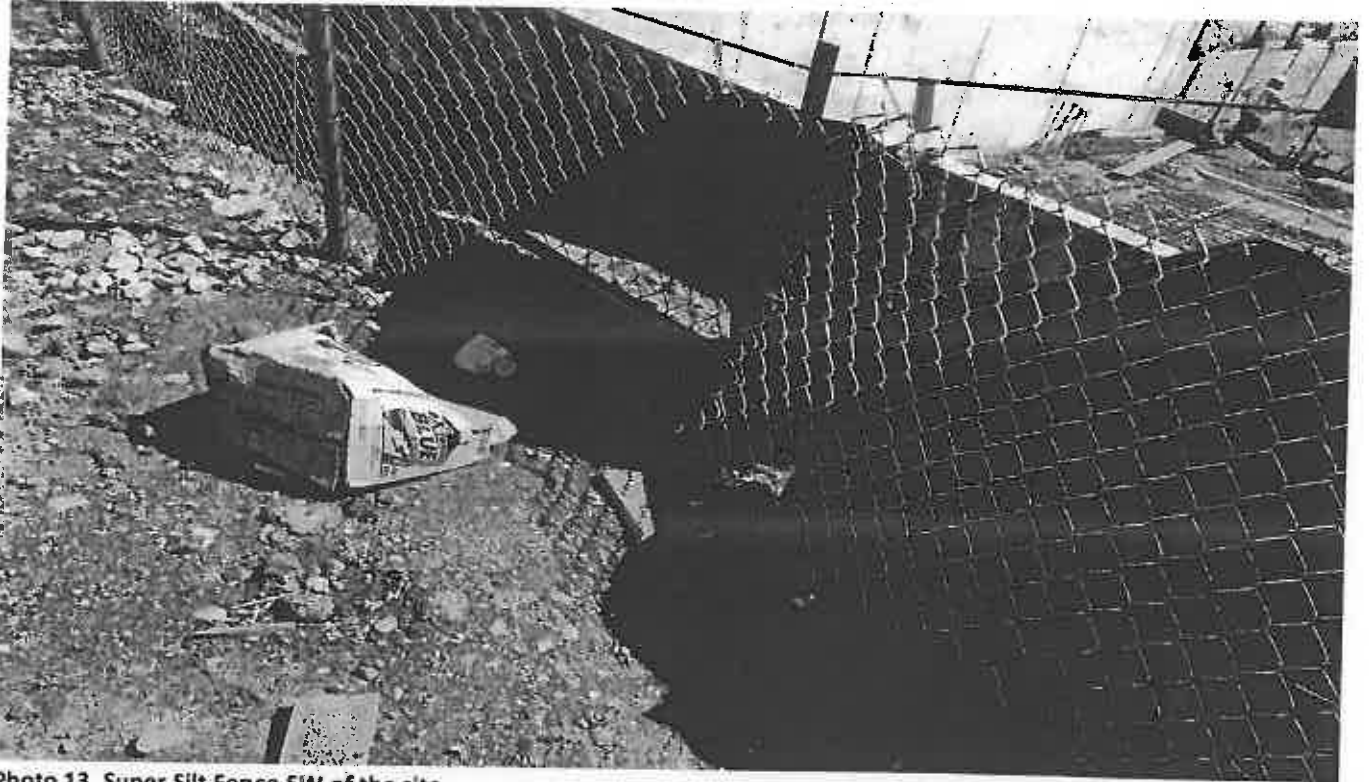
Photo 13. Super Silt Fence SW of the site
